VEHICLE INSPECTION REPORT

BU14FBN

Mercedes-Benz Econic 2629

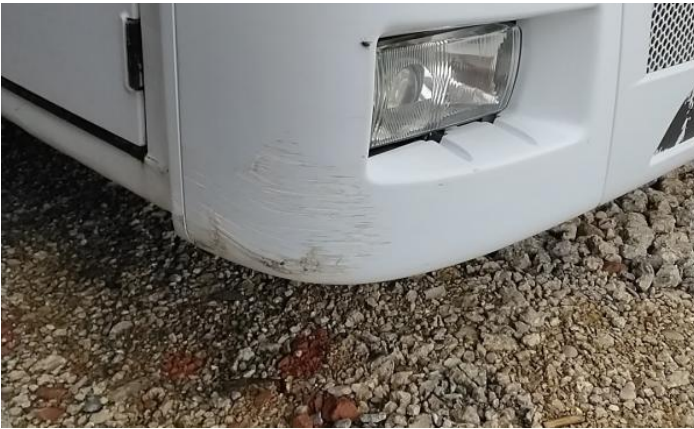
1: Bumper Front
Scratched
25 to 100mm Thru Paint

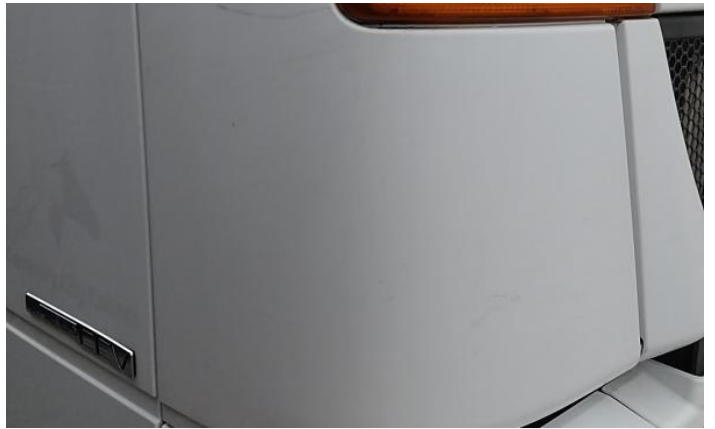
2: Wing osf
Scratched
Over 25mm Not Thru Paint

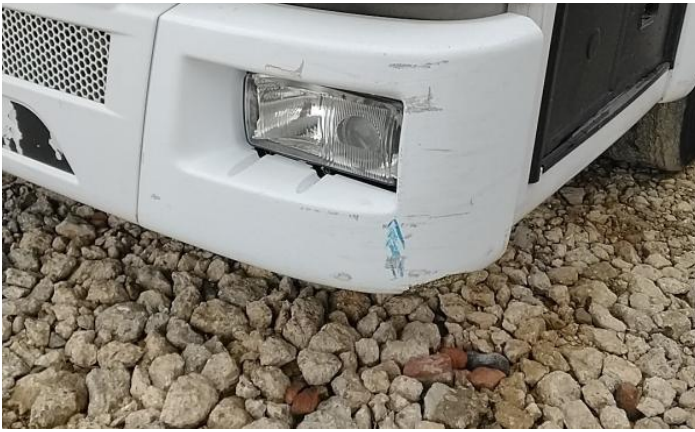
3: Bumper Front
Scratched
Over 25mm Not Thru Paint

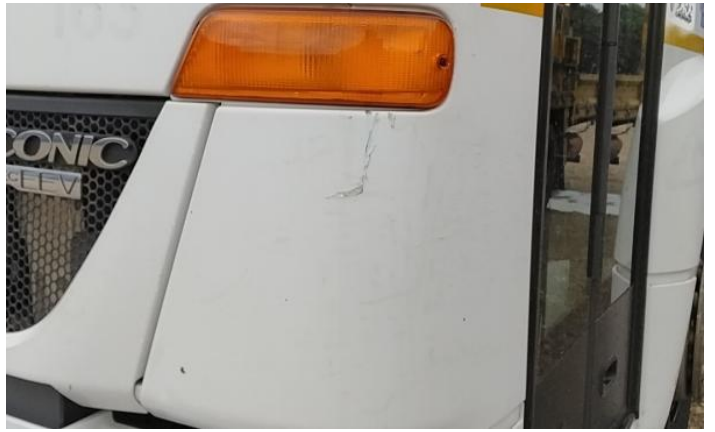
4: Wing nsf
Cracked
Replace

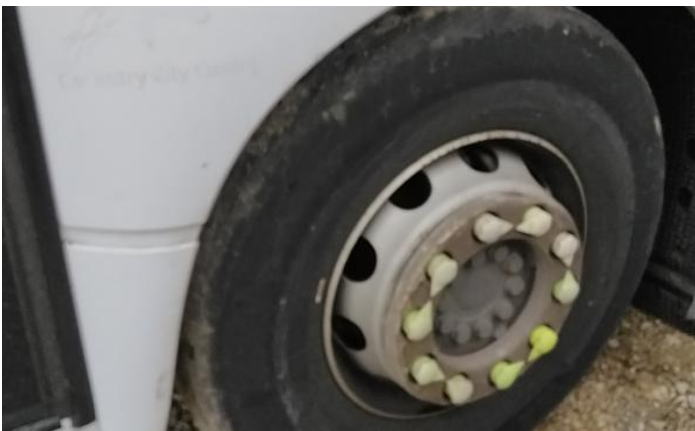
5: Wing Front Arch Extension ns
Broken
Replace

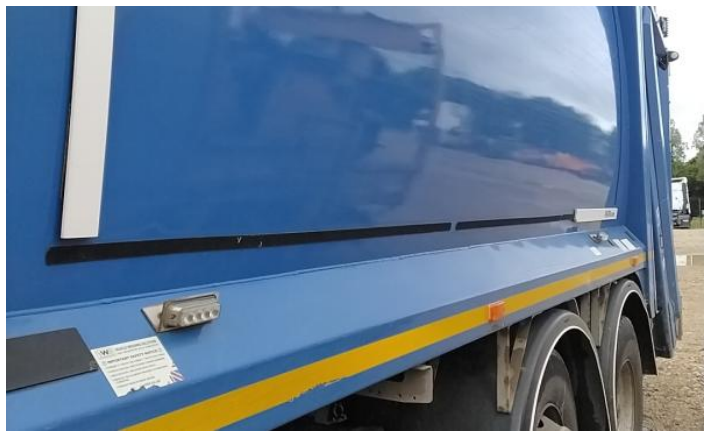
6: Qtr Panel nsr
Scratched
Over 25mm Not Thru Paint

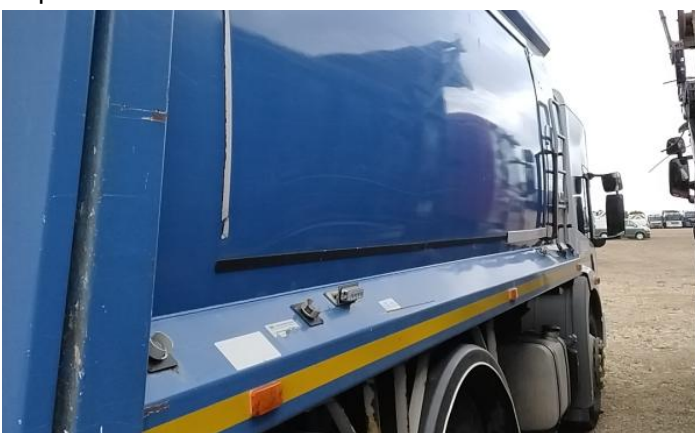
7: Qtr Panel osr
Scratched
Over 25mm Not Thru Paint

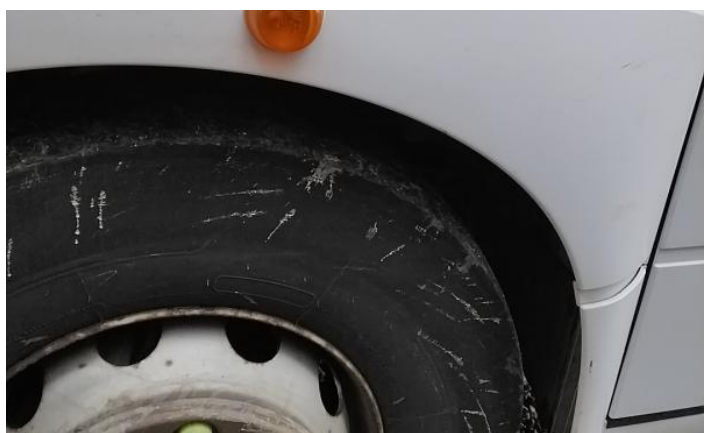
8: Wing Front Arch Extension os
Scratched (Painted)
Over 25mm Not Thru Paint

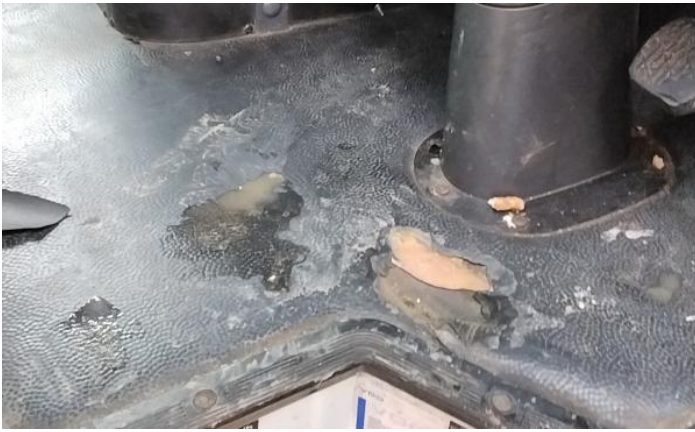
9: Carpets Front
Holed
Over 3mm

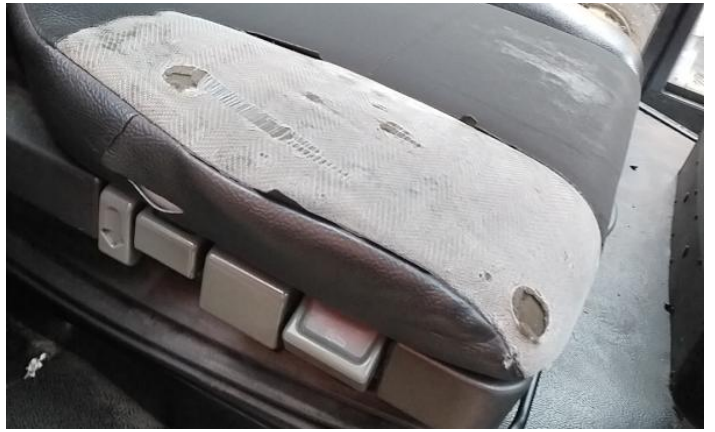
10: Seat Base Cover osf
Torn
Over 3mm

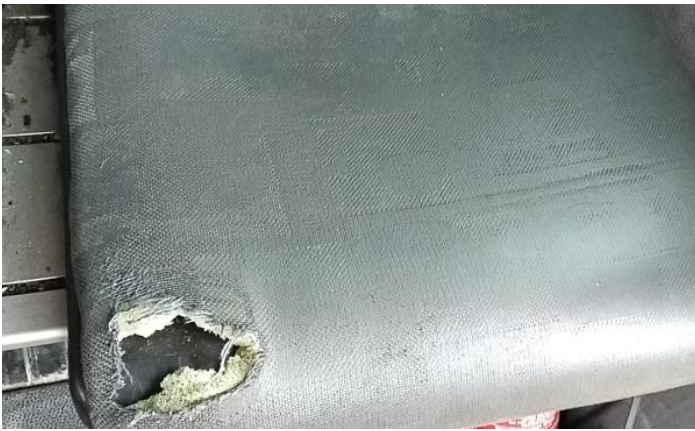
11: Seat Base Cover nsf
Holed
Over 3mm

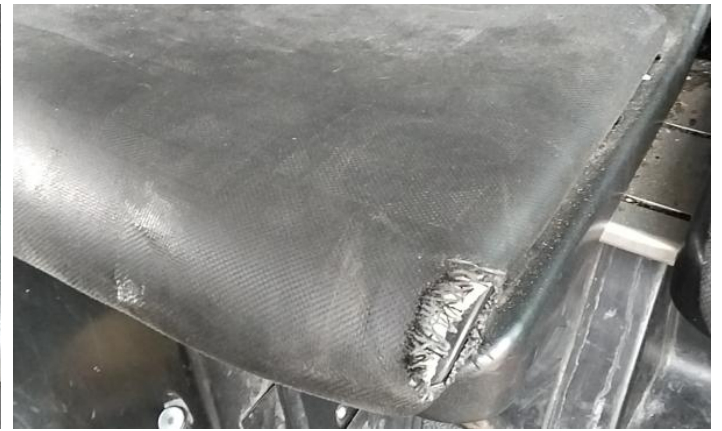
12: Seat Base Cover nsf
Holed
Over 3mm
