VEHICLE INSPECTION REPORT

BU14FBL

Mercedes-Benz Econic 2629

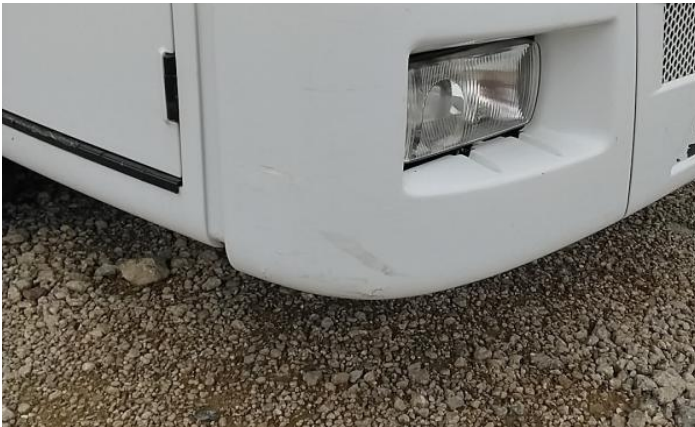
1: Bumper Front
Scratched
Over 25mm Not Thru Paint

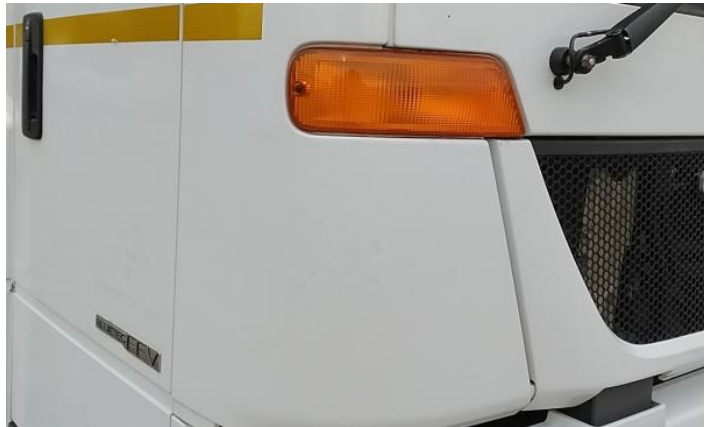
2: Wing of
Scratched
Over 25mm Not Thru Paint

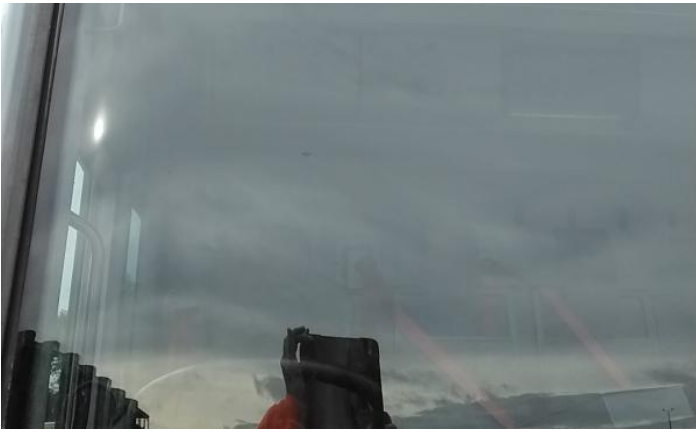
3: Screen Front
Chipped
Over 10mm

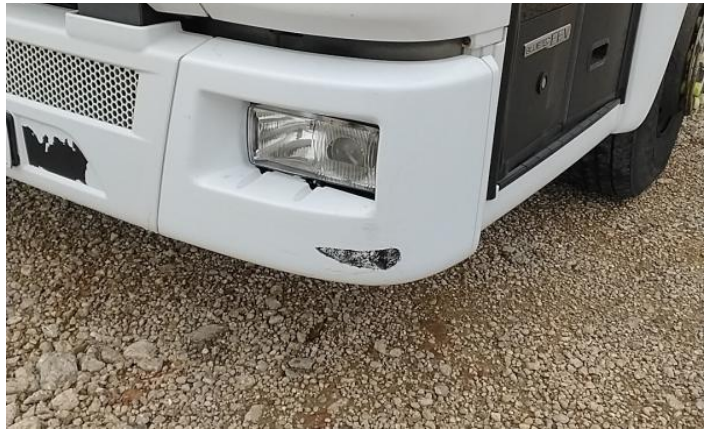
4: Bumper Front
Scratched
Over 25mm Not Thru Paint

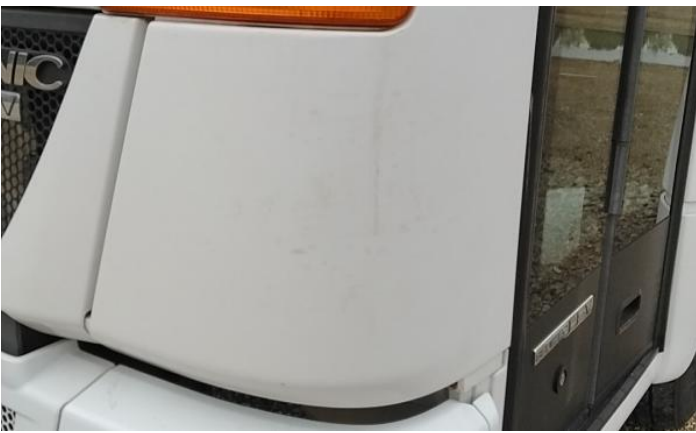
5: Wing nsf
Scratched
Over 25mm Not Thru Paint

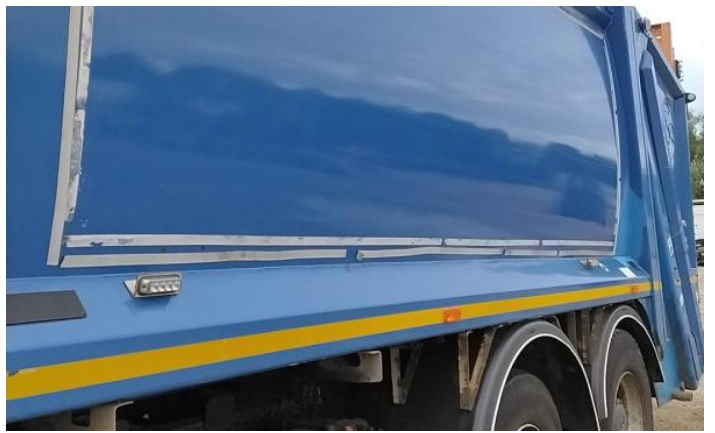
6: Qtr Panel nsr
Scratched
Over 25mm Not Thru Paint

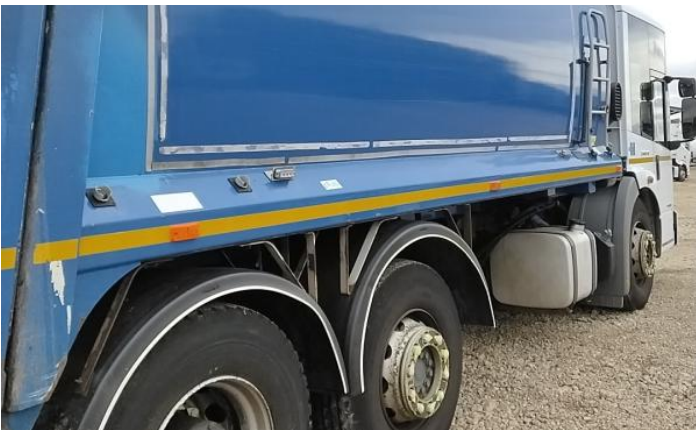
7: Qtr Panel osr
Scratched
Over 25mm Not Thru Paint

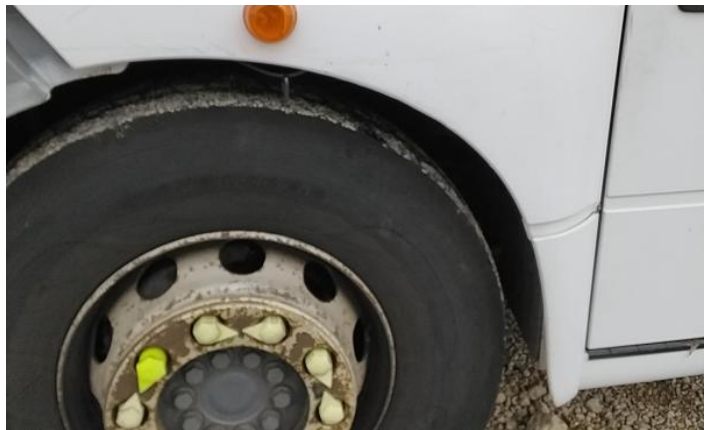
8: Wing Front Arch Extension os
Scratched (Painted)
UpTo 25mm Not Thru Paint

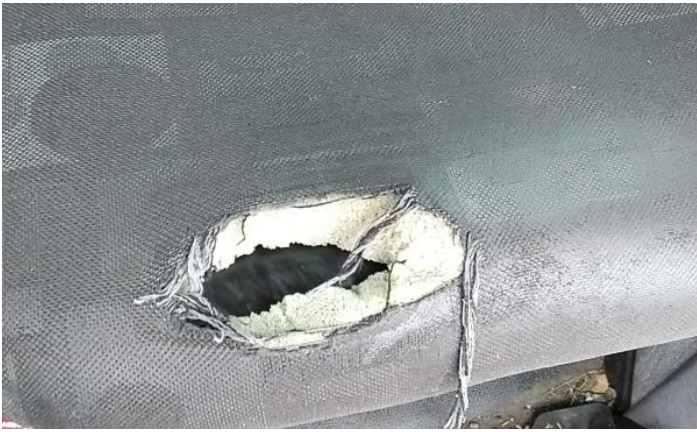
9: Seat Base Cover nsf
Holed
Over 3mm

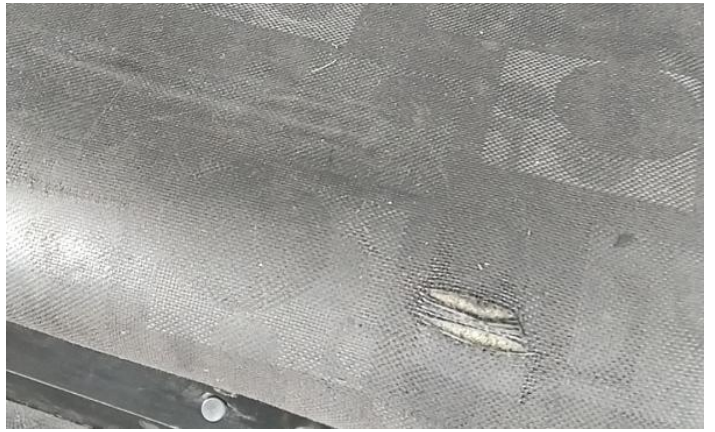
10: Seat Base Cover nsf
Holed
Over 3mm

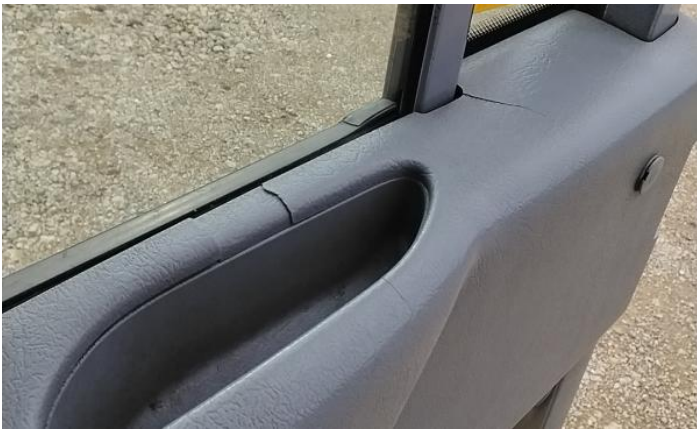
11: Door Pad osf
Broken
Replace

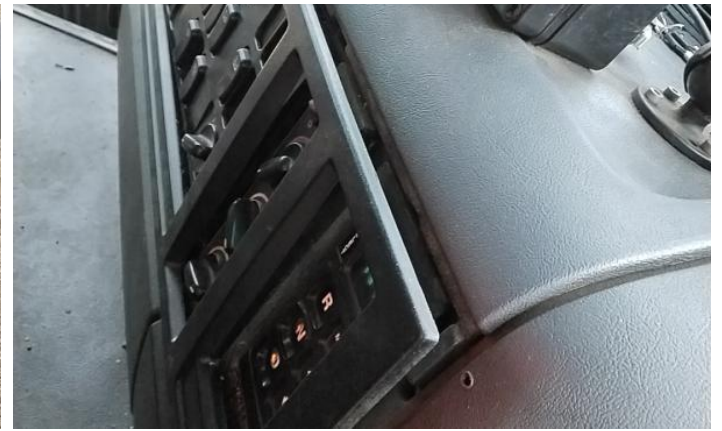
12: Centre Console Front
Broken
Replace
