# VEHICLE INSPECTION REPORT

**DA69GOJ**

## Isuzu N75 190

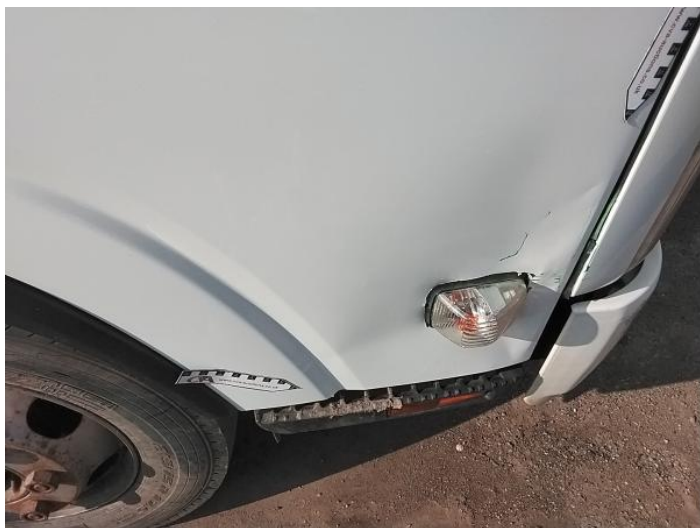
1: Door osf  
Dented  
Over 30mm

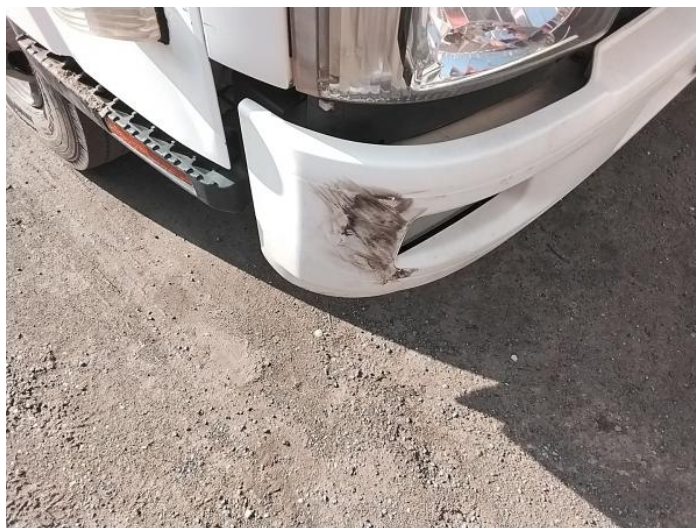
2: Bumper Front  
Scratched  
Over 100mm Thru Paint

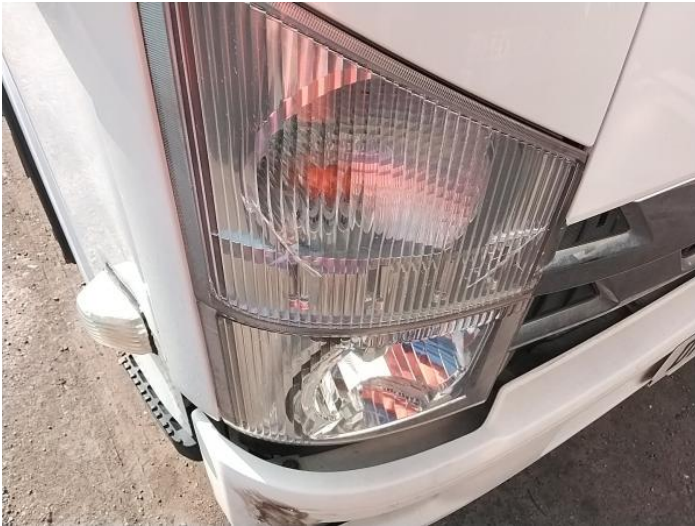
3: Headlamp os  
Broken  
Replace

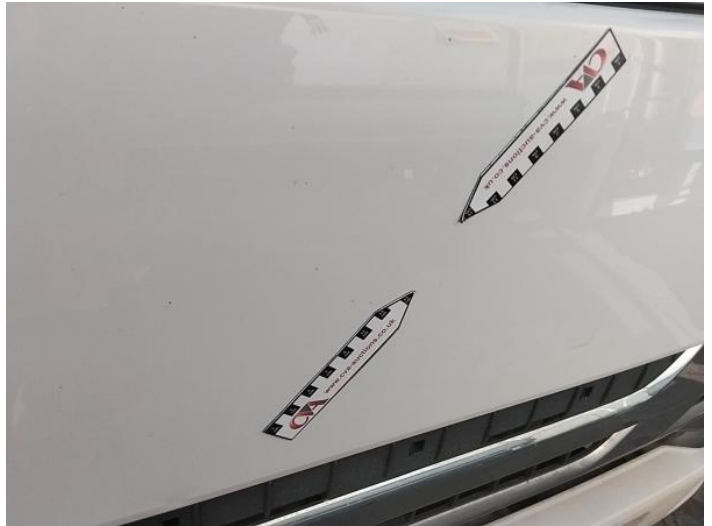
4: Bonnet  
Dented  
Over 30mm

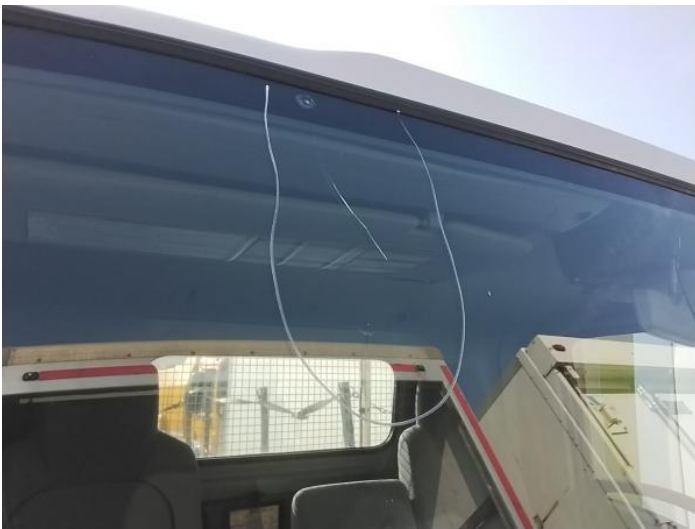
5: Screen Front  
Cracked  
Replace

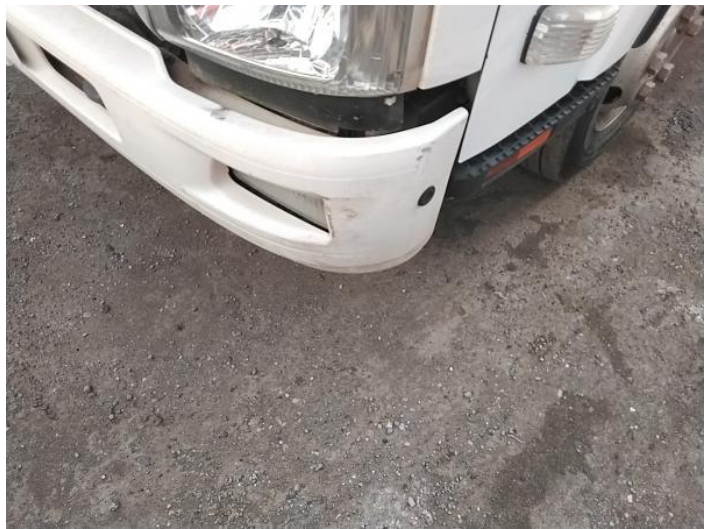
6: Bumper Front  
Scratched  
Over 100mm Thru Paint

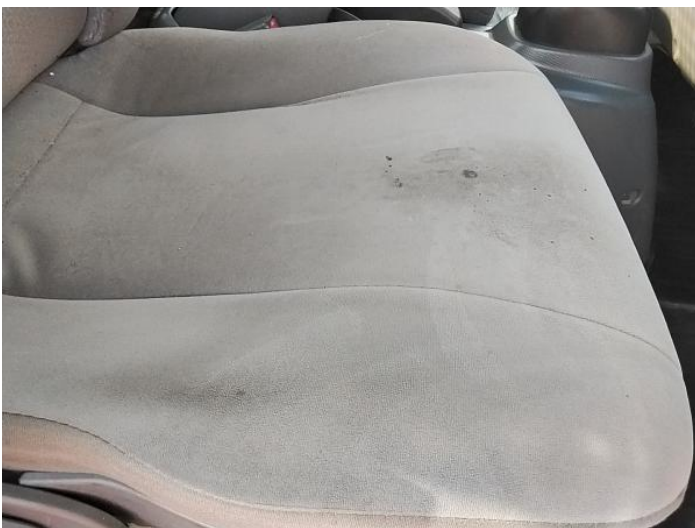
7: Seat Base Cover osf  
Soiled  
Heavy
