VEHICLE INSPECTION REPORT

BL64UVA

Mercedes-Benz Actros 1840

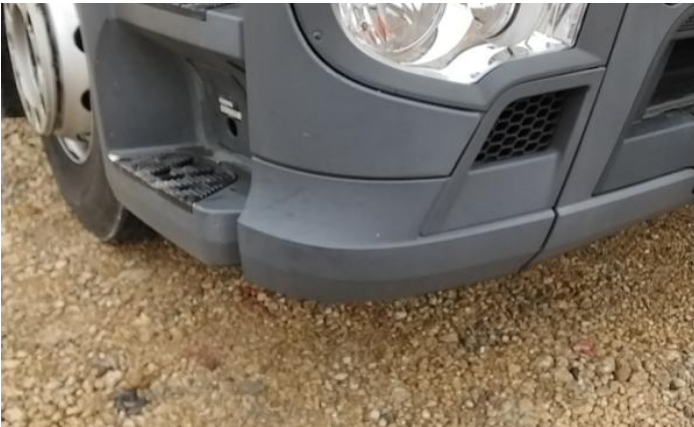
1: Bumper Front Moulding
Scuffed (Unpainted)
UpTo 100mm

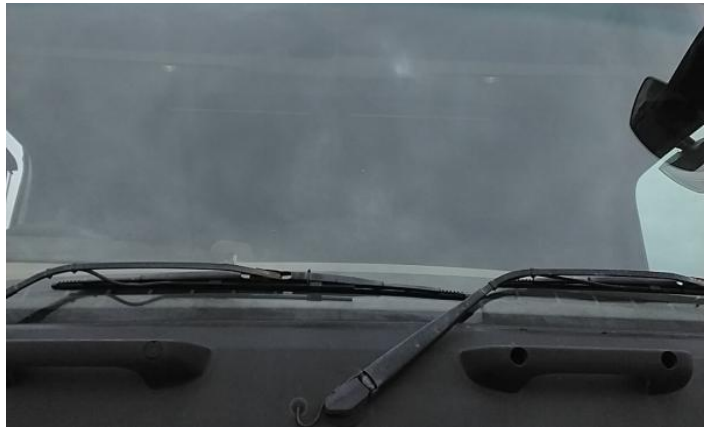
2: Screen Front
Chipped
UpTo 10mm

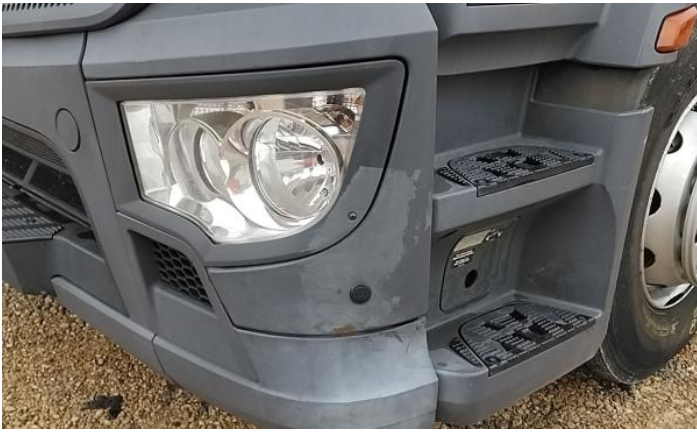
3: Bumper Front Moulding
Scuffed (Unpainted)
Over 100mm

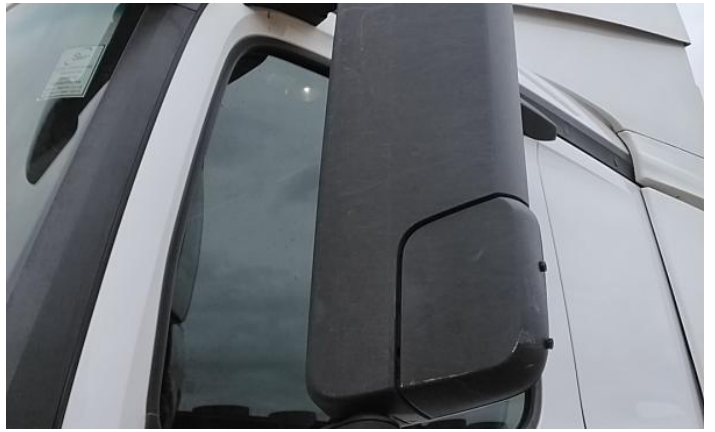
4: Door Mirror Assy nsf
Scuffed (Unpainted)
Over 100mm

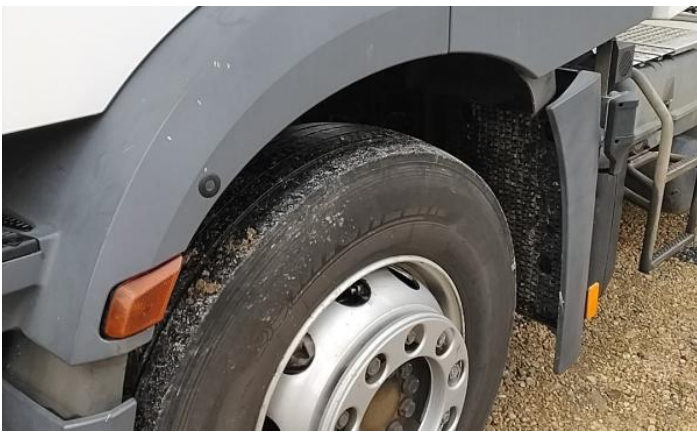
5: Wing Front Arch Extension ns
Scratched (Painted)
Over 25mm Thru Paint

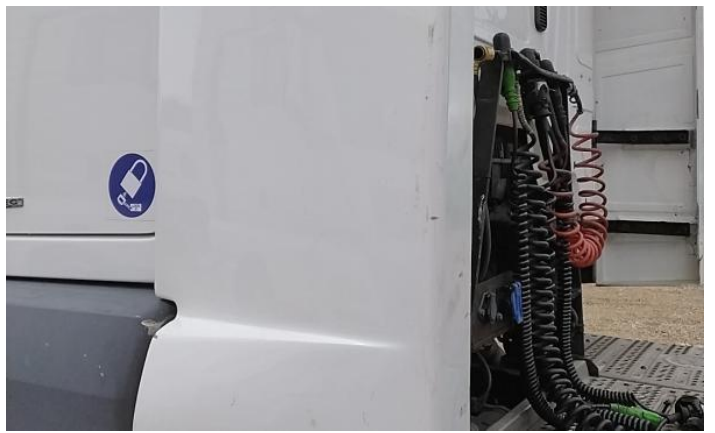
6: Qtr Panel nsr
Cracked
Replace

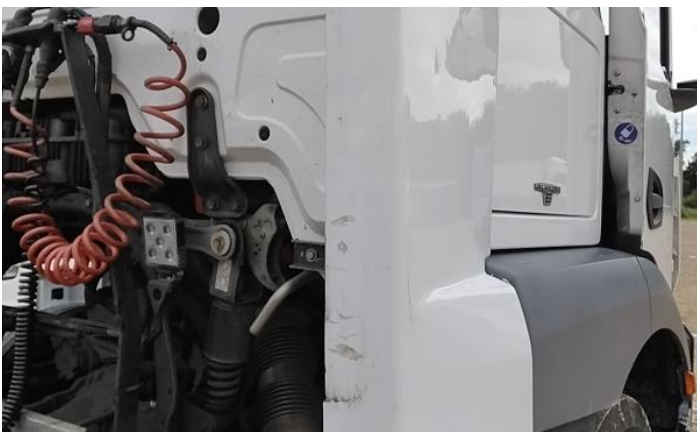
7: Qtr Panel osr
Cracked
Replace

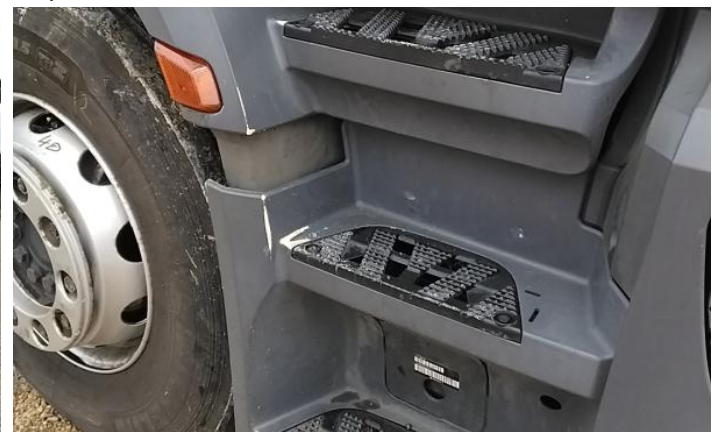
8: Wing Front Arch Extension os
Scratched (Painted)
Over 25mm Thru Paint

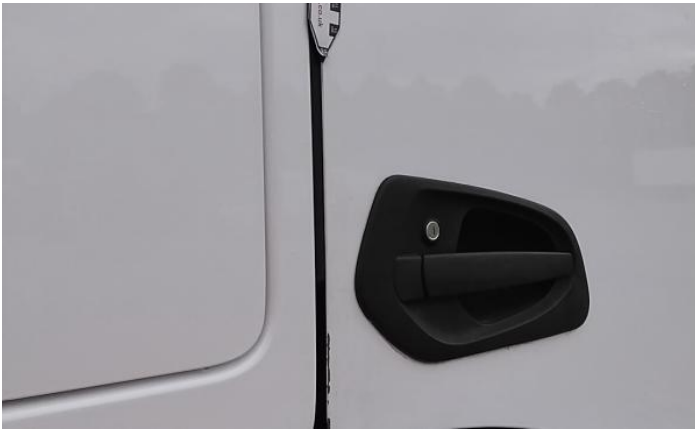
9: Door osf
Chipped
Edge Chip

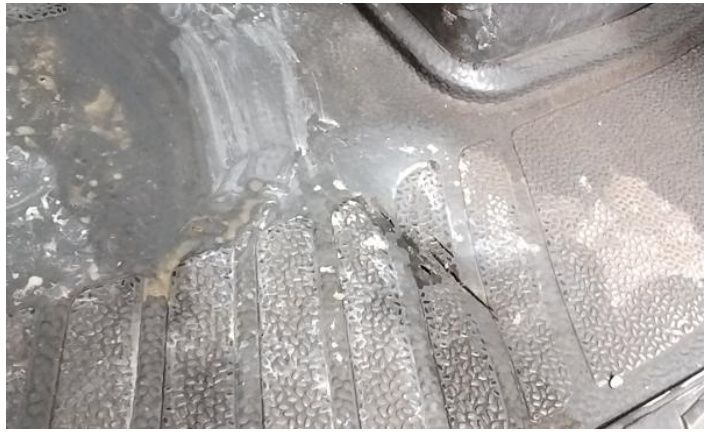
10: Carpets Front
Holed
Over 3mm
