VEHICLE INSPECTION REPORT

BL64UUV

Mercedes-Benz Actros 1840

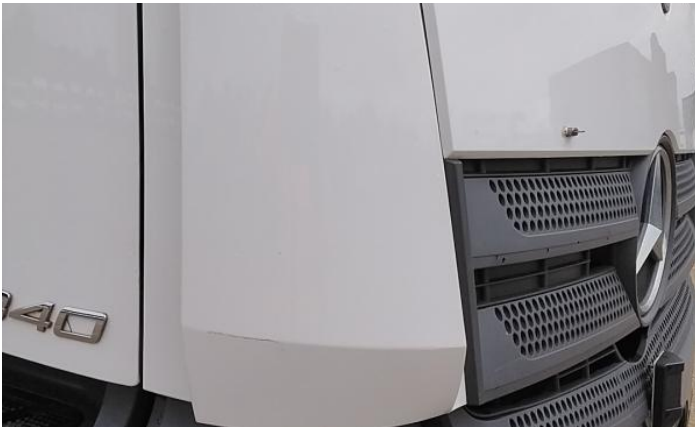
1: Wing of
Scratched
Over 25mm Not Thru Paint

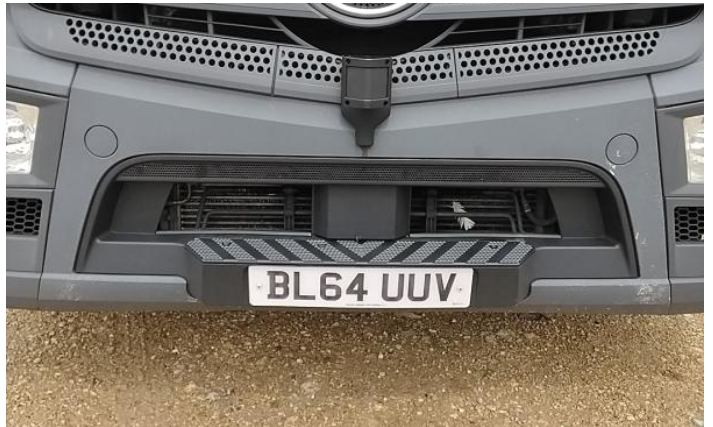
2: Bumper Front
Chipped
Multiple Chips

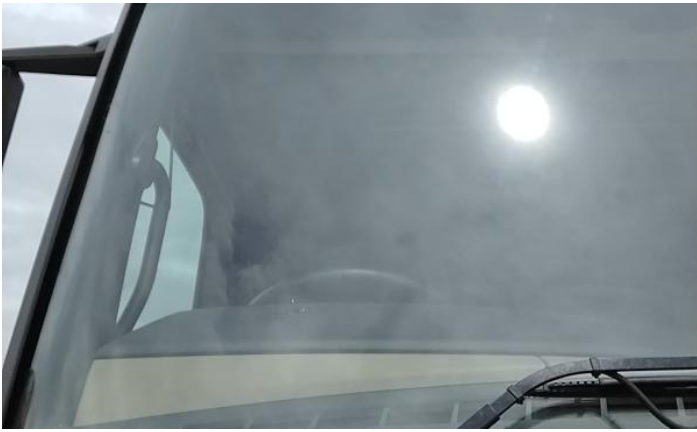
3: Screen Front
Chipped
Over 10mm

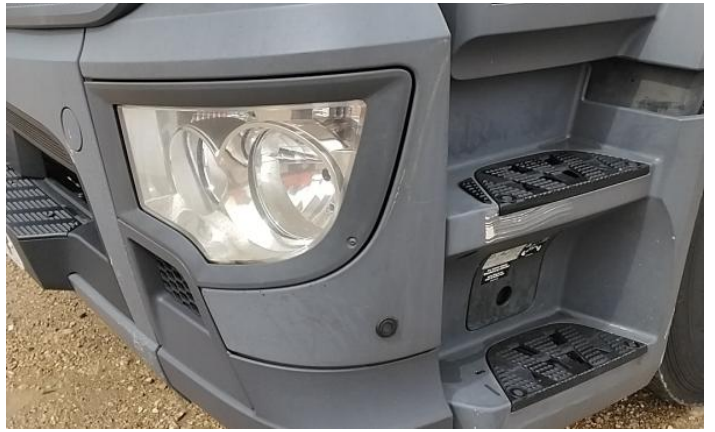
4: Bumper Front Moulding
Scuffed (Unpainted)
Up To 100mm

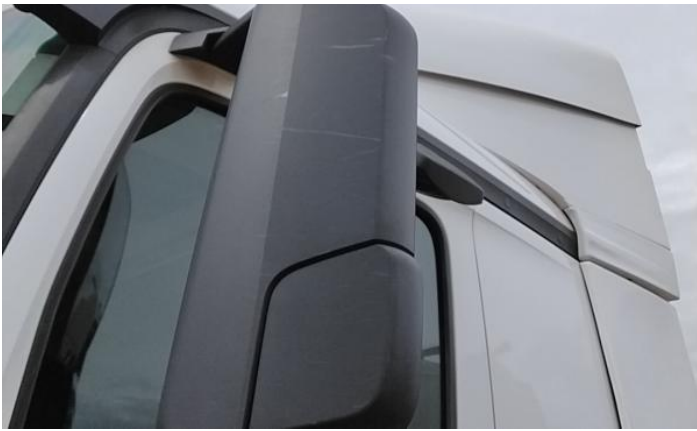
5: Door Mirror Assy nsf
Scuffed (Unpainted)
Over 100mm

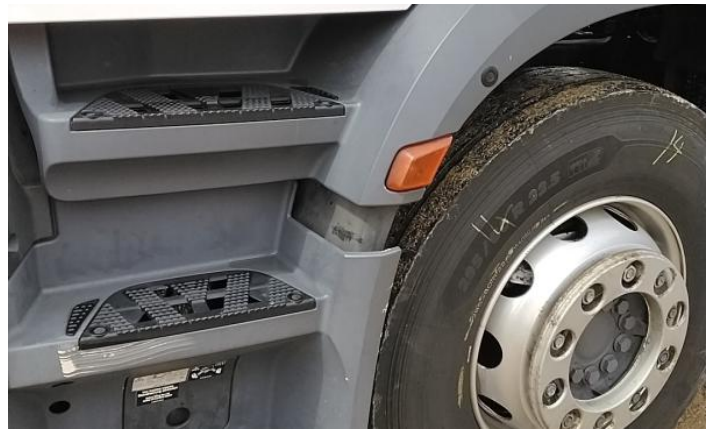
6: Wing Front Arch Extension ns
Scratched (Painted)
Over 25mm Thru Paint

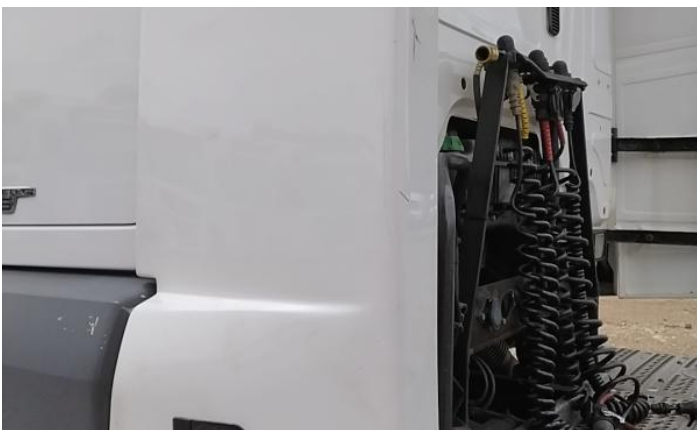
7: Qtr Panel nsr
Cracked
Replace

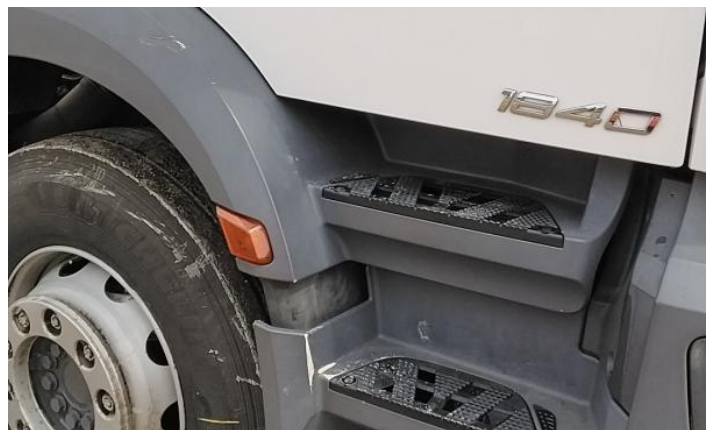
8: Wing Front Arch Extension os
Scratched (Painted)
Over 25mm Thru Paint

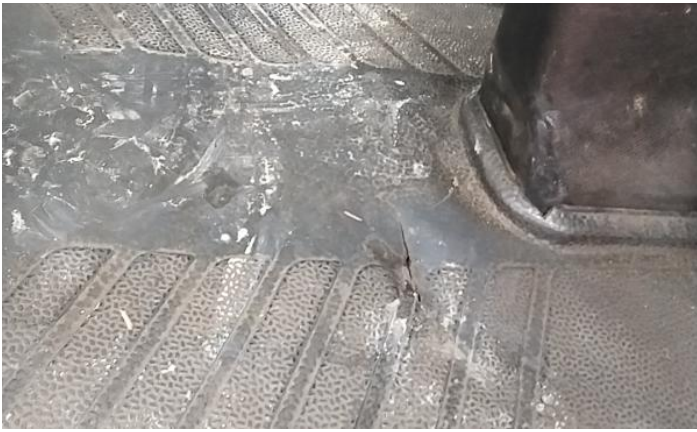
9: Carpets Front
 Holed
 Over 3mm
