VEHICLE INSPECTION REPORT

DX20TKT

Daf LF 180

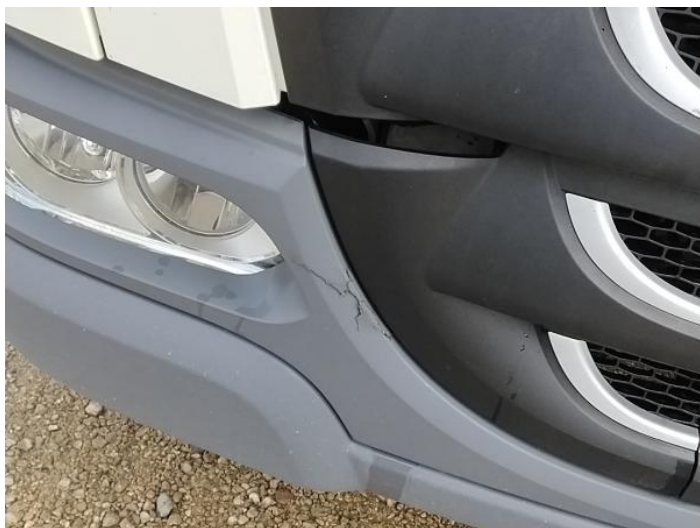
1: Bumper Front
Cracked
Over 25mm

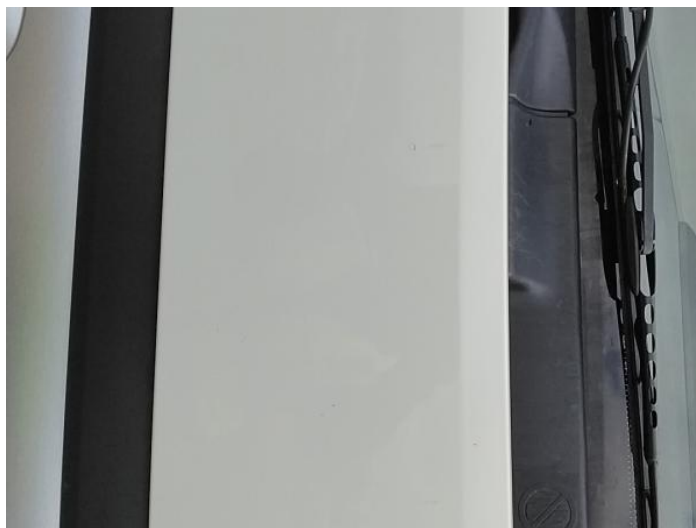
2: Bonnet
Chipped
Multiple Chips

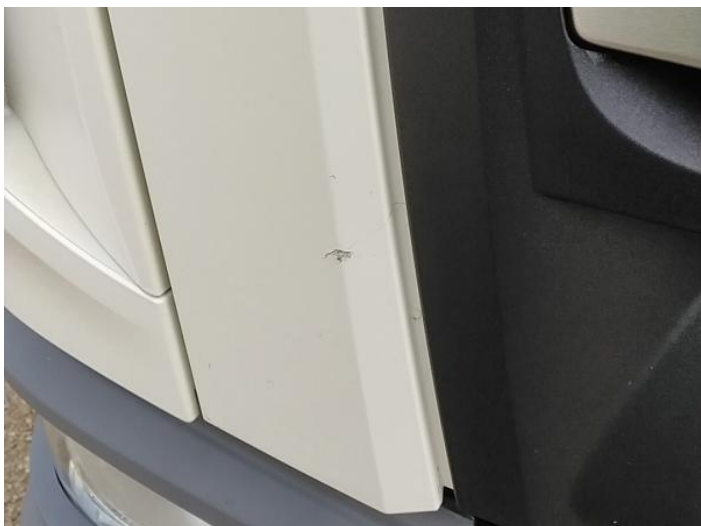
3: Bonnet
Cracked
Replace

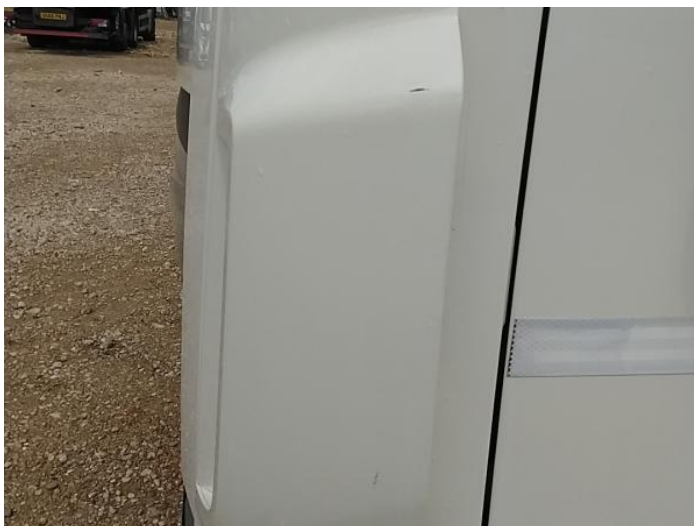
4: Moulding nsf Wing
Scratched (Painted)
UpTo 25mm Not Thru Paint

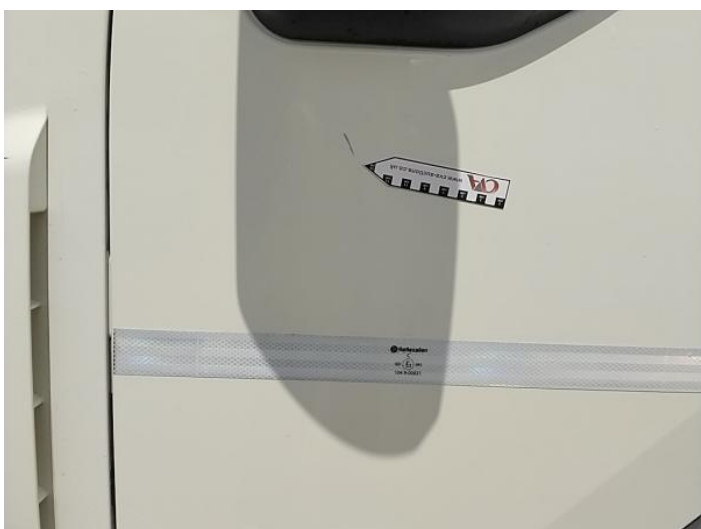
5: Door nsf
Scratched
Over 25mm Not Thru Paint

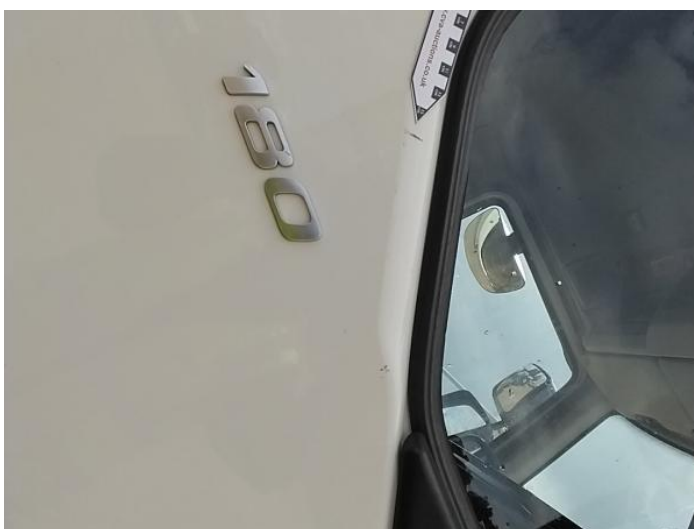
6: Door osf
Scratched
Over 25mm Not Thru Paint

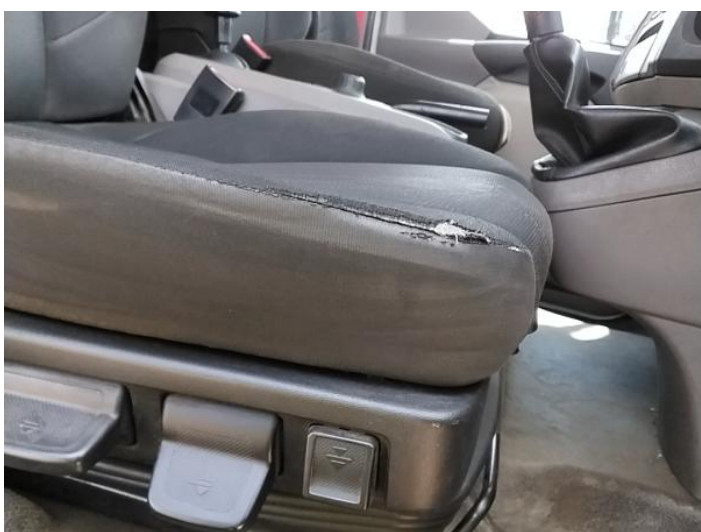
7: Seat Base Cover osf
Torn
Over 3mm
