# VEHICLE INSPECTION REPORT

**LT18XRY**

## Toyota Hilux ICON 2.4 D-4D

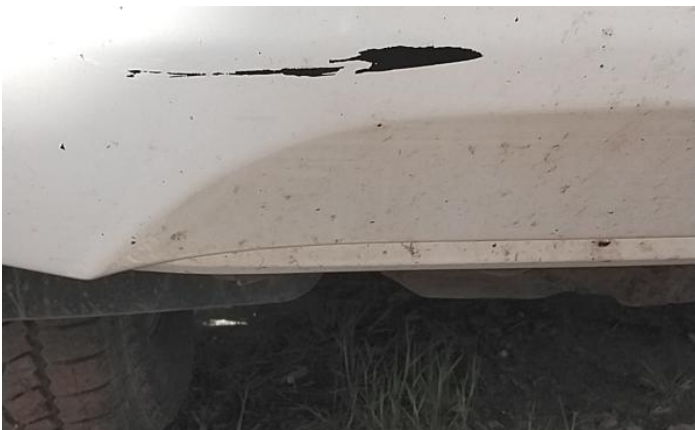
1: Bumper Front  
Scratched  
Over 100mm Thru Paint

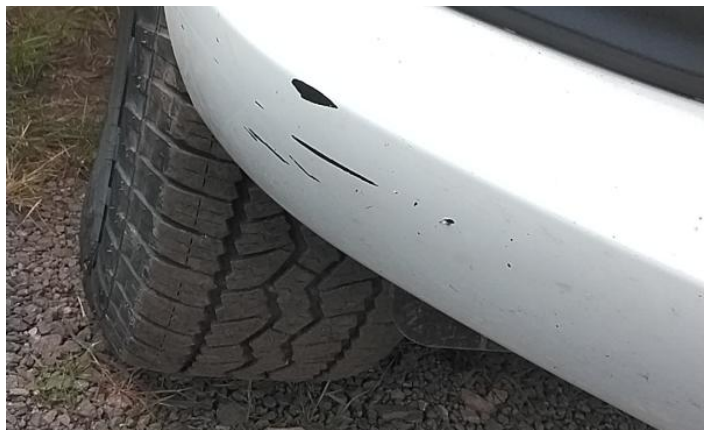
2: Bumper Front  
Scratched  
25 to 100mm Thru Paint

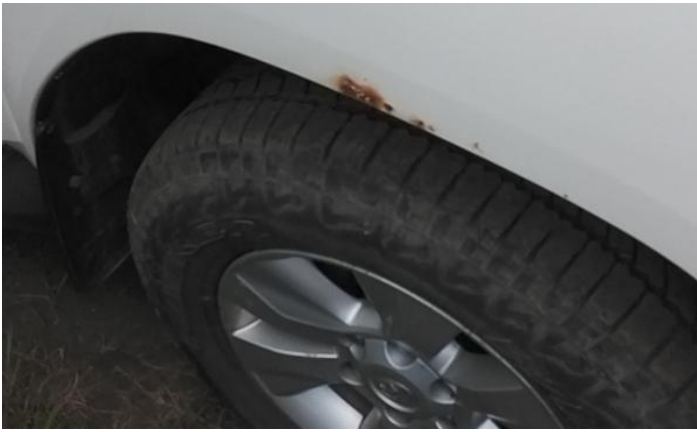
3: Wing osf  
Rusted  
Over 5mm

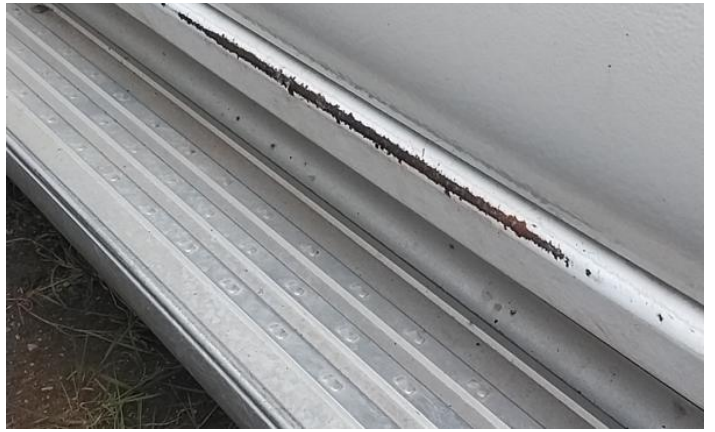
4: Sill os  
Scratched  
Over 25mm Thru Paint

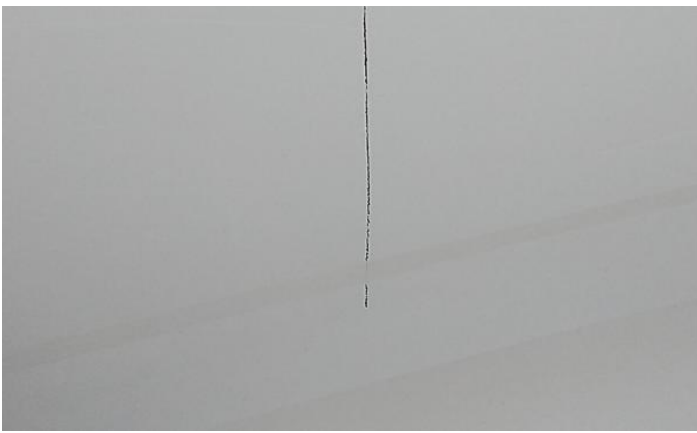
5: Door osf  
Scratched  
Over 25mm Thru Paint

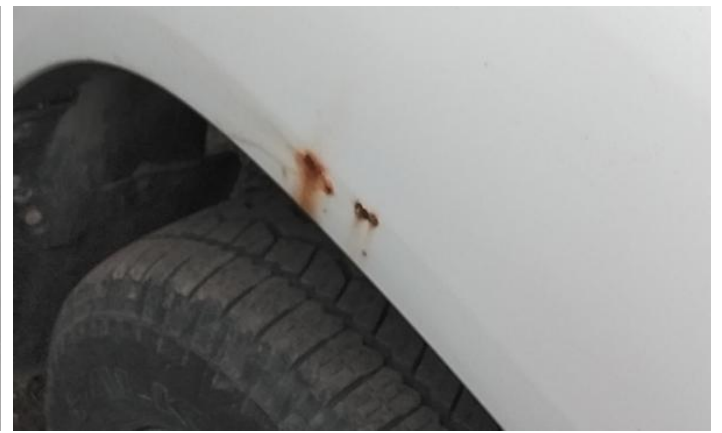
6: Qtr Panel osr  
Rusted  
Over 5mm

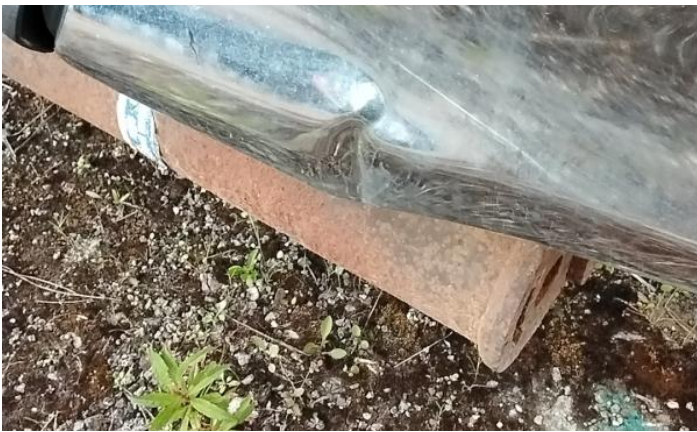
7: Bumper Rear  
Dented  
Over 30mm

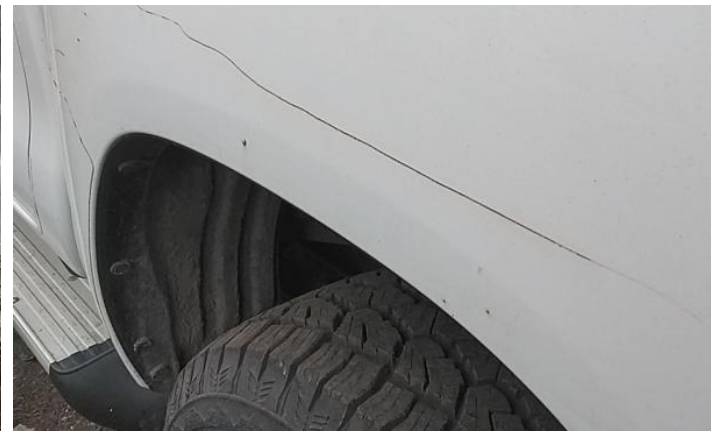
8: Qtr Panel osr  
Scratched  
Over 25mm Not Thru Paint

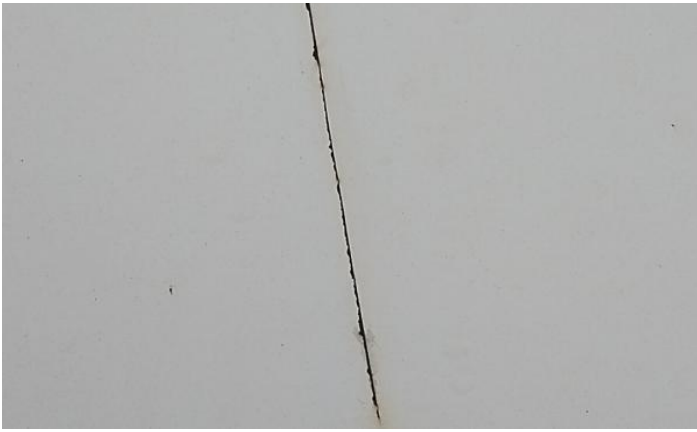
9: Bonnet  
Scratched  
Rusted

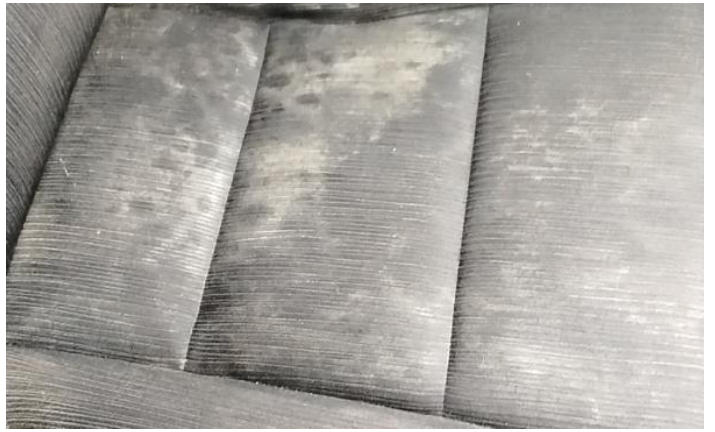
10: Seat Base Cover osf  
Soiled  
Heavy

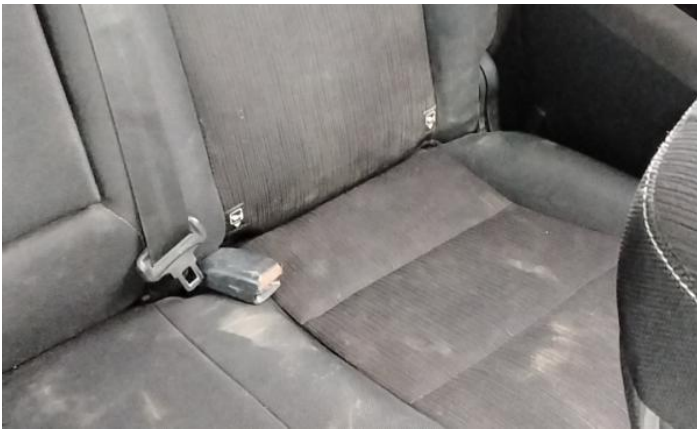
11: Seat Base Cover nsr  
Soiled  
Light

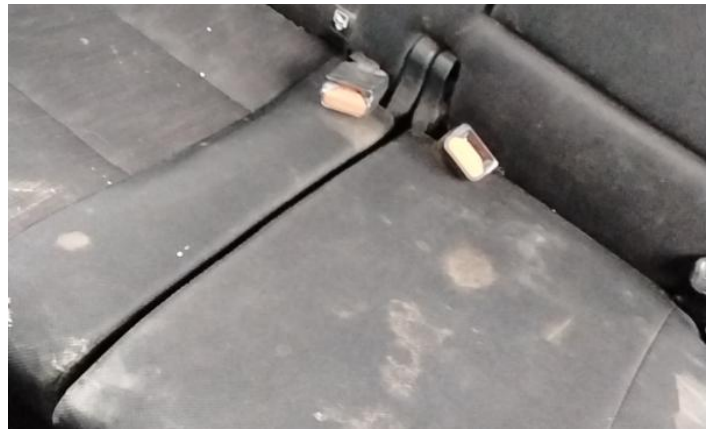
12: Seat Base Cover osr  
Soiled  
Light
