VEHICLE INSPECTION REPORT

LP69LPO

Volkswagen Crafter CR35 2.0 TDI 140PS TRENDLINE

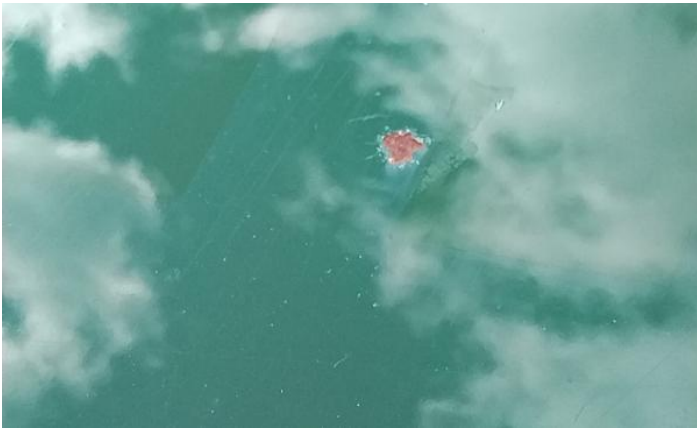
1: Bonnet
Chipped
Over 5mm

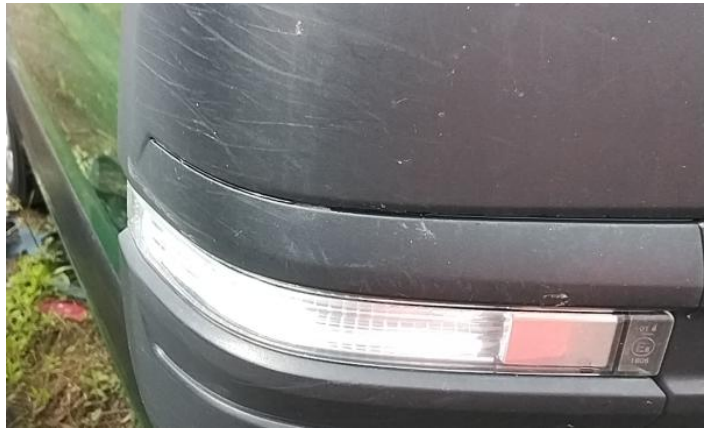
2: Door Mirror Assy nsf
Scuffed (Unpainted)
UpTo 100mm

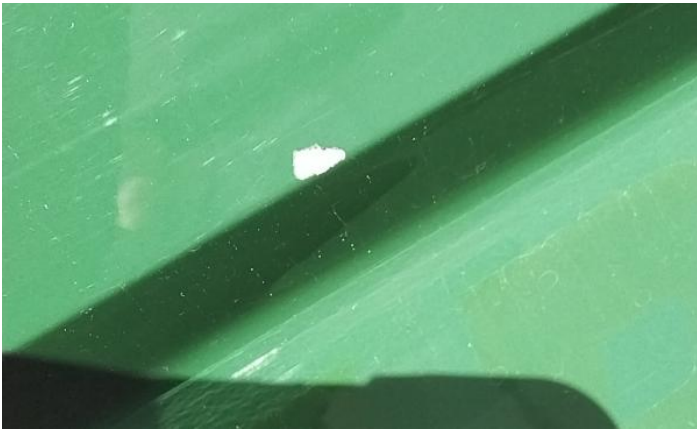
3: Door nsf
Chipped
Over 5mm

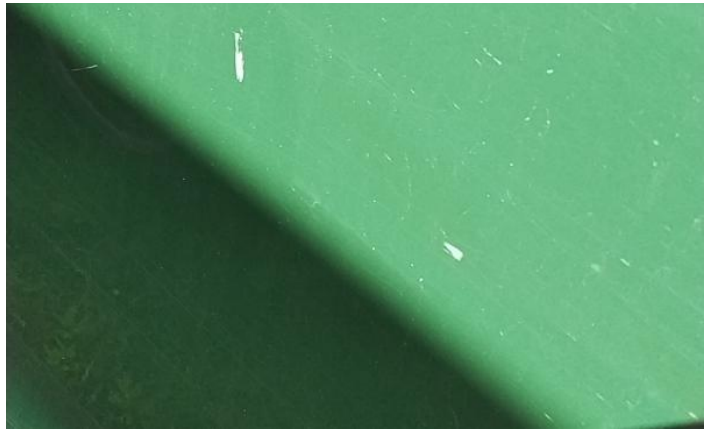
4: Panel Rear
Scratched
UpTo 25mm Thru Paint

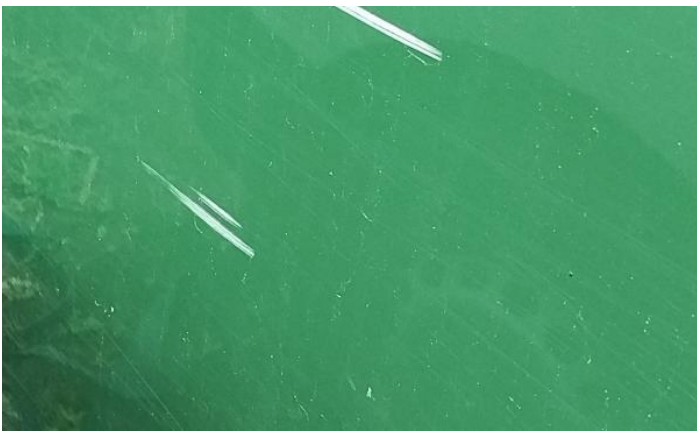
5: Panel Rear
Scratched
Over 25mm Thru Paint

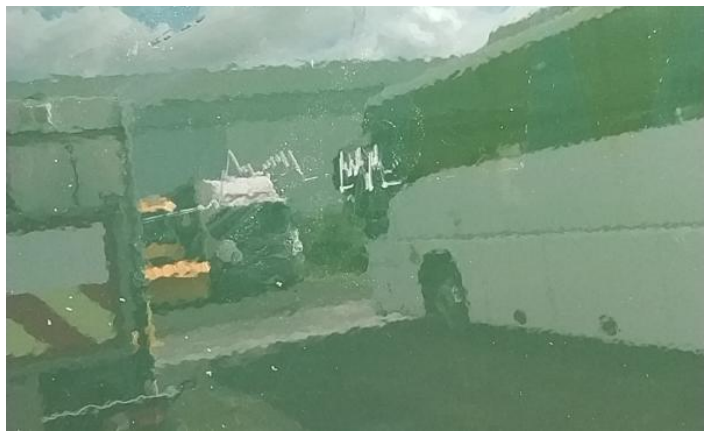
6: Door nsr
Scratched
Over 25mm Not Thru Paint

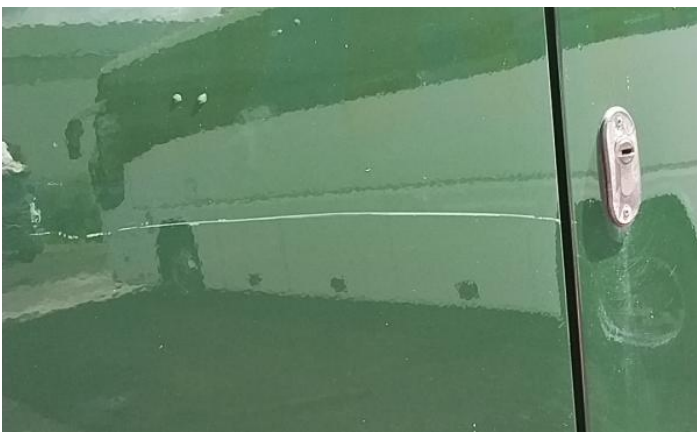
7: Door osr
Scratched
Over 25mm Not Thru Paint

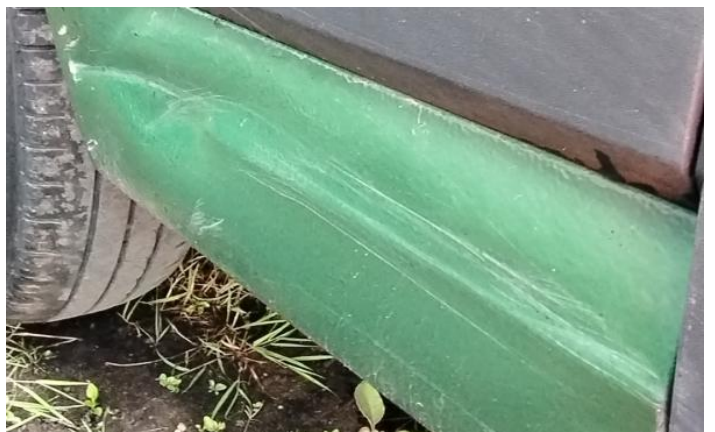
8: Bumper Rear
Scratched
Over 100mm Thru Paint

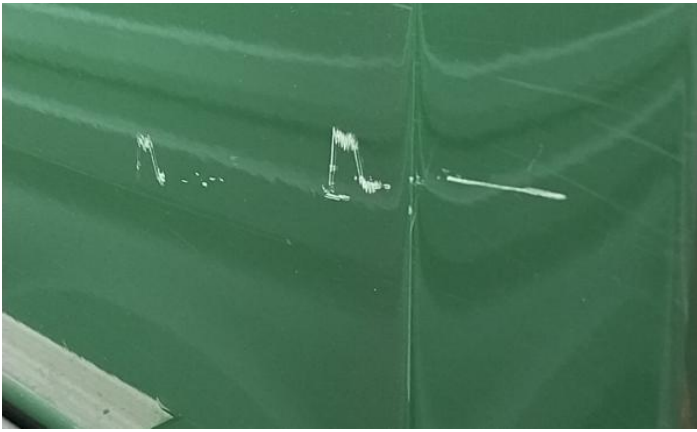
9: Panel Rear
Scratched
Over 25mm Not Thru Paint

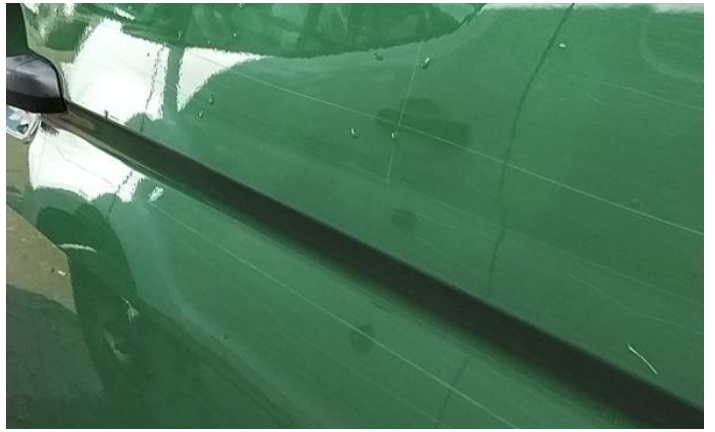
10: Panel Rear
Scratched
Over 25mm Not Thru Paint

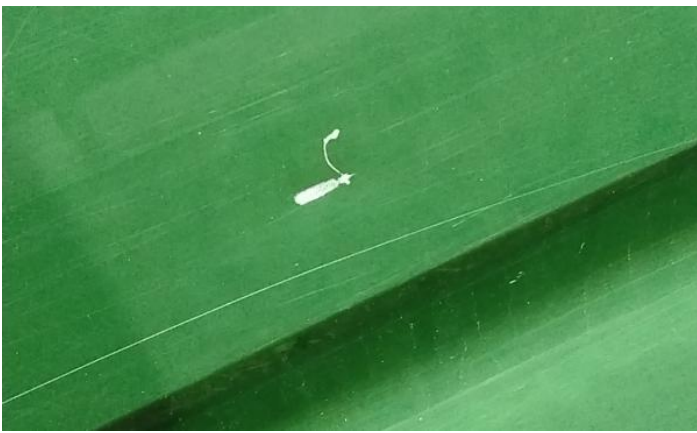
11: Panel Rear
Scratched
Up To 25mm Thru Paint

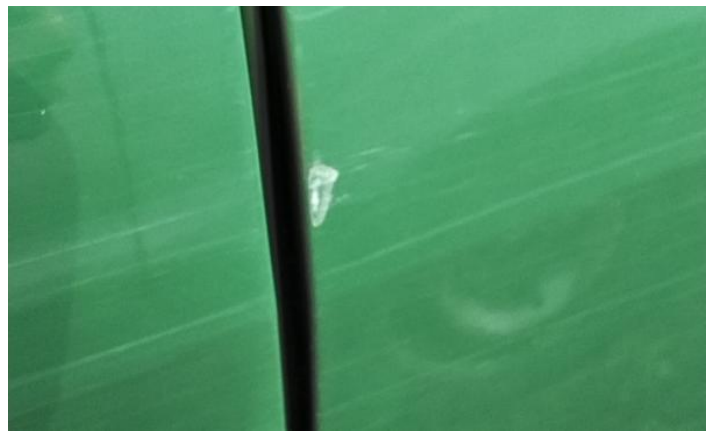
12: Panel Rear
Chipped
1 To 5

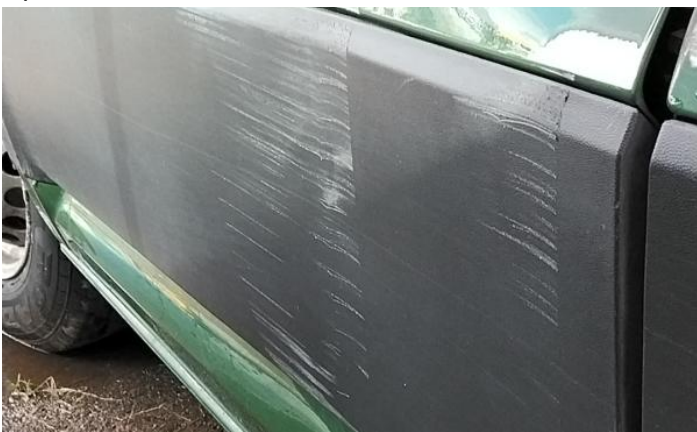
13: Sill Panel Trim ns
Scuffed (Unpainted)
Over 100mm

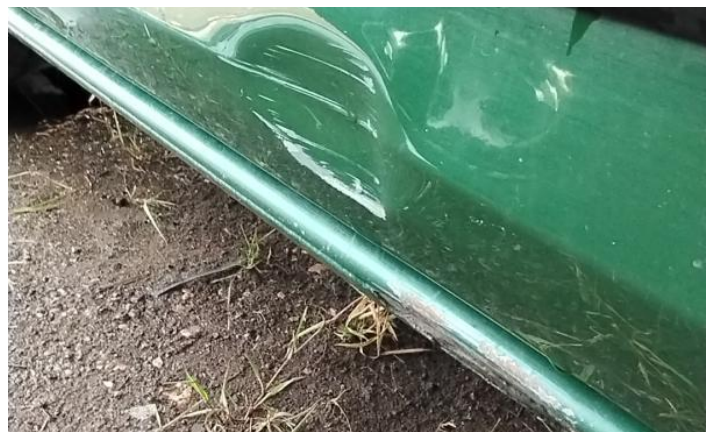
14: Sill ns
Dented
With Paint Damage

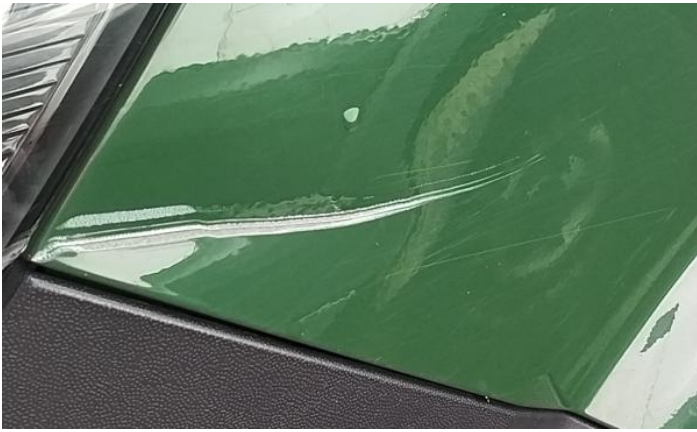
15: Wing nsf
Scratched
Over 25mm Thru Paint

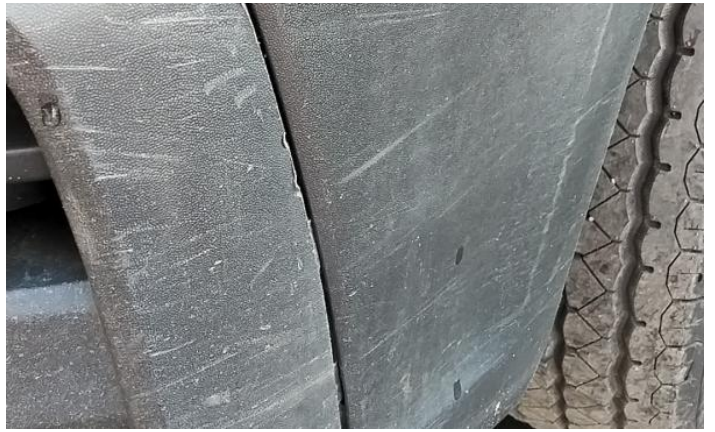
16: Bumper Front Moulding
Scuffed (Unpainted)
UpTo 100mm

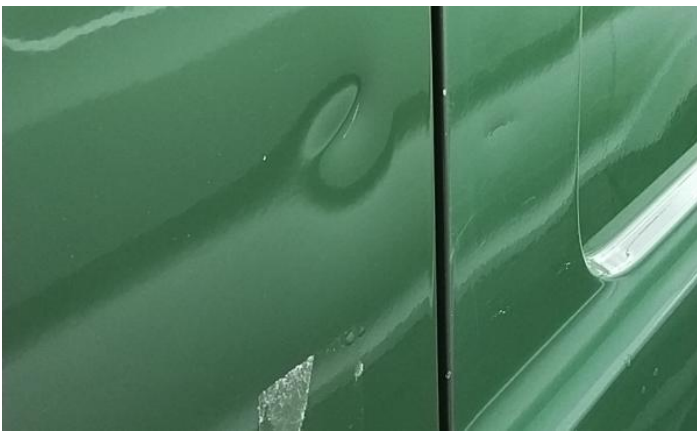
17: Door nsf
Dented
2 Or Less UpTo 10mm

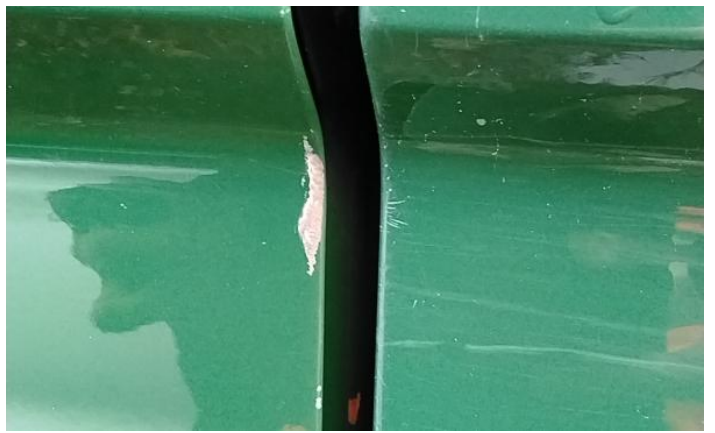
18: Door nsf
Chipped
Edge Chip

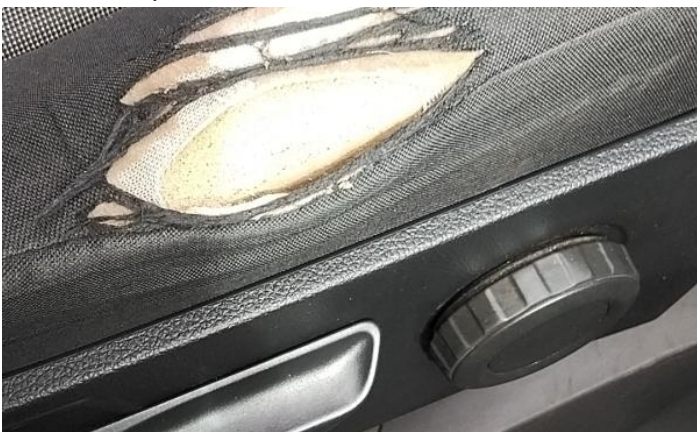
19: Seat Base Cover osf
Torn
Over 3mm

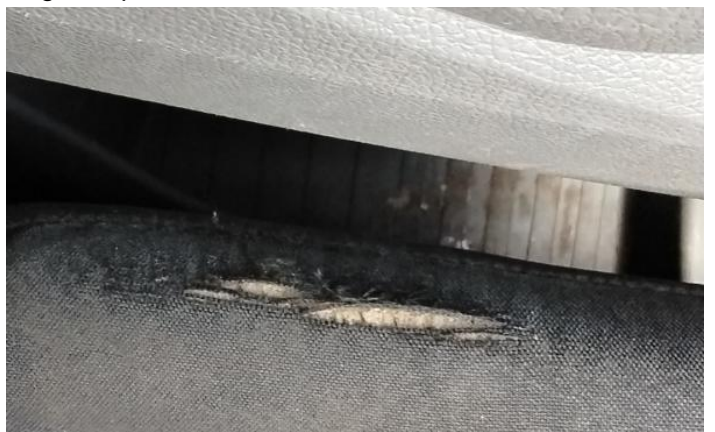
20: Seat Base Cover nsf
Torn
Over 3mm

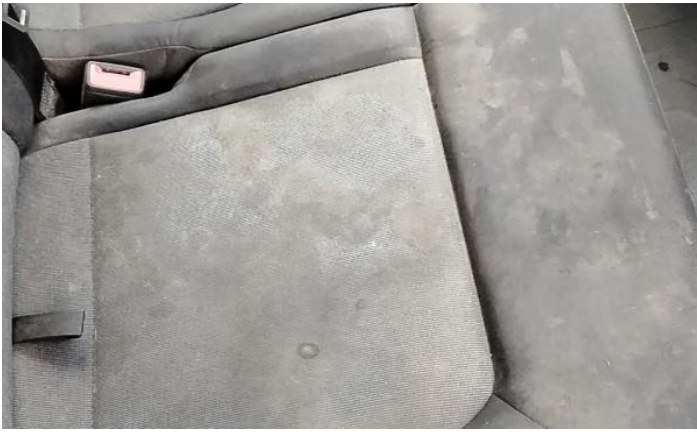
21: Seat Base Cover nsf
Soiled
Heavy
