VEHICLE INSPECTION REPORT

LN17EHR

Mitsubishi Fuso Canter 7C15 34

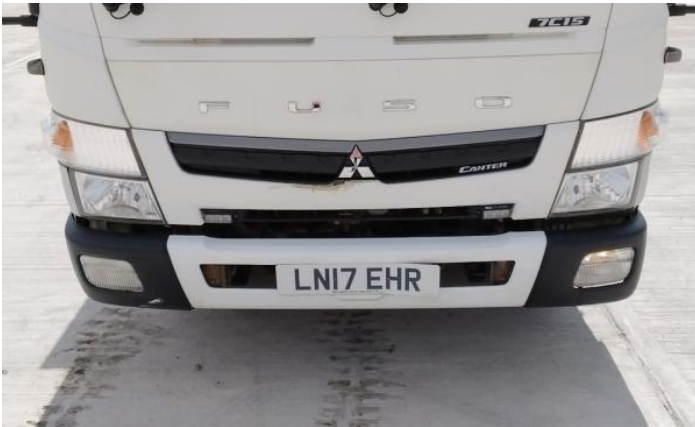
1: Bonnet
Chipped
Multiple Chips

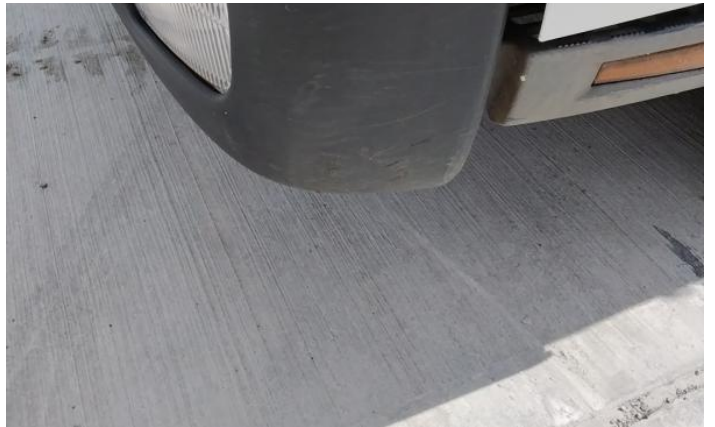
2: Bumper Front
Scratched
Over 100mm Thru Paint

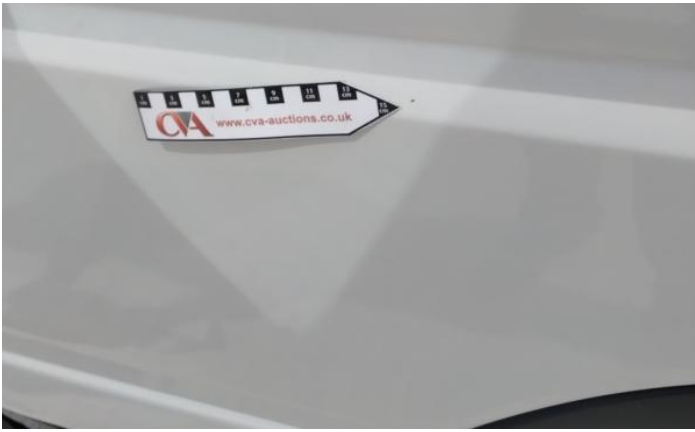
3: Door nsf
Chipped
Multiple Chips

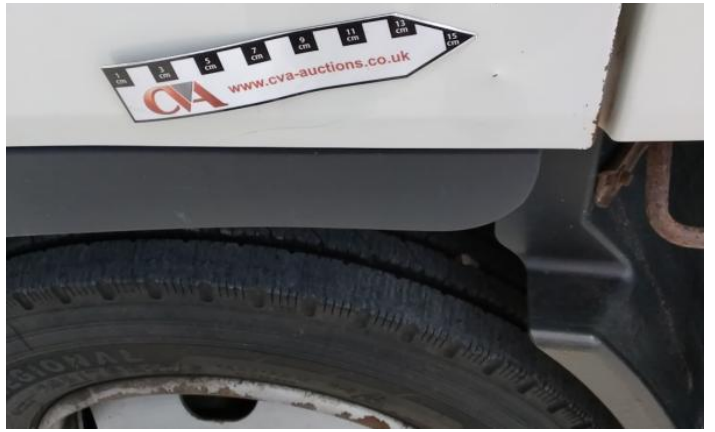
4: Door nsf
Dented
With Paint Damage

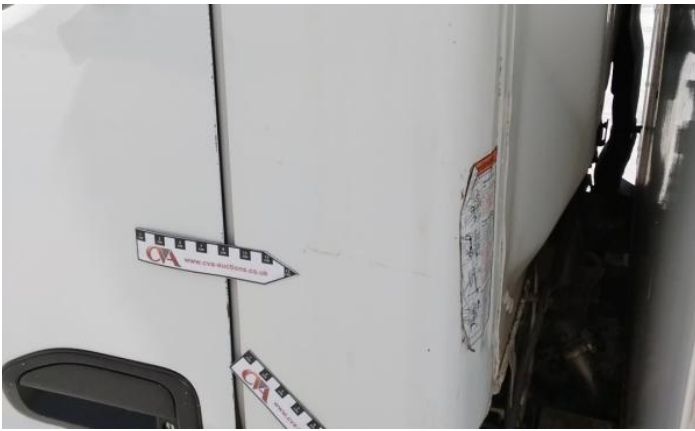
5: Qtr Panel nsr
Scratched
Over 25mm Thru Paint

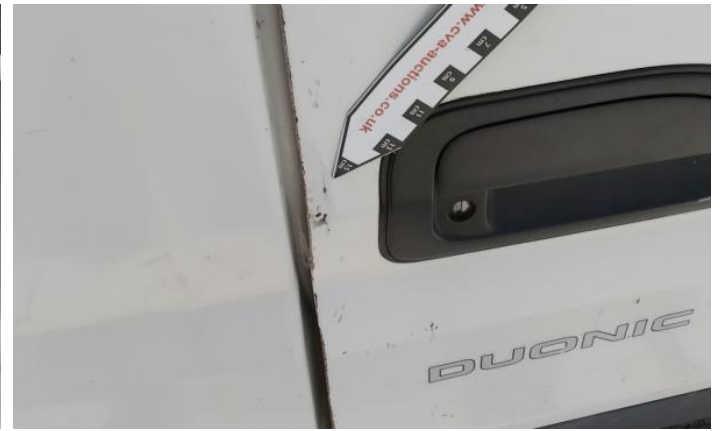
6: Door osf
Dented
With Paint Damage

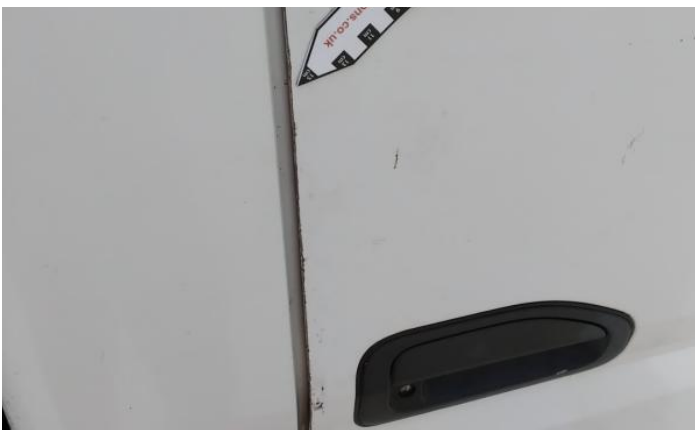
7: Door osf
Chipped
Multiple Chips

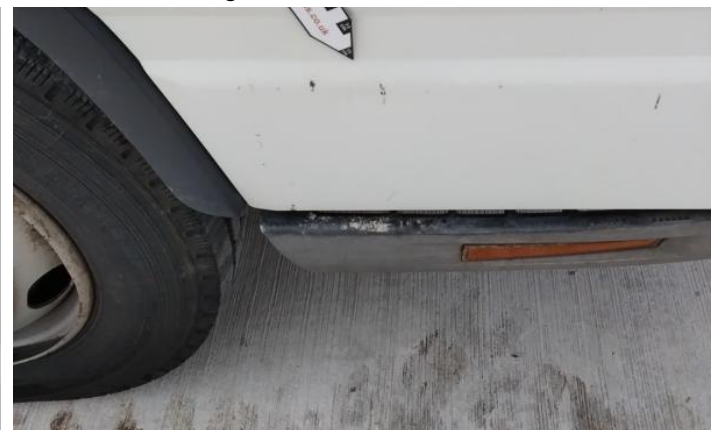
8: Door osf
Scratched
Over 25mm Thru Paint

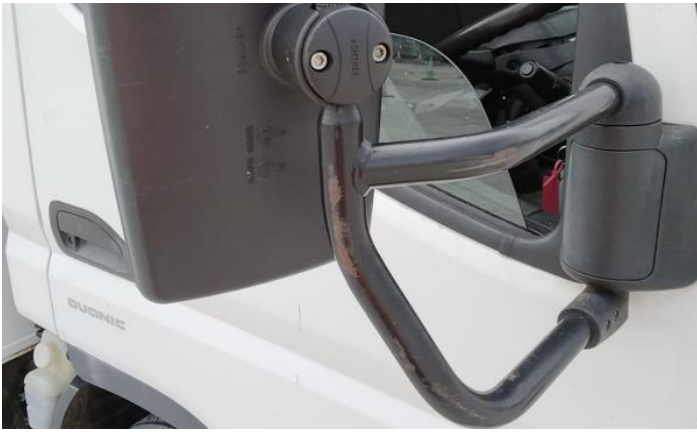
9: Door Mirror Assy of
Scratched (Painted)
Over 25mm Thru Paint

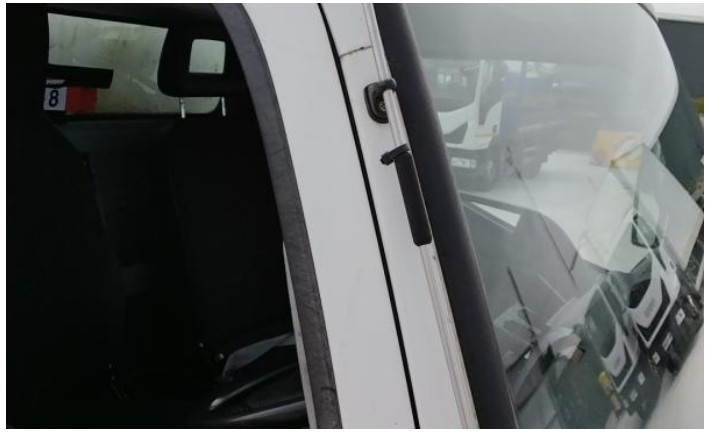
10: Aerial
Broken
Replace

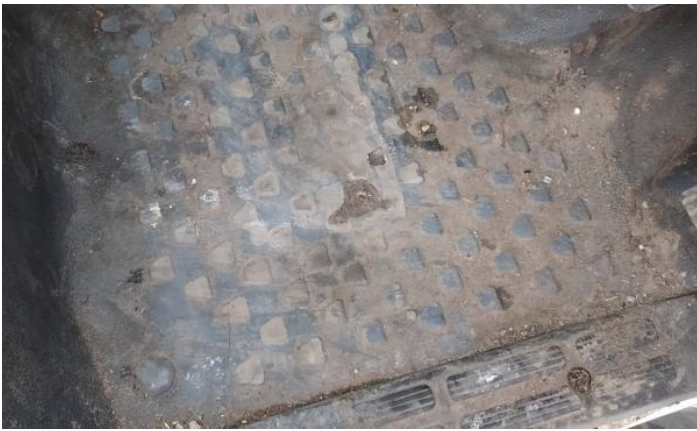
11: Carpets Front
Holed
Over 3mm

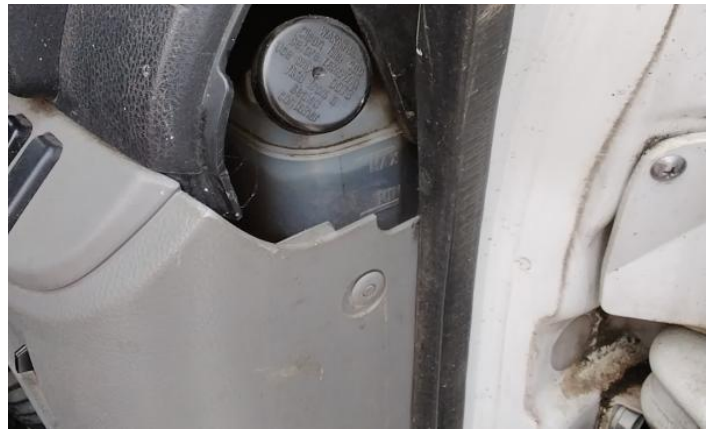
12: Fascia Panel
Missing
Replace

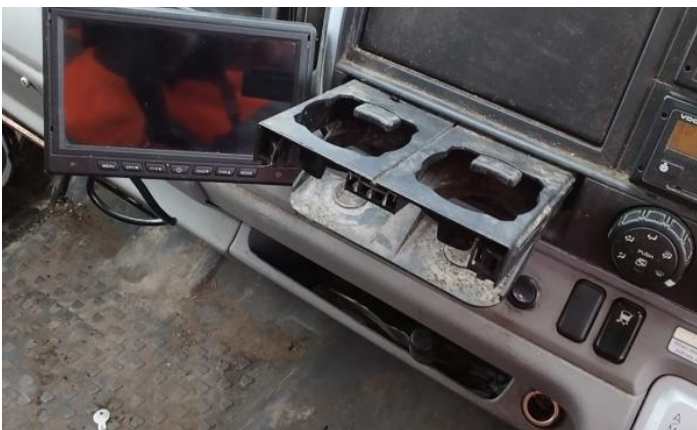
13: General Interior
Soiled
Light

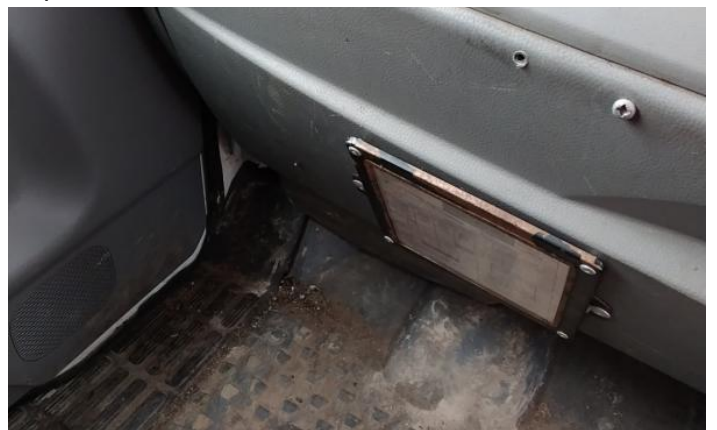
14: Centre Console Front
Holed
Over 3mm
