# VEHICLE INSPECTION REPORT

**LN17EHS**

## Mitsubishi Fuso Canter 7C15 34

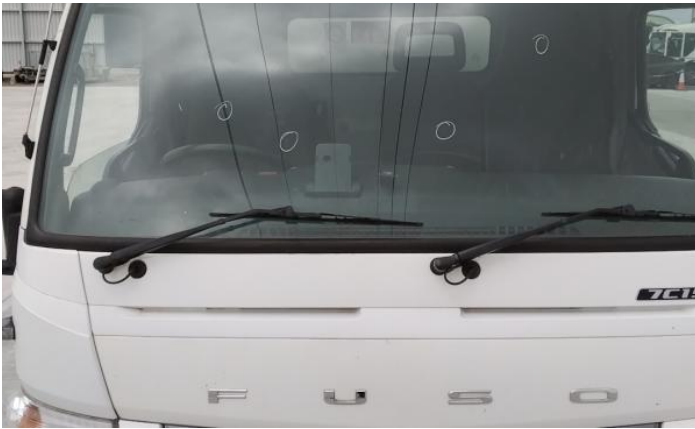
1: Screen Front  
Chipped  
Over 10mm

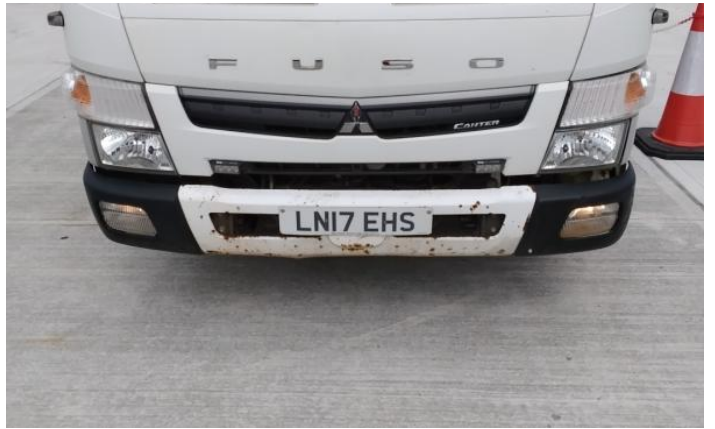
2: Bonnet  
Chipped  
Multiple Chips

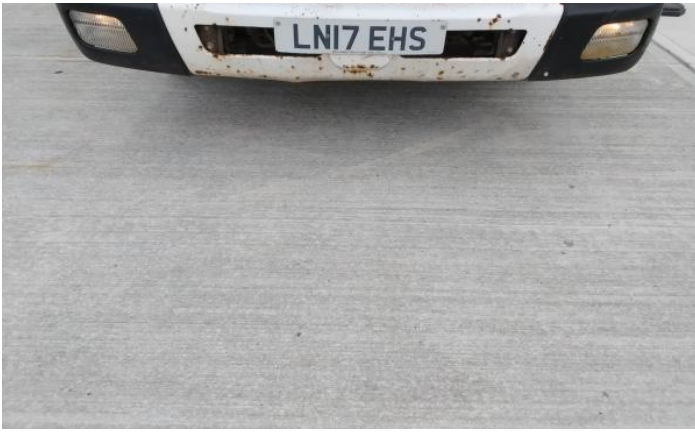
3: Bumper Front  
Rusted  
Over 5mm

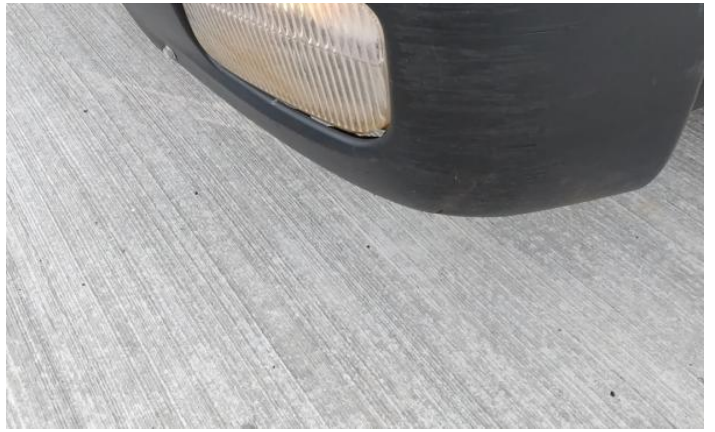
4: Bumper Front  
Scratched  
Over 100mm Thru Paint

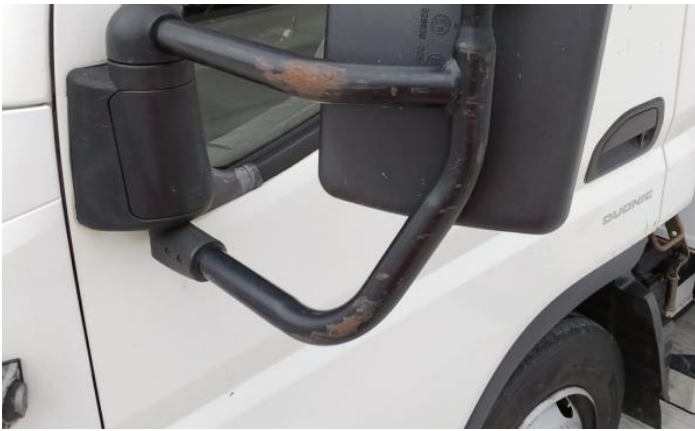
5: Door Mirror Assy nsf  
Scratched (Painted)  
Over 25mm Thru Paint

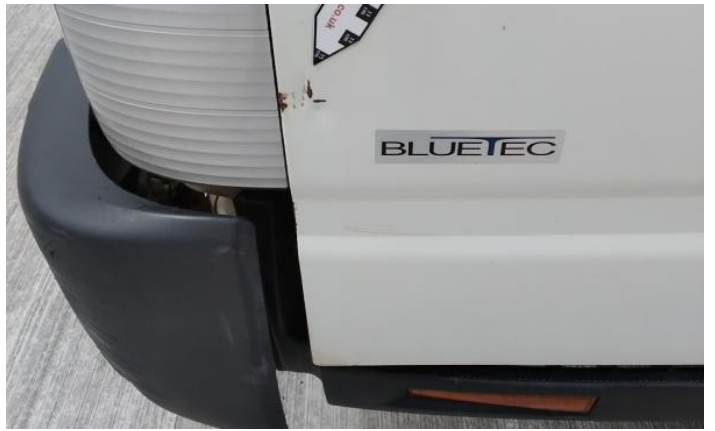
6: Door nsf  
Dented  
With Paint Damage

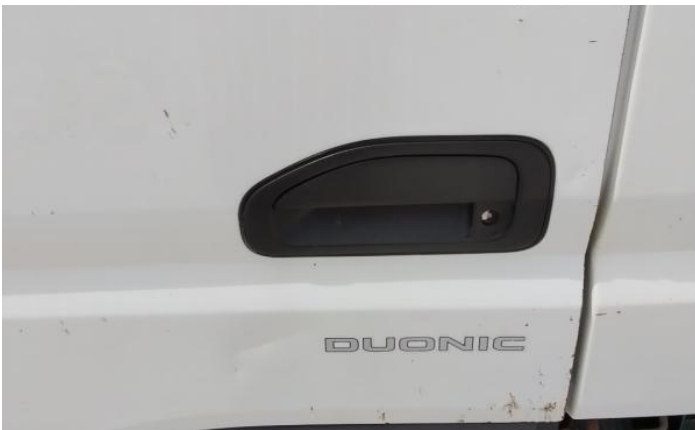
7: Door nsf  
Scratched  
Over 25mm Thru Paint

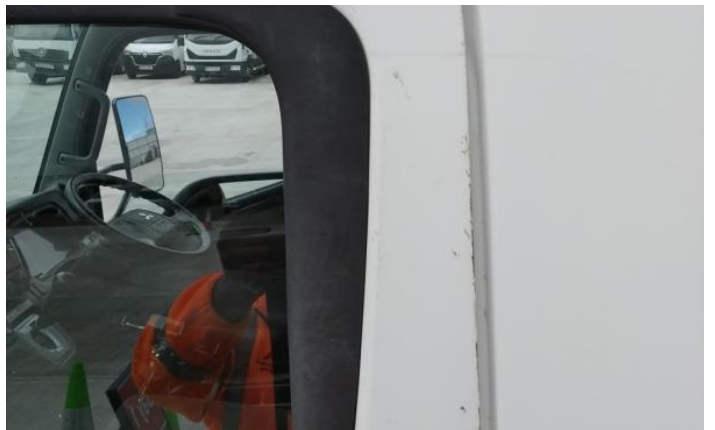
8: Door nsf  
Scratched  
Over 25mm Thru Paint

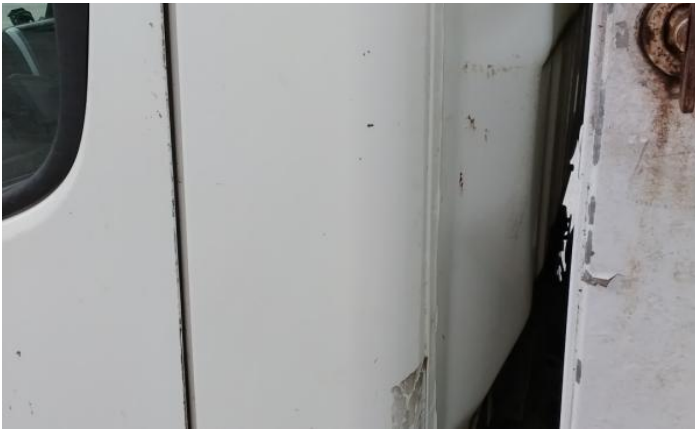
9: Qtr Panel nsr  
Scratched  
Over 25mm Thru Paint

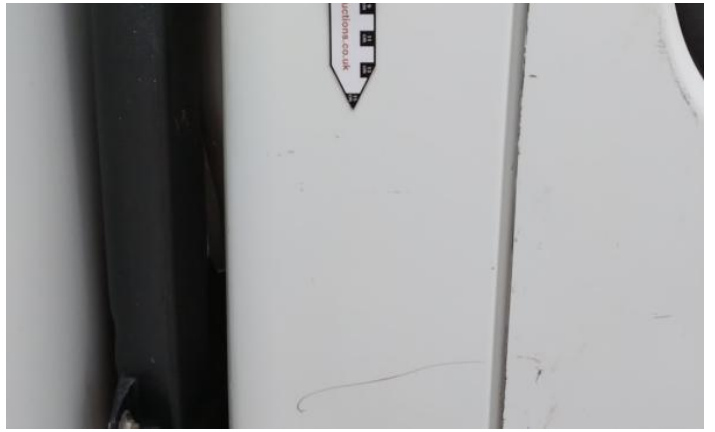
10: Qtr Panel osr  
Scratched  
Over 25mm Thru Paint

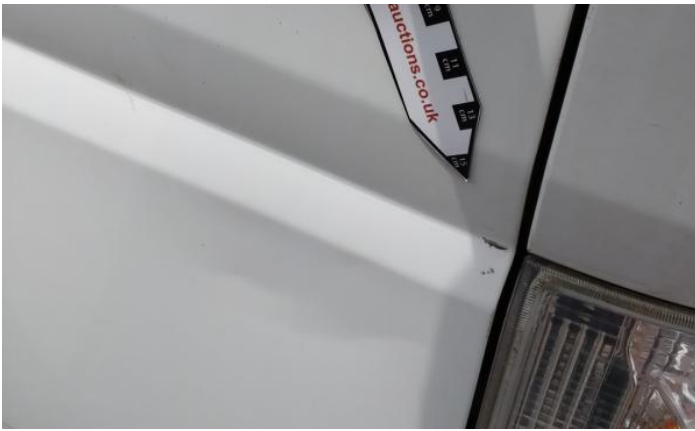
11: Door osf  
Scratched  
Over 25mm Thru Paint

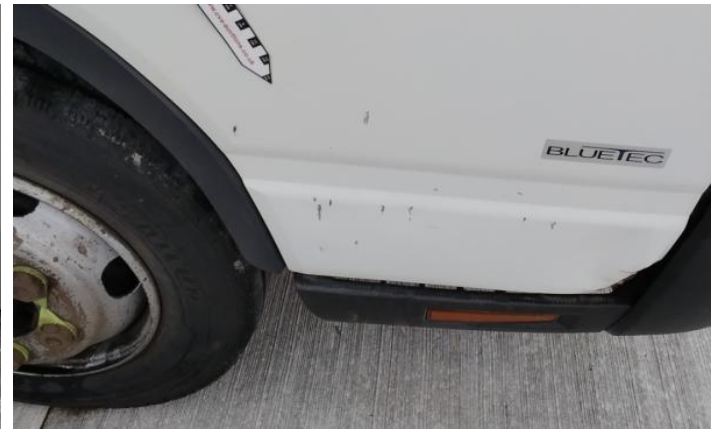
12: Door osf  
Scratched  
Over 25mm Thru Paint

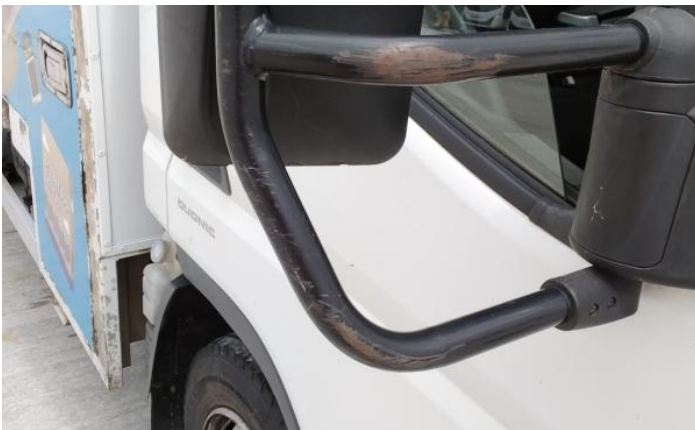
13: Door Mirror Assy osf  
Scratched (Painted)  
Over 25mm Thru Paint

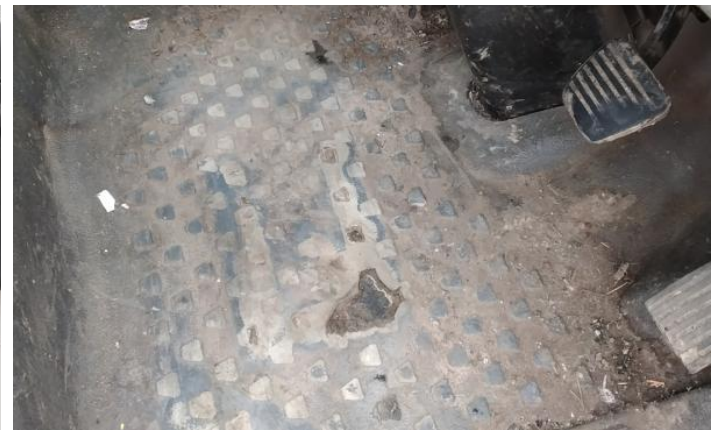
14: Carpets Front  
Holed  
Over 3mm

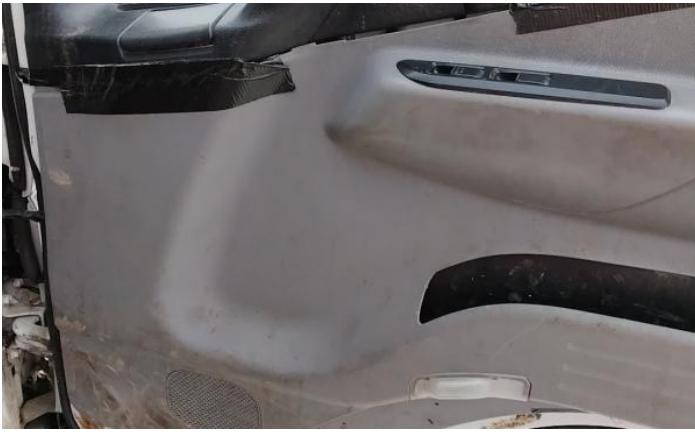
15: Door Pad osf  
Broken  
Replace

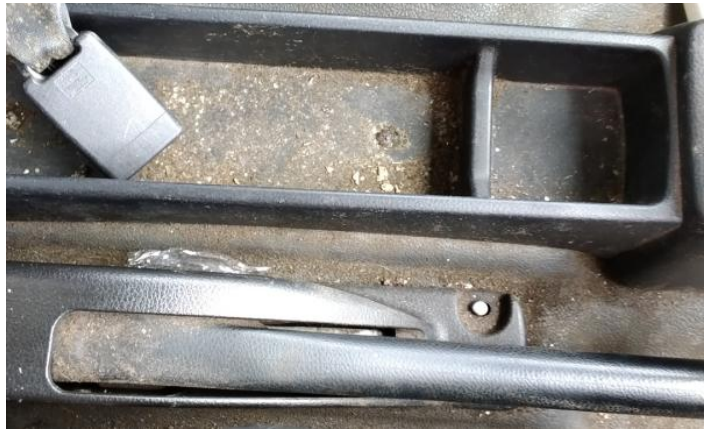
16: General Interior  
Soiled  
Light

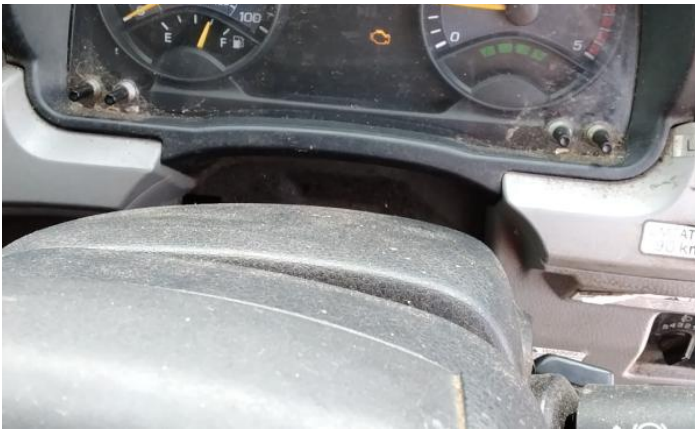
\*WARNING LIGHT ON DASH\*

17: Dash Warning Lights  
Displayed  
No Action

Carpet Condition	Average	Upholstery Condition	Average
Seat Condition	Average	Odour	-
Engine Runs	OK	No Excessive Smoking	OK
EML light illuminated	Fault	DPF light illuminated	OK
ABS light illuminated	OK
