VEHICLE INSPECTION REPORT

LN17EHT

FUSO Canter 7C15 34

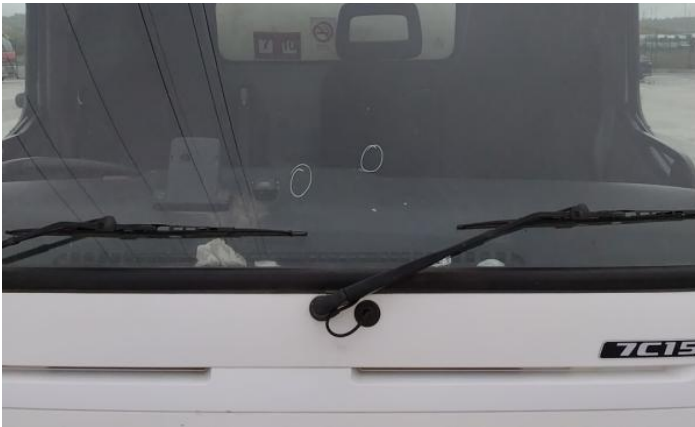
1: Screen Front
Chipped
Over 10mm

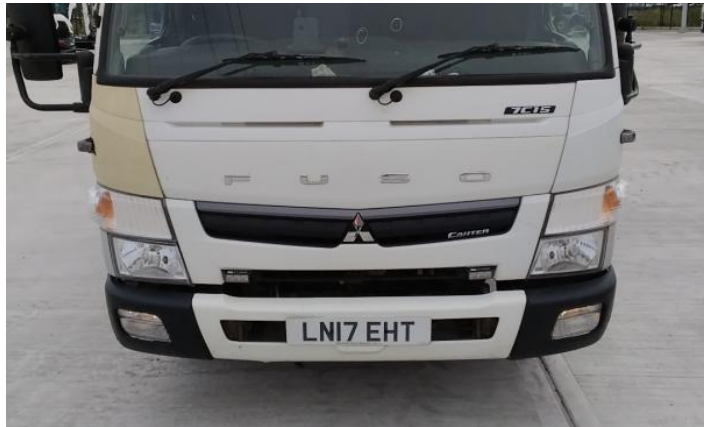
2: Bonnet
Chipped
Multiple Chips

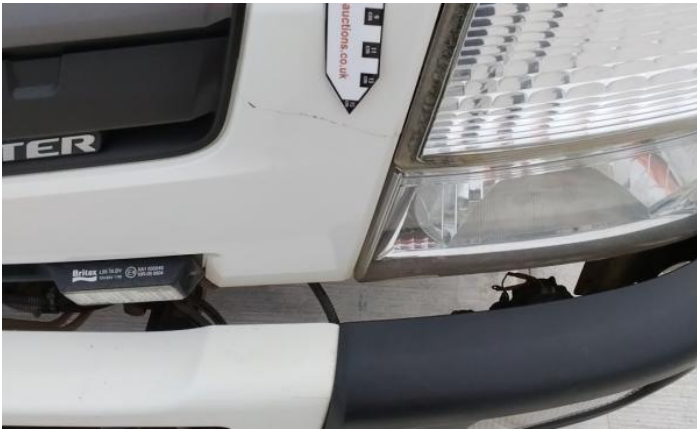
3: Bumper Front Grill
Broken
Replace

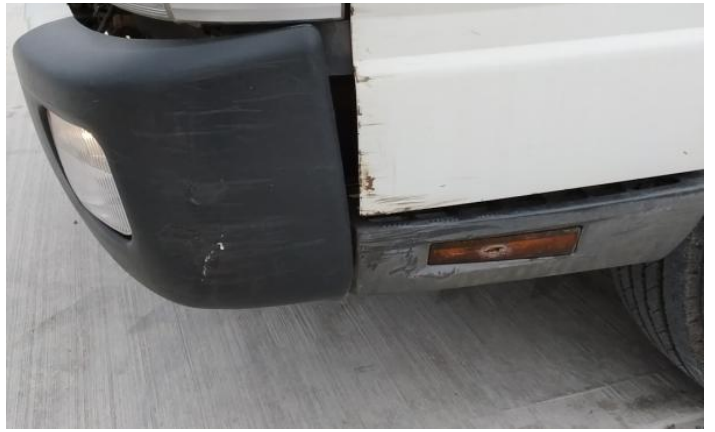
4: Bumper Front
Scratched
Over 100mm Thru Paint

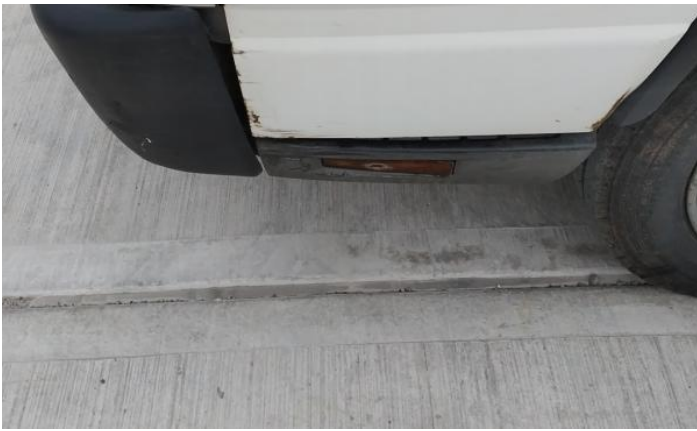
5: Door nsf
Scratched
Rusted

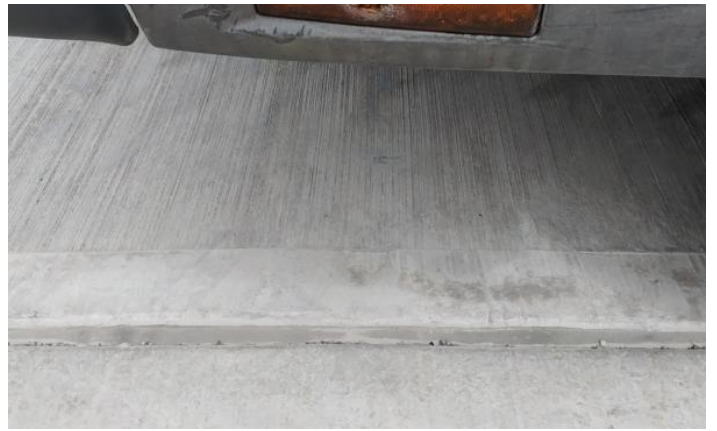
6: Reflector nsr
Broken
Replace

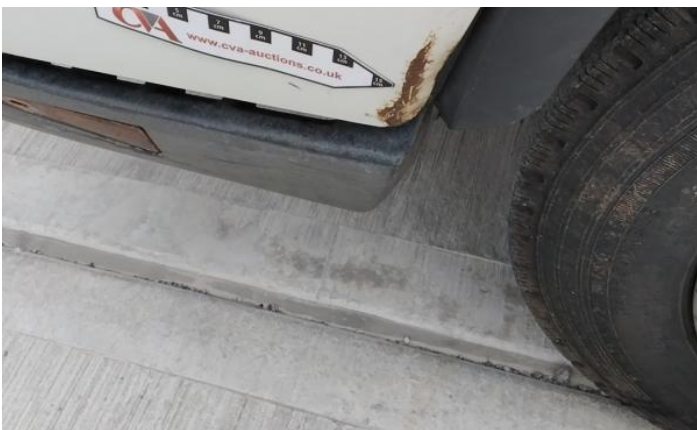
7: Door nsf
Dented
With Paint Damage

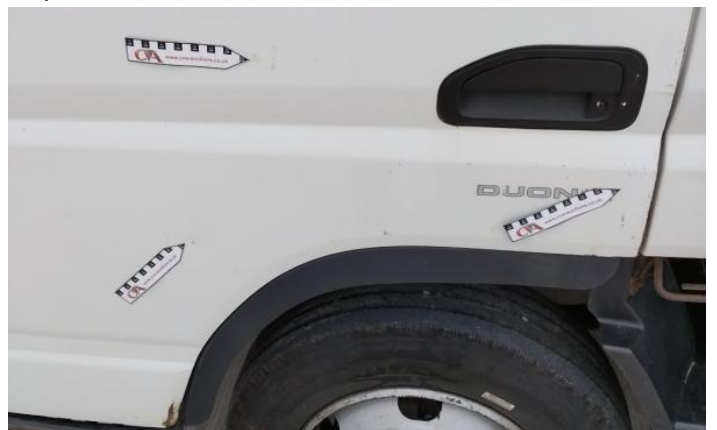
8: Door nsf
Scratched
Over 25mm Thru Paint

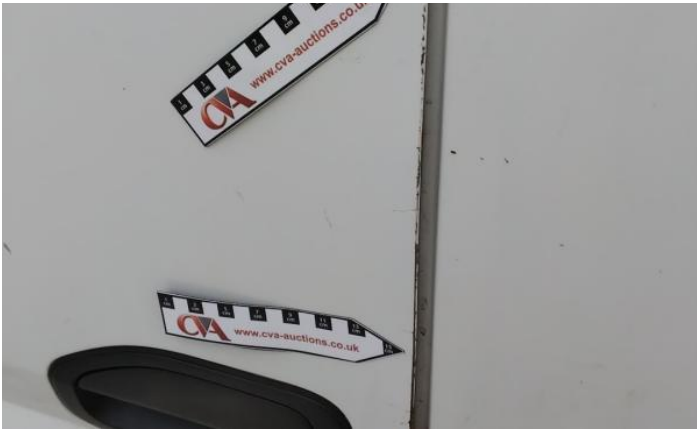
9: Door nsf
Chipped
Multiple Chips

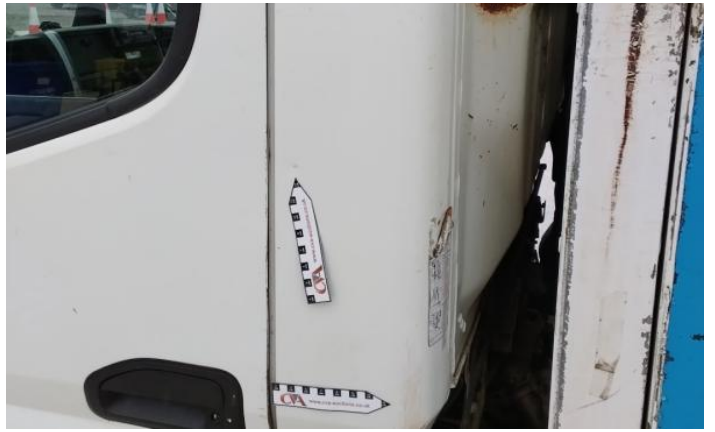
10: Qtr Panel nsr
Dented
With Paint Damage

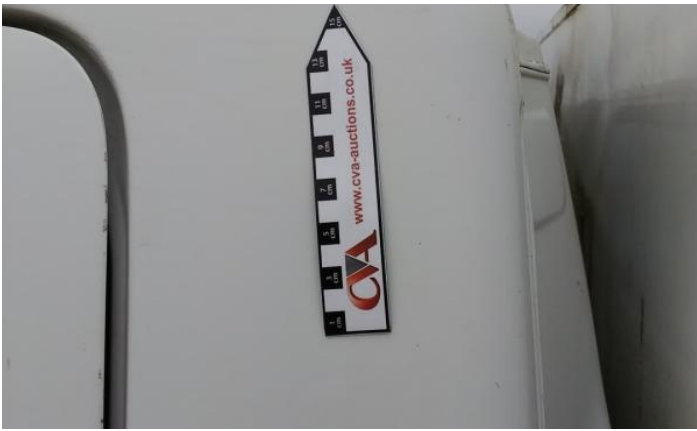
11: Qtr Panel nsr
Dented
With Paint Damage

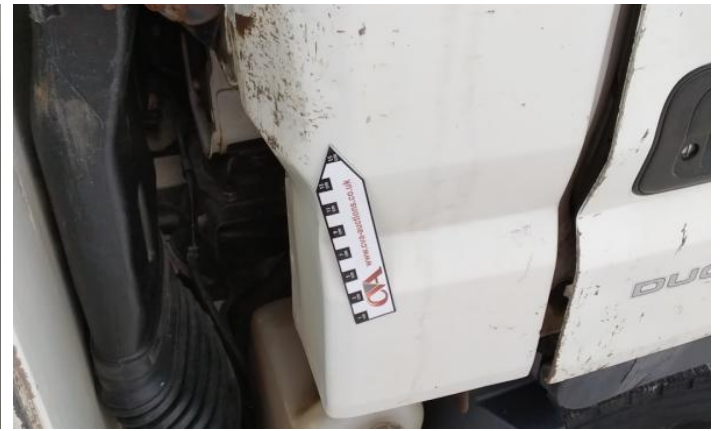
12: Qtr Panel osr
Dented
With Paint Damage

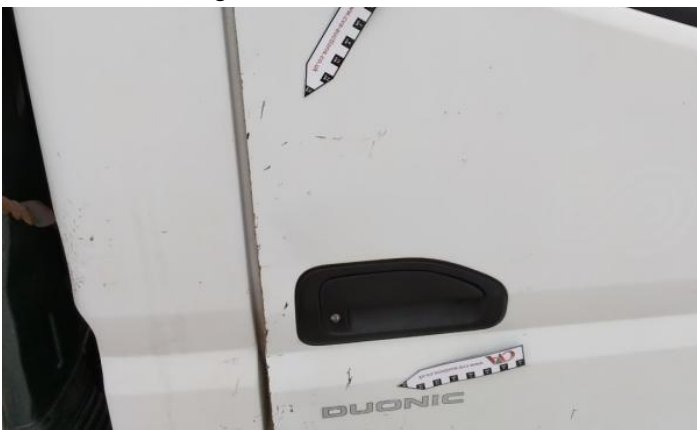
13: Door osf
Scratched
Over 25mm Thru Paint

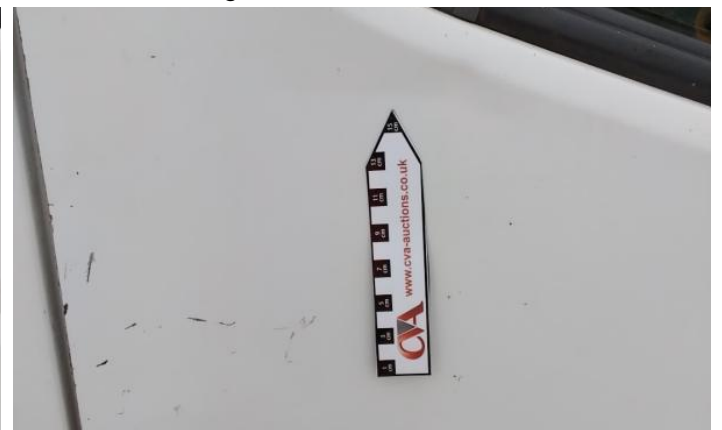
14: Door osf
Dented
Over 30mm

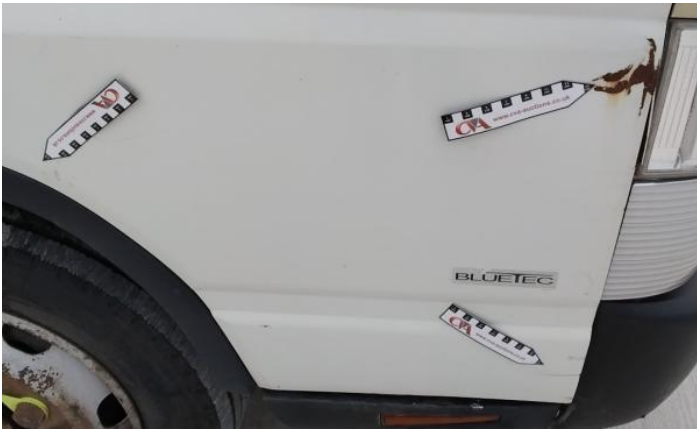
15: Door osf
Dented
Hail - Severe

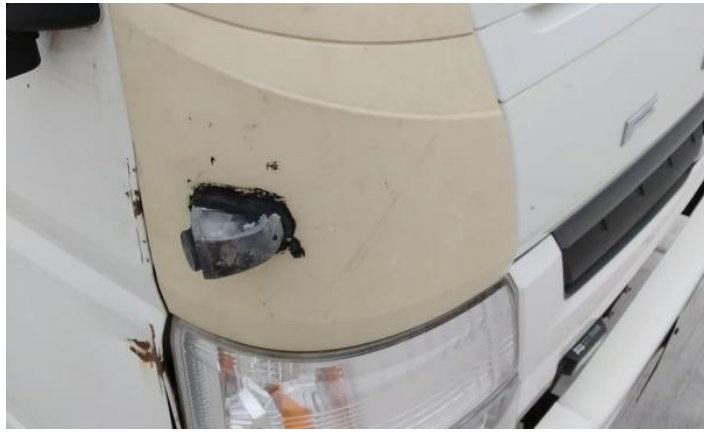
16: Wing osf
Poor Previous Repair
Poor Colour

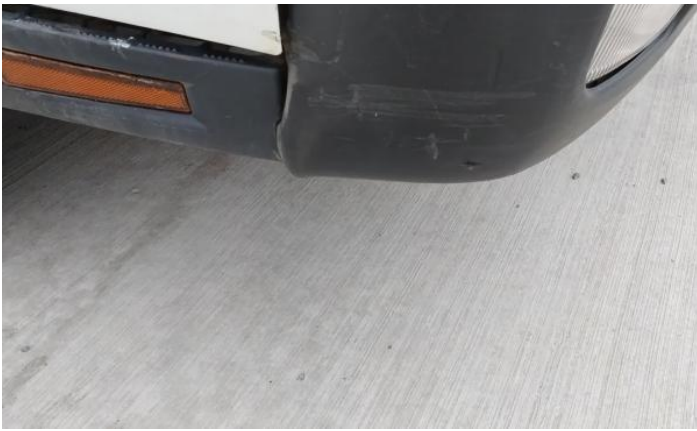
17: Bumper Front
Scratched
Over 100mm Thru Paint

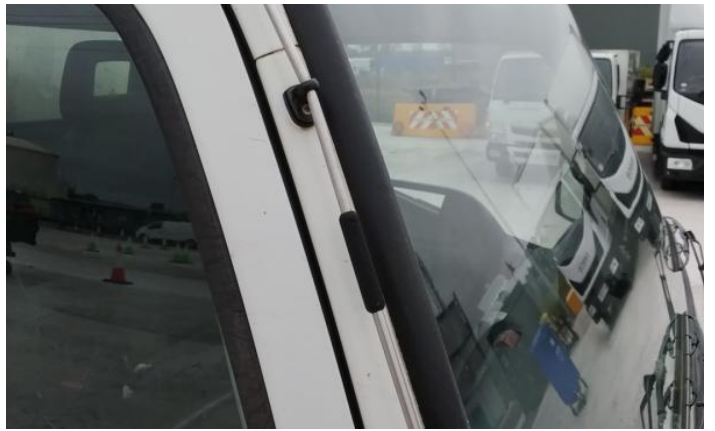
18: Aerial
Broken
Replace

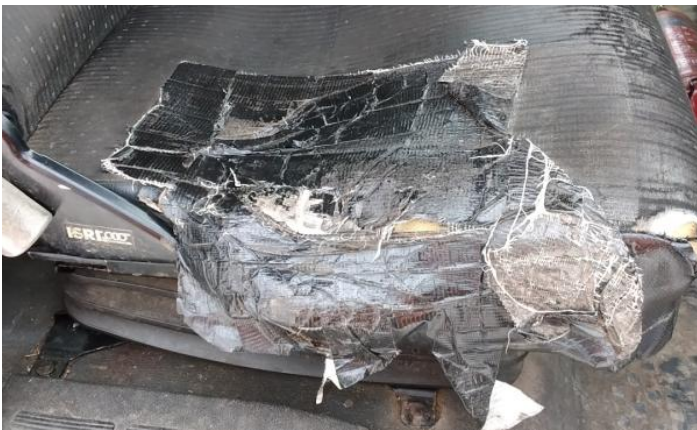
19: Seat Base Cover osf
Holed
Over 3mm

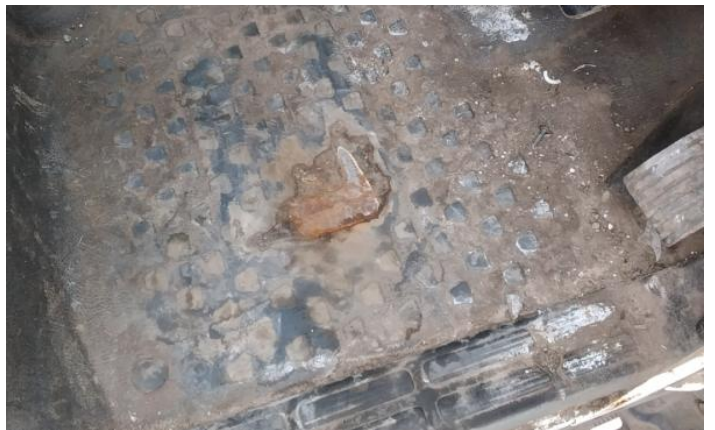
20: Carpets Front
Holed
Over 3mm

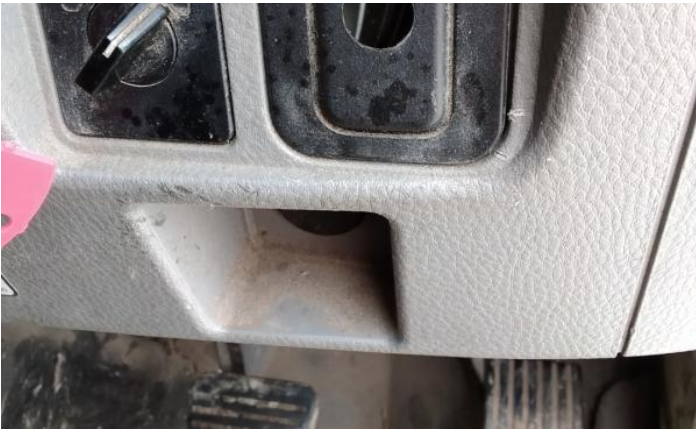
21: Switches And Controls
Missing
Replace

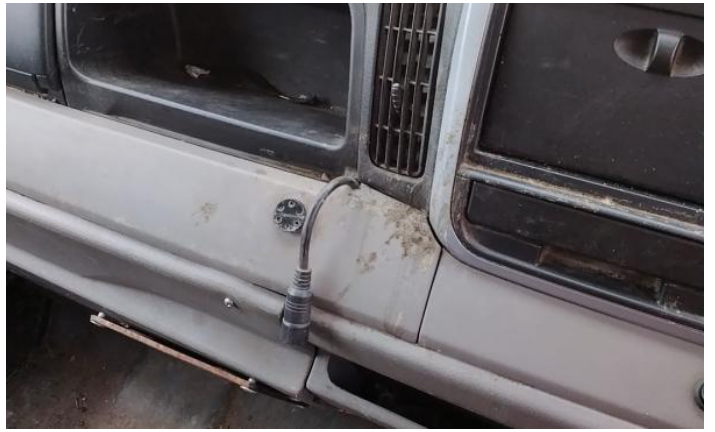
22: General Interior
Soiled
Light

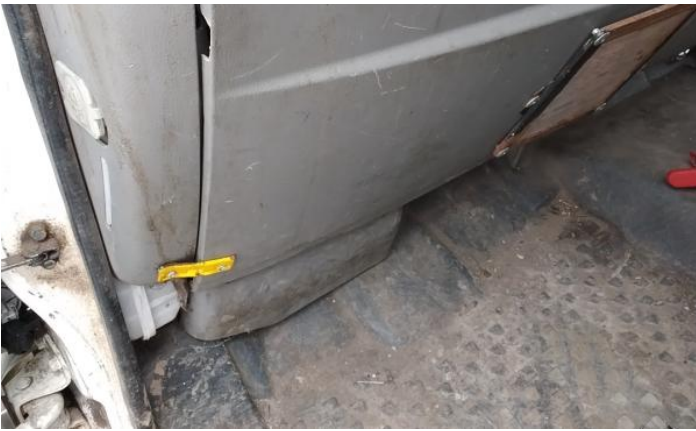
23: Centre Console Front
Broken
Replace

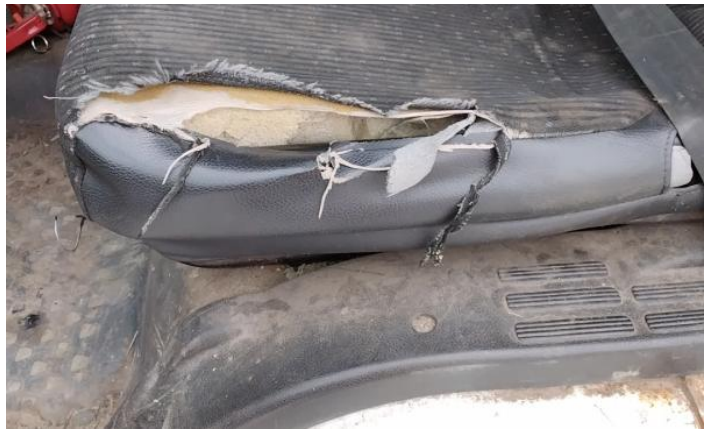
24: Seat Base Cover nsf
Holed
Over 3mm

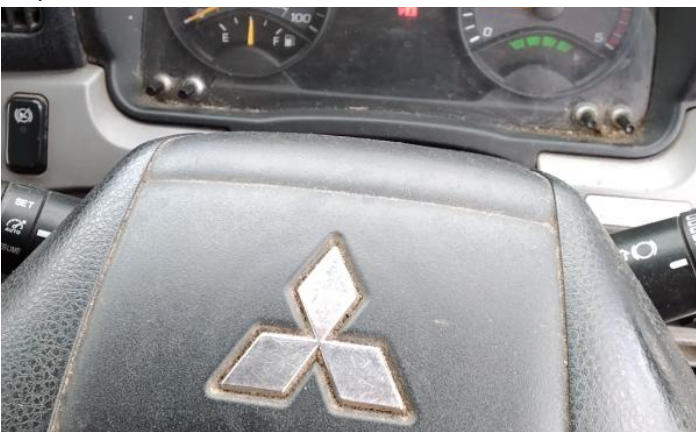
WARNING LIGHT ON DASH

25: Dash Warning Lights
Displayed
No Action
