# VEHICLE INSPECTION REPORT

**RV70DJD**

## Iveco Eurocargo 75-160

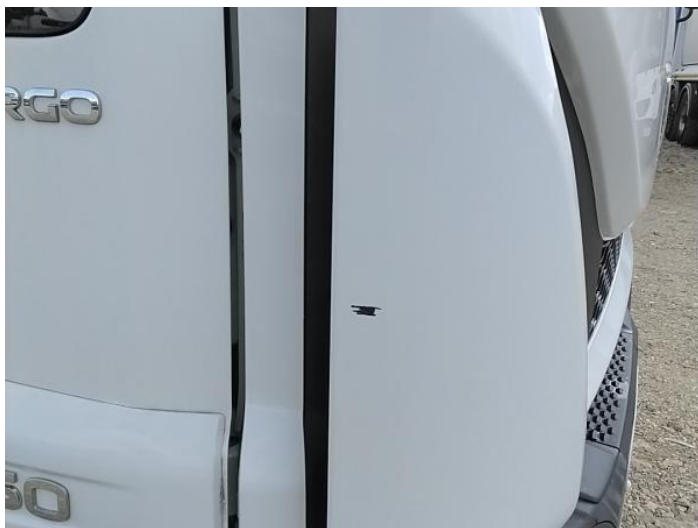
1: Wing osf  
Scratched  
Over 25mm Thru Paint

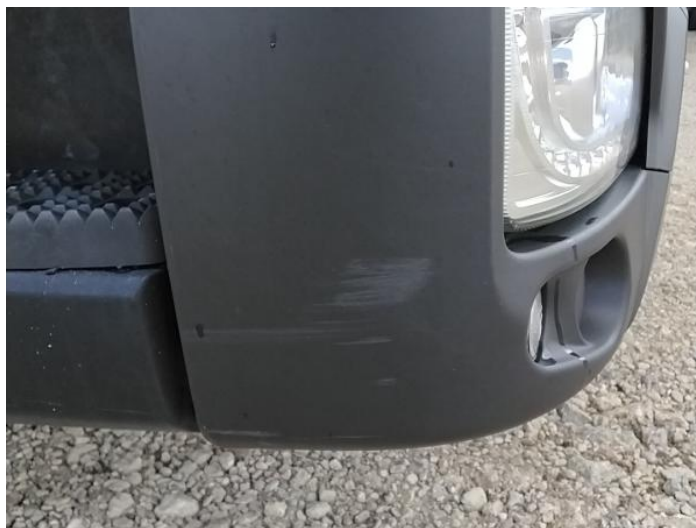
2: Bumper Front  
Scratched  
Over 25mm Not Thru Paint

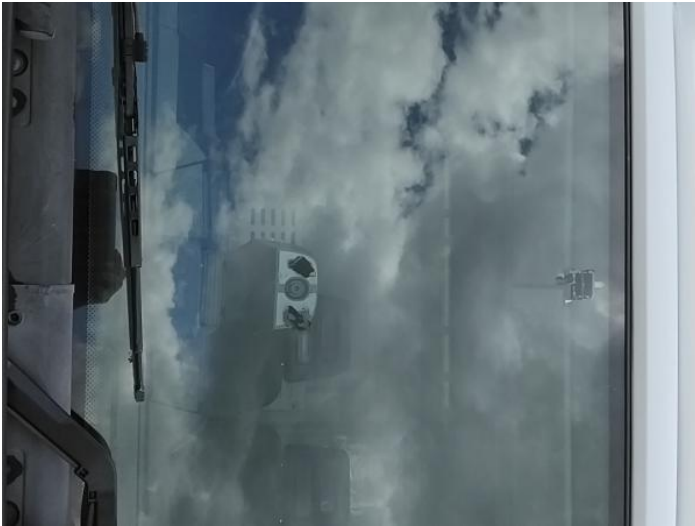
3: Screen Front  
Chipped  
UpTo 10mm

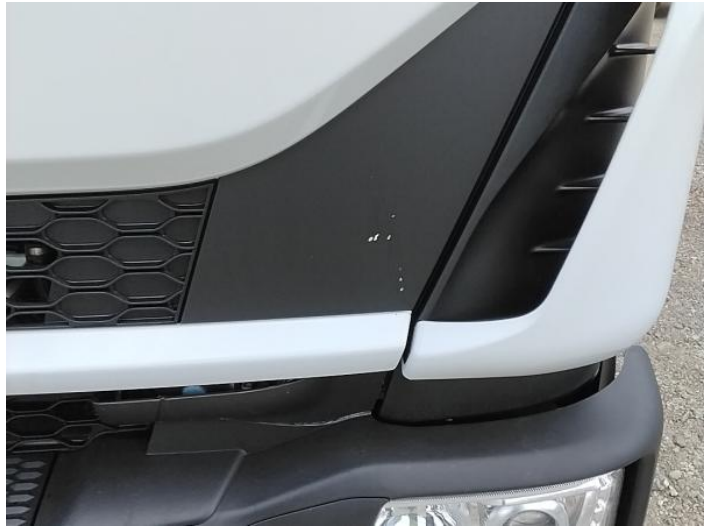
4: Bonnet  
Chipped  
Multiple Chips

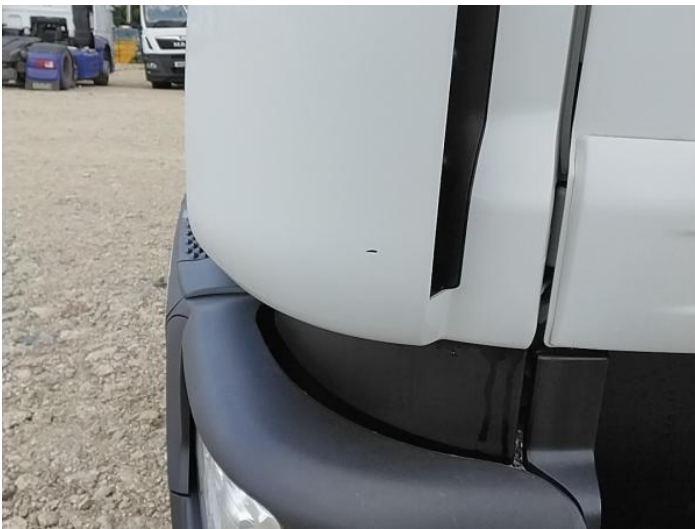
5: Wing nsf  
Scratched  
UpTo 25mm Thru Paint

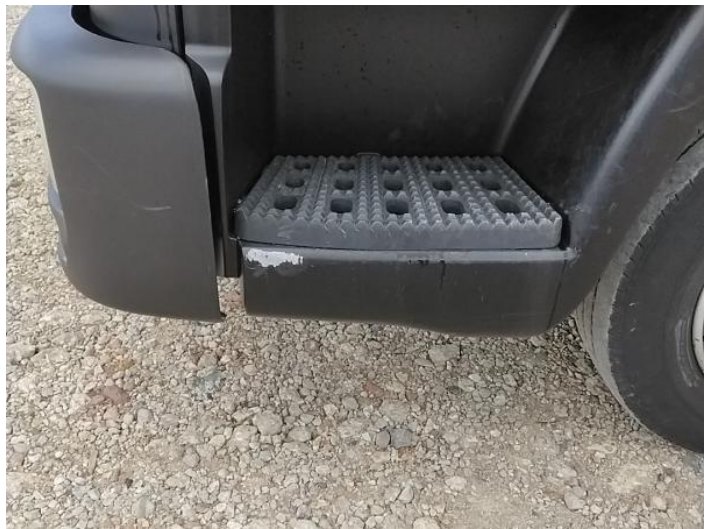
6: General Exterior  
Soiled  
Light

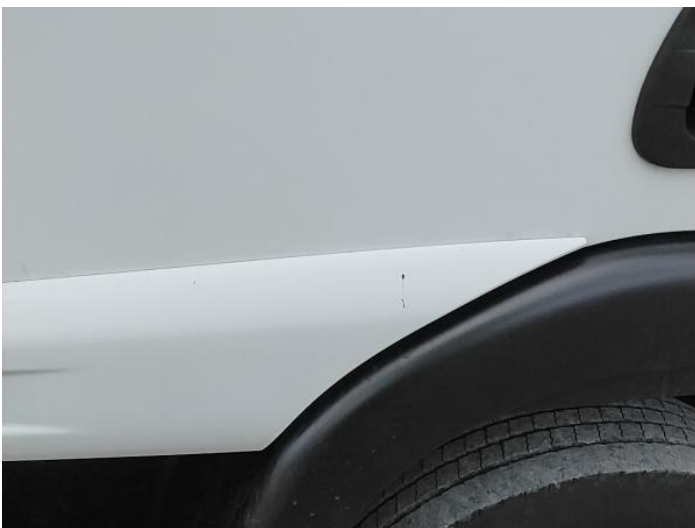
7: Door Moulding nsf  
Scratched (Painted)  
Over 25mm Thru Paint

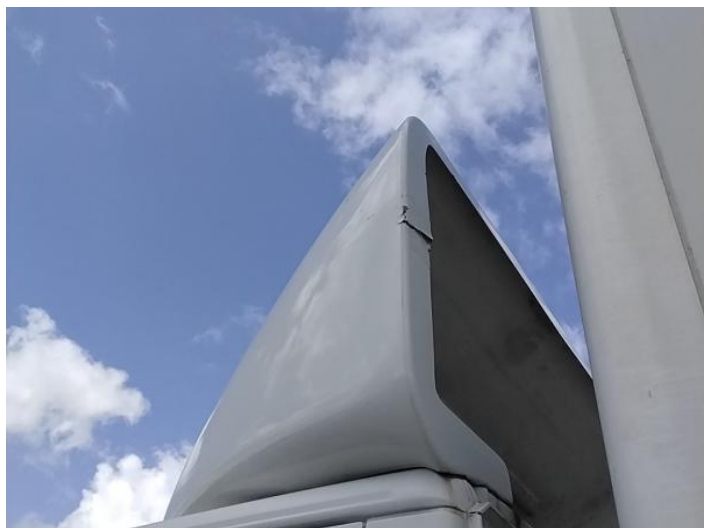
8: General Exterior  
Soiled  
Light

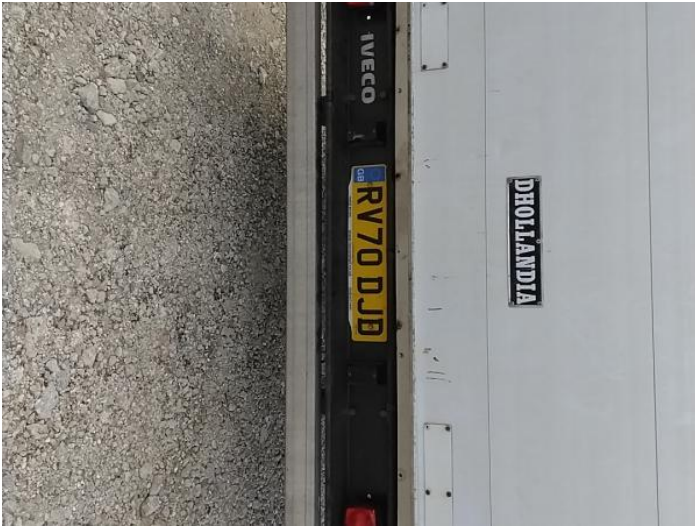
9: Bumper Rear  
Rusted  
Over 5mm

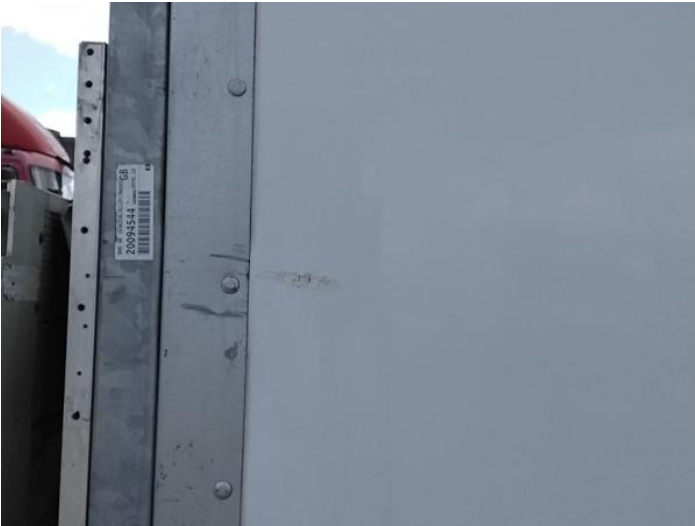
10: Qtr Panel osr  
Scratched  
Over 25mm Thru Paint

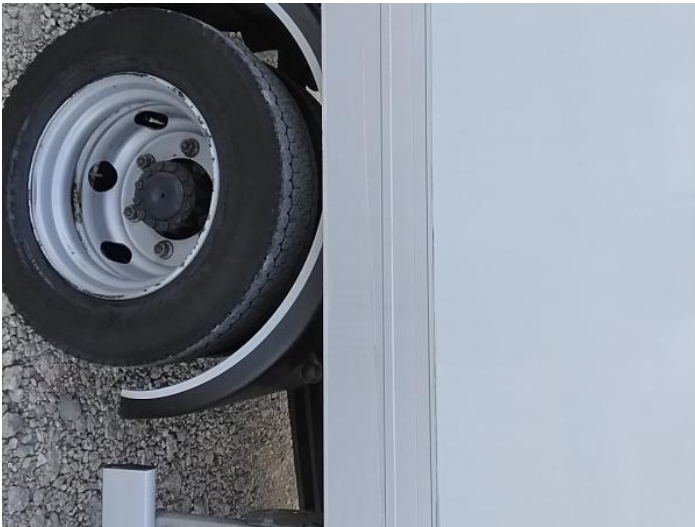
11: General Exterior  
Soiled  
Light

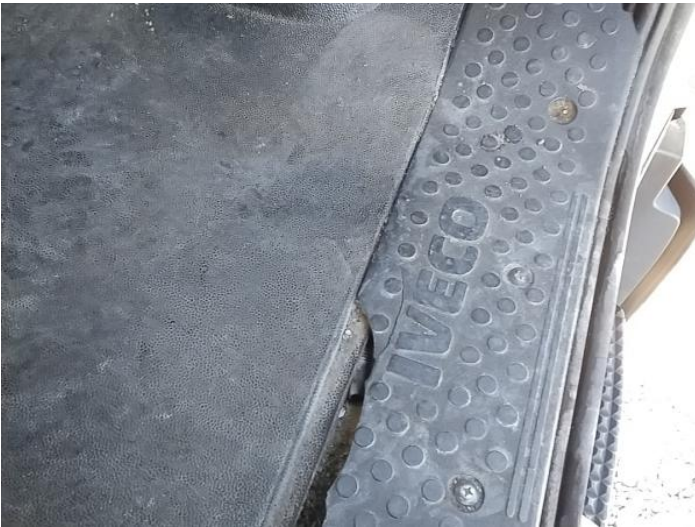
12: Carpets Front  
Holed  
Over 3mm
