# VEHICLE INSPECTION REPORT

**DG18CUU**

## Isuzu N75 190

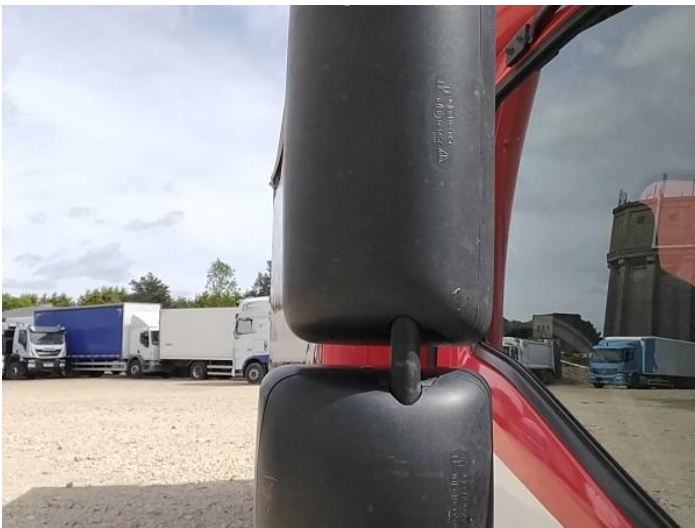
1: Door Mirror Assy of  
Scuffed (Unpainted)  
Over 100mm

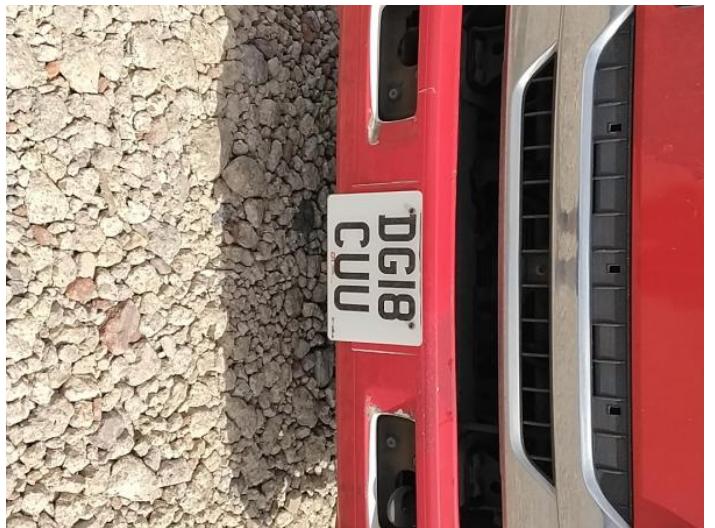
2: Bumper Front  
Scratched  
Over 100mm Thru Paint

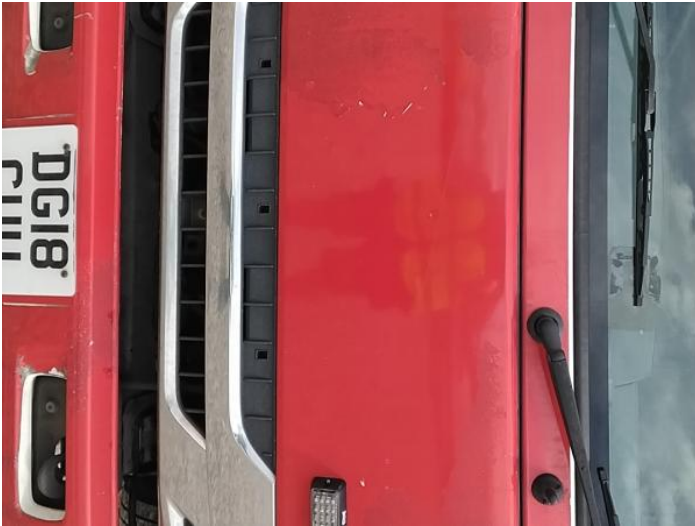
3: Bonnet  
Scratched  
Over 25mm Thru Paint

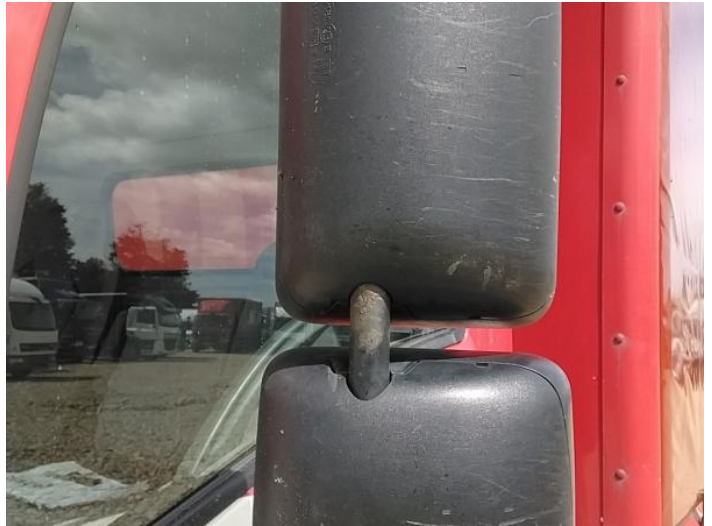
4: Door Mirror Assy nsf  
Scuffed (Unpainted)  
Over 100mm

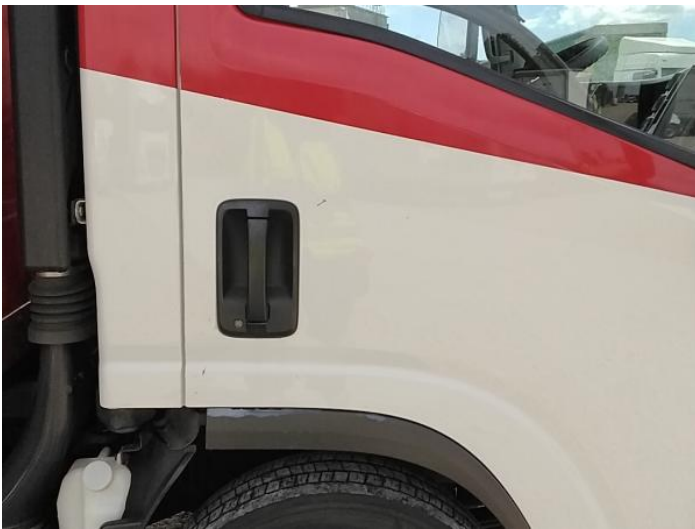
5: Door osf  
Scratched  
Over 25mm Thru Paint

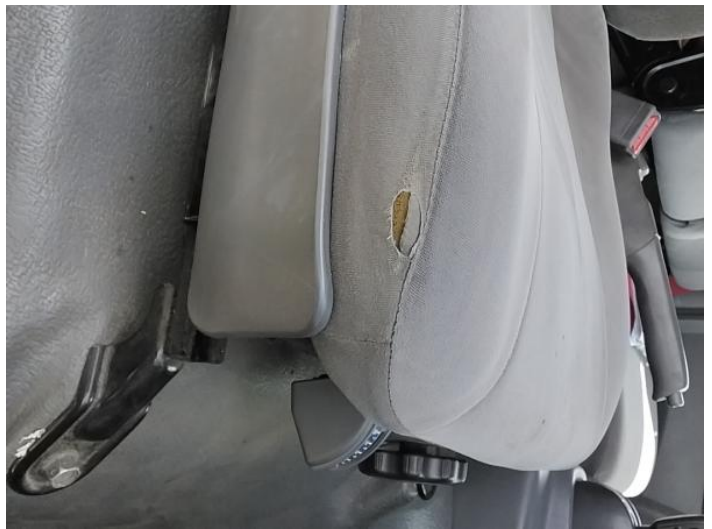
6: Seat Base Cover osf  
Holed  
Over 3mm

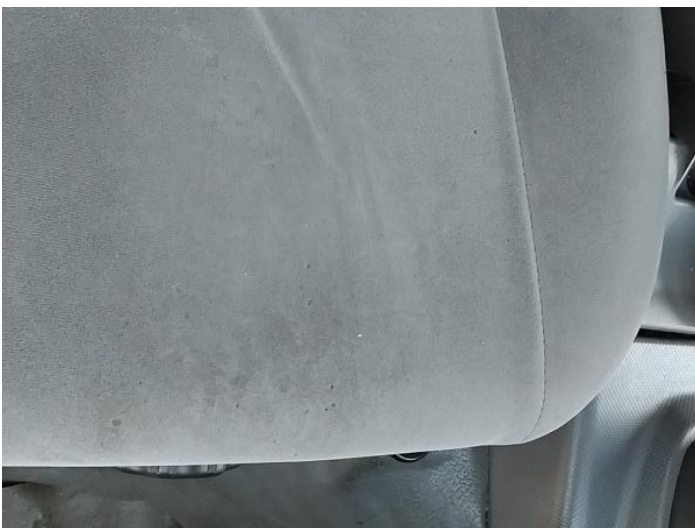
7: Seat Base Cover osf  
Burn  
Over 3mm
