VEHICLE INSPECTION REPORT

WN12DCU

Mercedes-Benz Sprinter 513 CDI

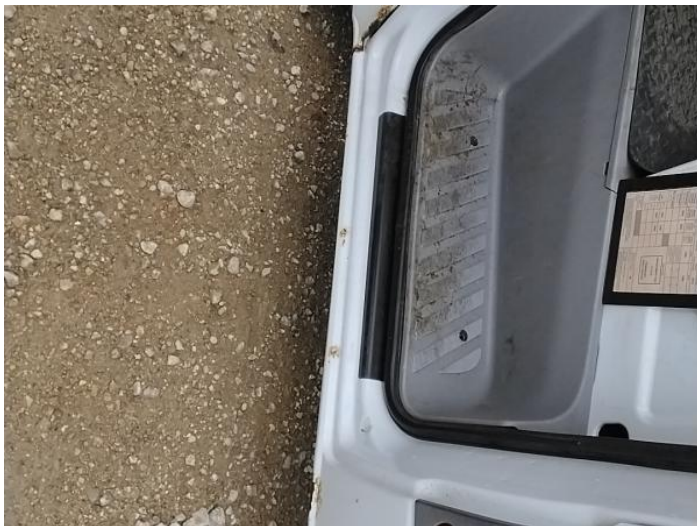
1: Sill ns
Rusted
Over 5mm

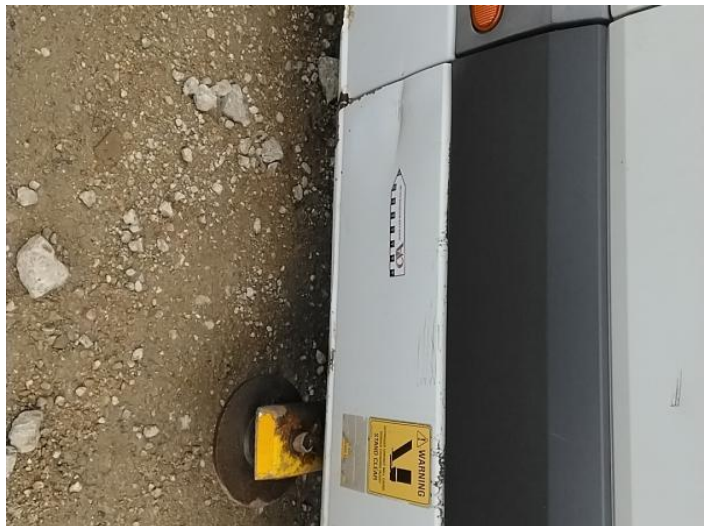
2: Door nsr
Dented
With Paint Damage

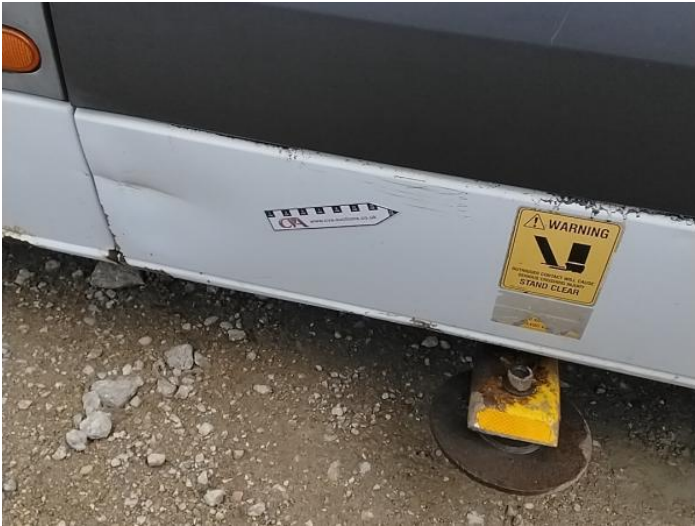
3: Door nsr
Scratched
Over 25mm Thru Paint

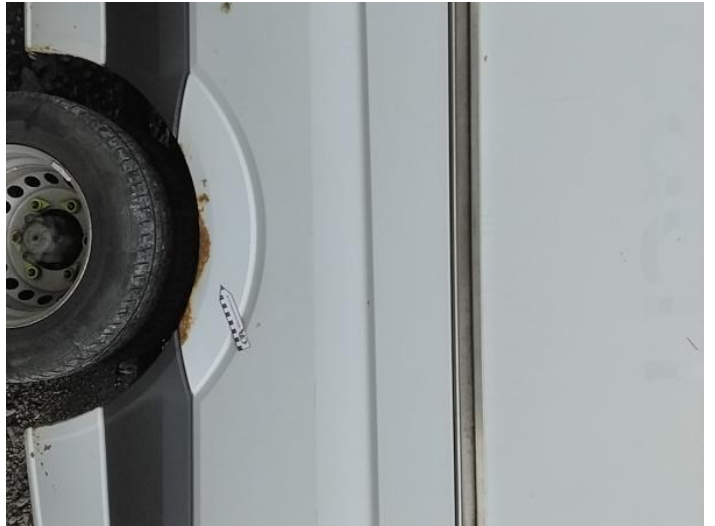
4: General Exterior
Soiled
Light

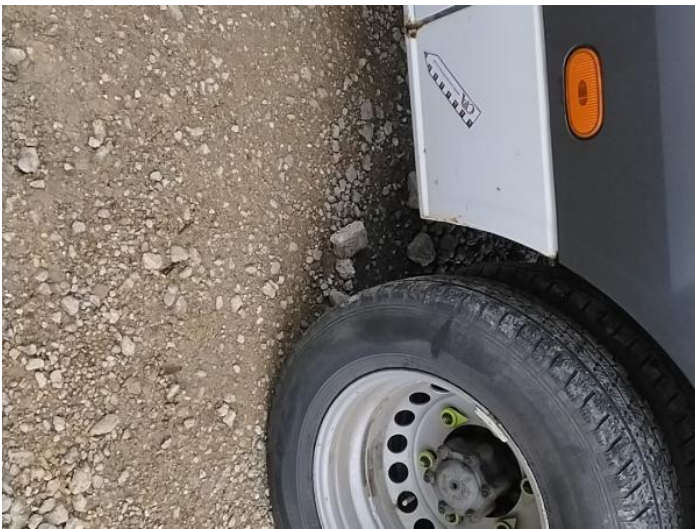
5: General Exterior
Soiled
Light

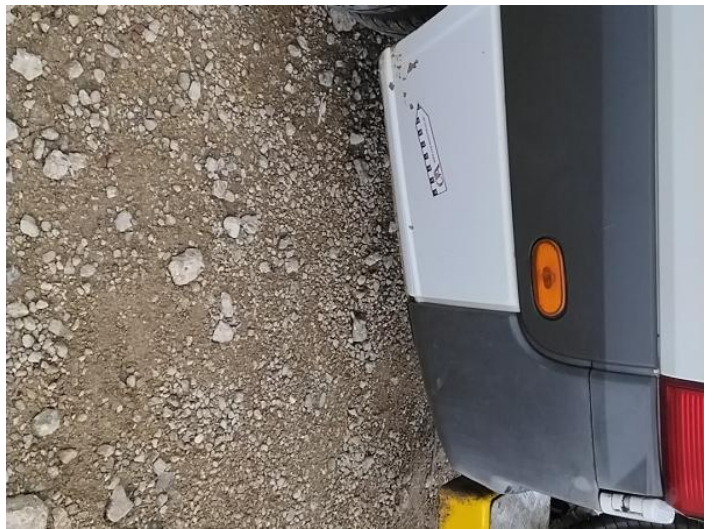
6: General Exterior
Soiled
Light

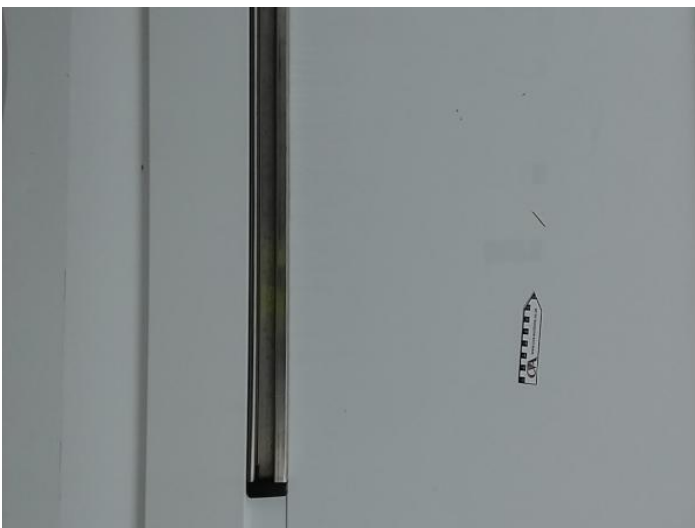
7: Qtr Panel nsr
Rusted
Over 5mm

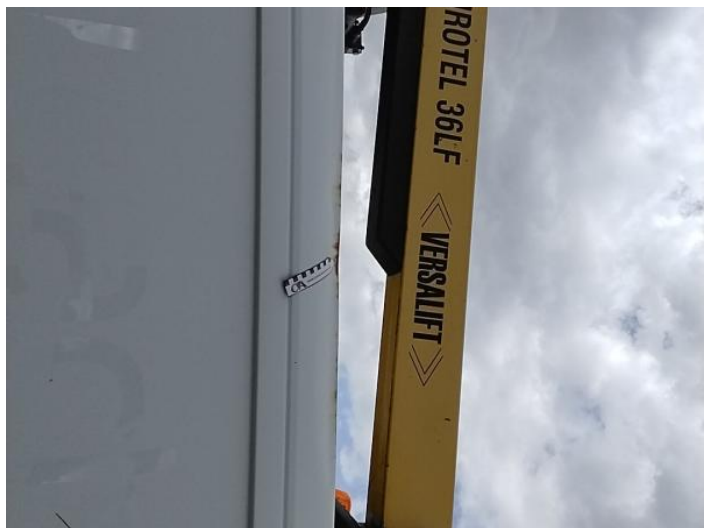
8: Qtr Panel nsr
Rusted
Over 5mm

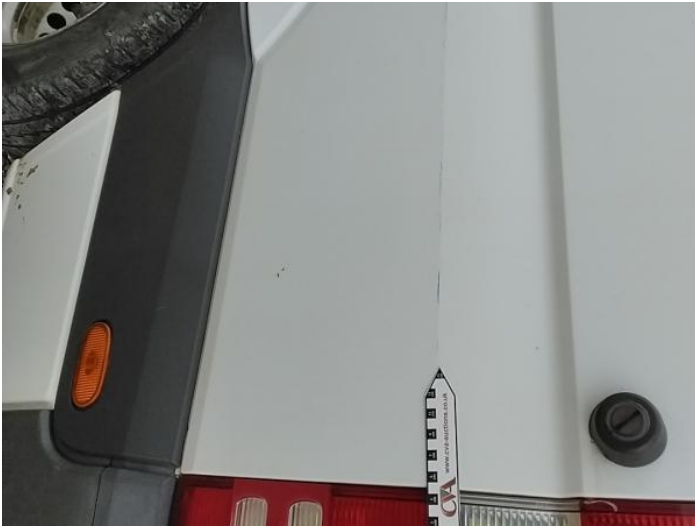
9: Qtr Panel nsr
Scratched
Over 25mm Not Thru Paint

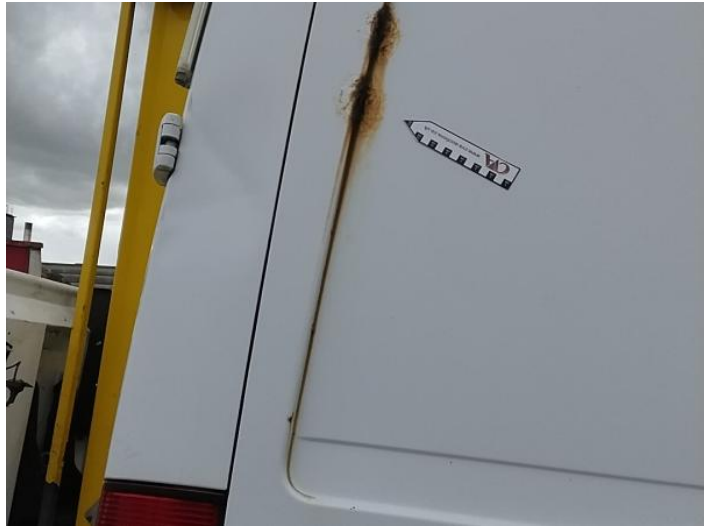
10: Qtr Panel osr
Rusted
Holed

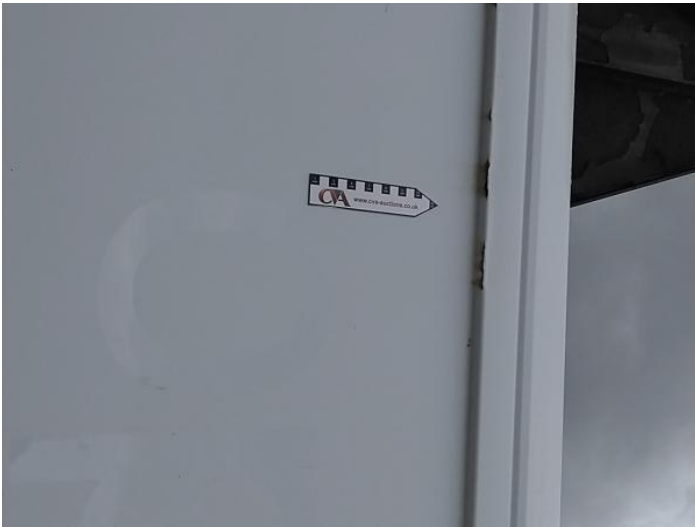
11: Qtr Panel osr
Rusted
Over 5mm

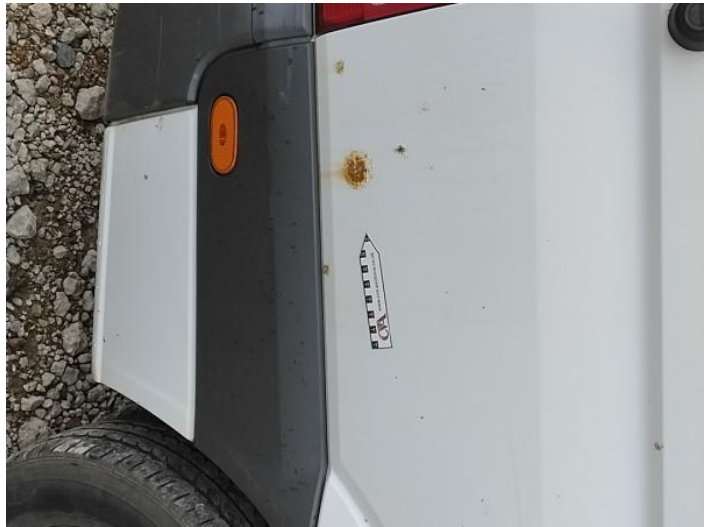
12: Qtr Panel osr
Rusted
Over 5mm

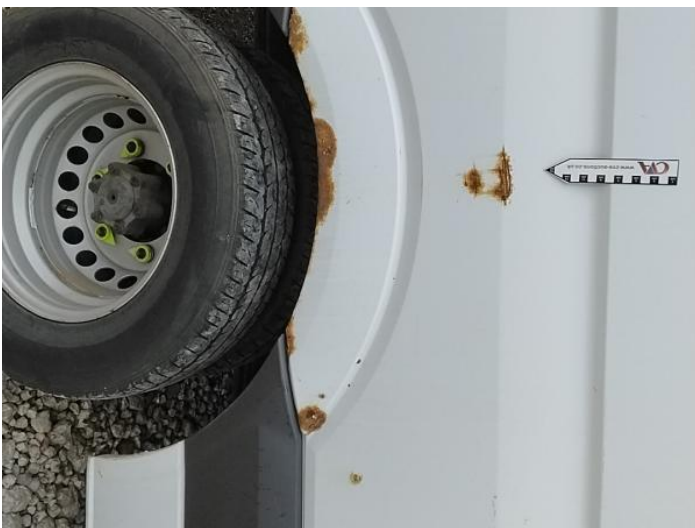
13: General Exterior
Soiled
Light

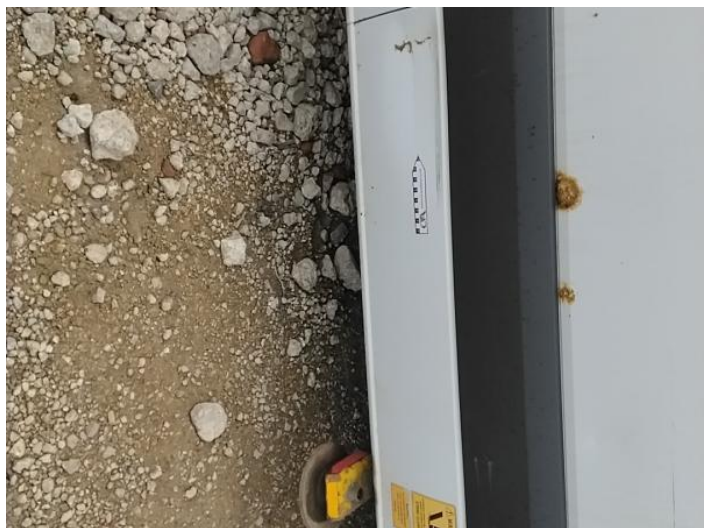
14: Qtr Panel osr
Dented
With Paint Damage

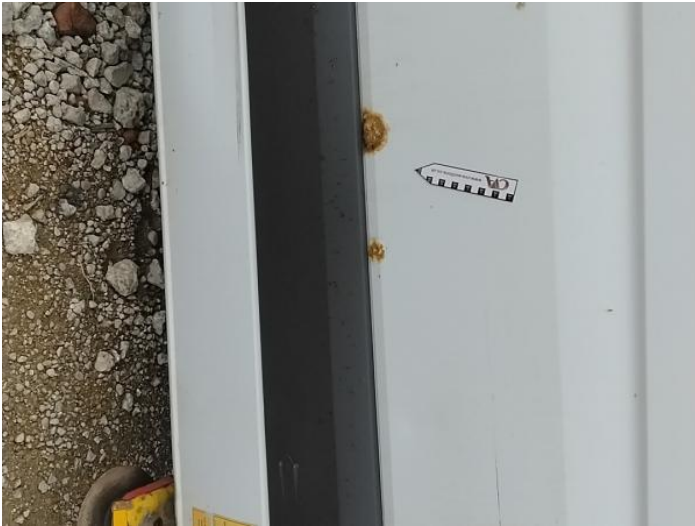
15: Qtr Panel osr
Rusted
Over 5mm

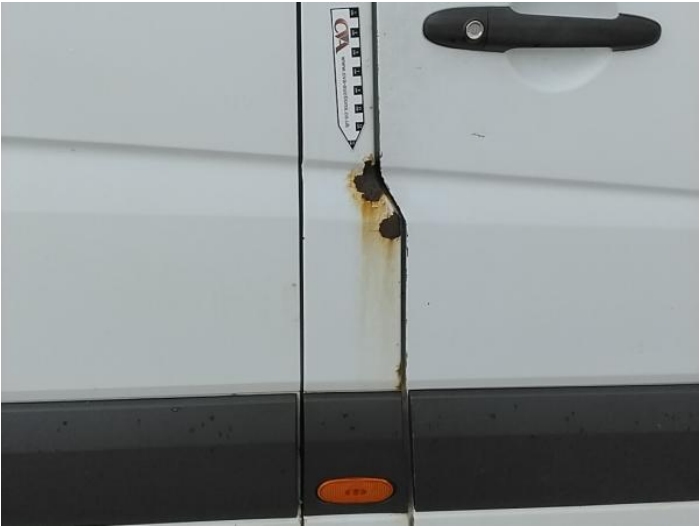
16: B Post os
Rusted
Over 5mm

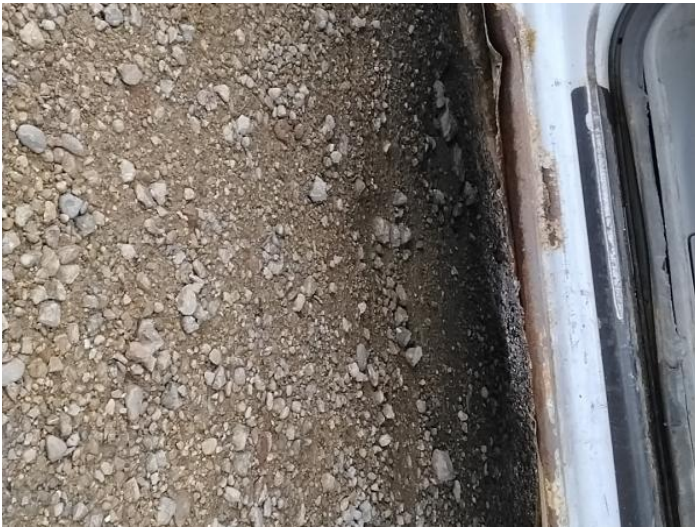
17: Sill os
Rusted
Over 5mm
