# VEHICLE INSPECTION REPORT

**SV70NWW**

## Scania R 450

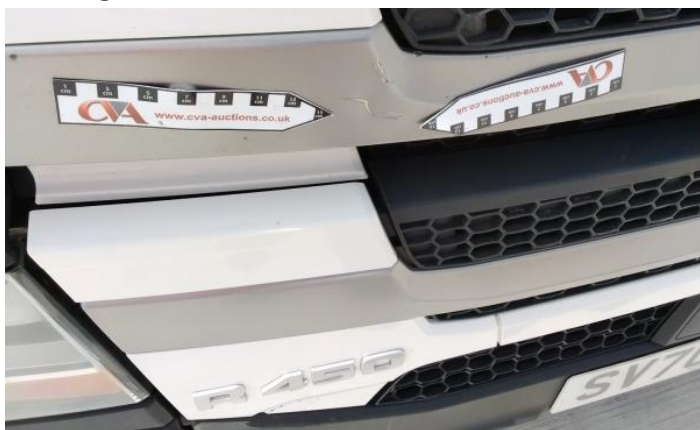
1: Bonnet  
Scratched  
Over 25mm Thru Paint

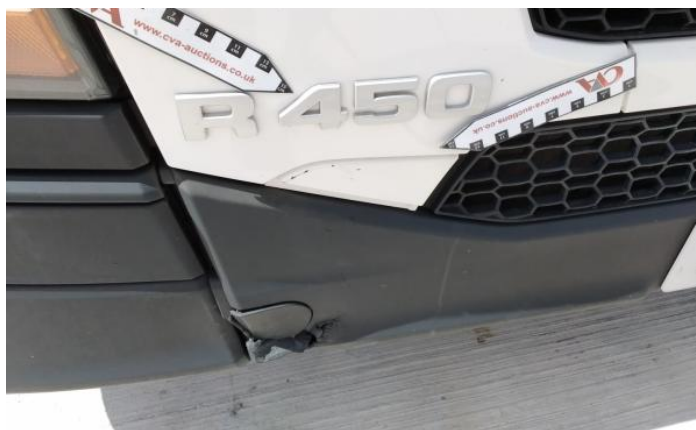
2: Bonnet  
Scratched  
Over 25mm Thru Paint

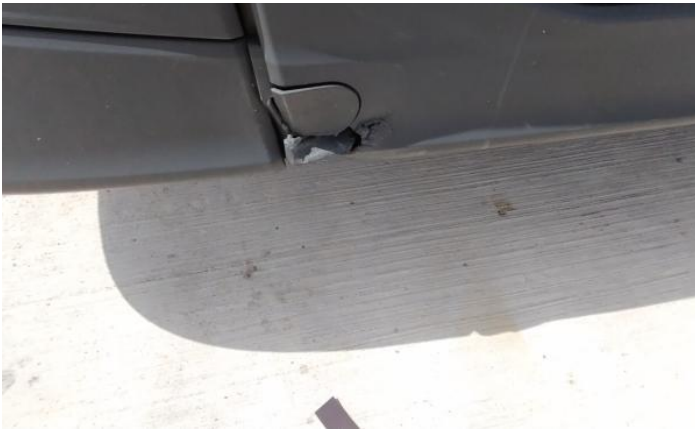
3: Bumper Front  
Dented  
Over 2 UpTo 10mm

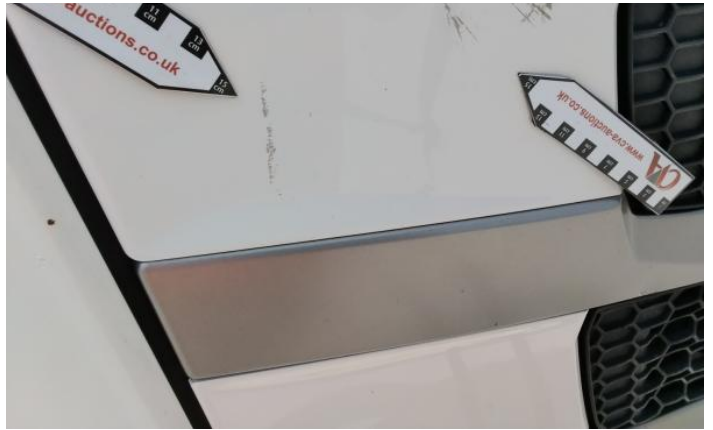
4: Bonnet  
Scratched  
Over 25mm Thru Paint

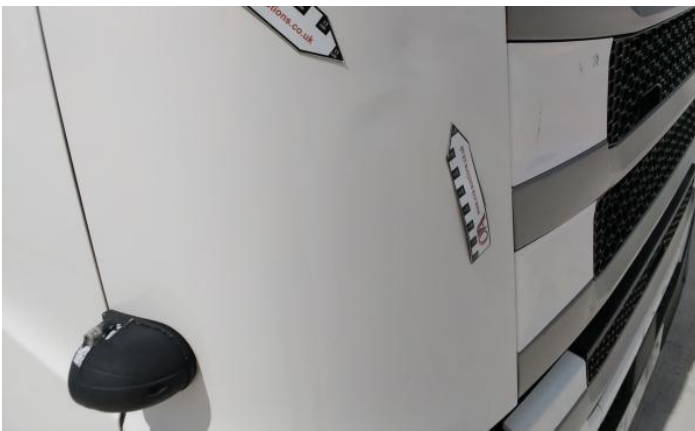
5: A Post os  
Dented  
Between 10mm + 30mm

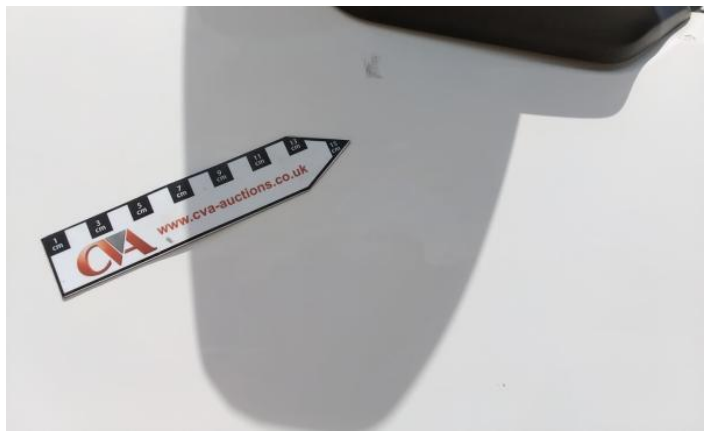
6: Door osf  
Scratched  
Over 25mm Not Thru Paint

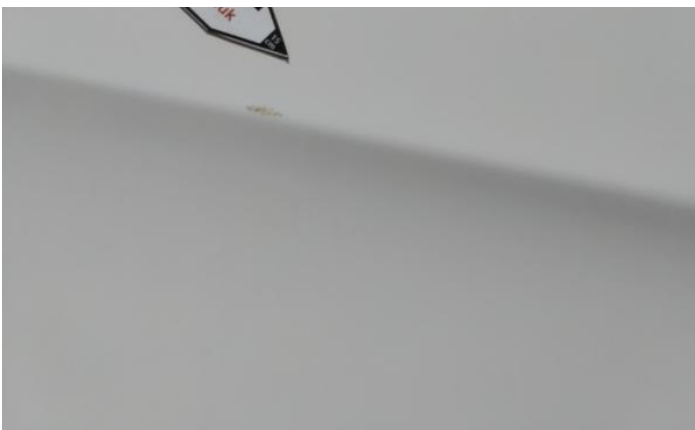
7: Door osf  
Scratched  
Over 25mm Thru Paint

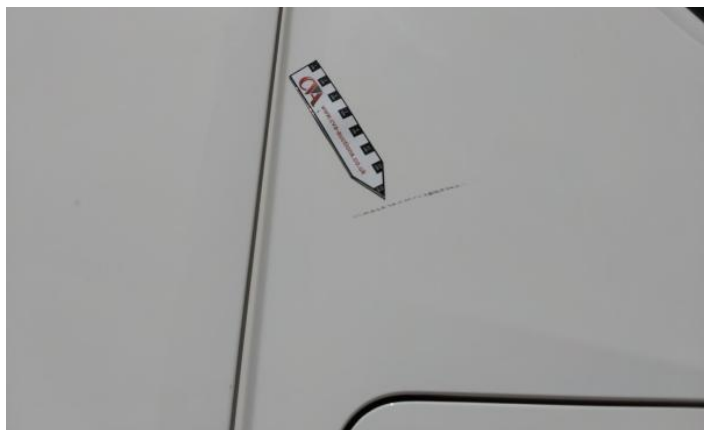
8: Qtr Panel osr  
Scratched  
Over 25mm Thru Paint

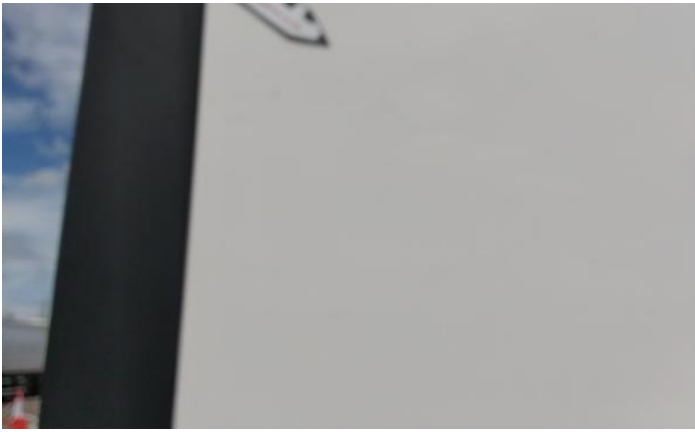
9: Qtr Panel osr  
Scratched  
Over 25mm Thru Paint

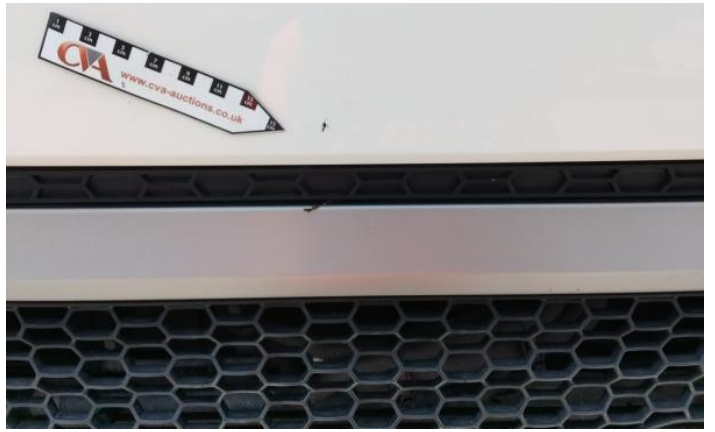
10: Bonnet  
Chipped  
1 To 5

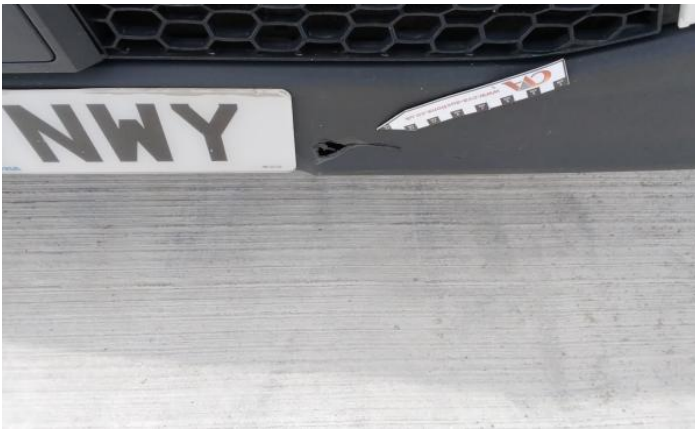
11: Bumper Front  
Dented  
Over 30mm

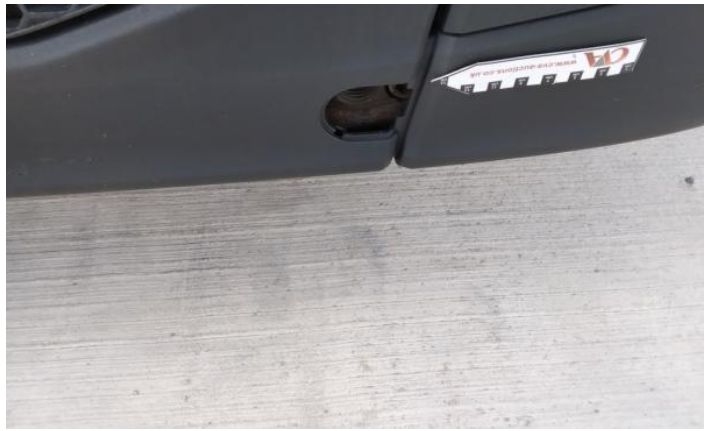
12: Bumper Front  
Hole  
Over 25mm

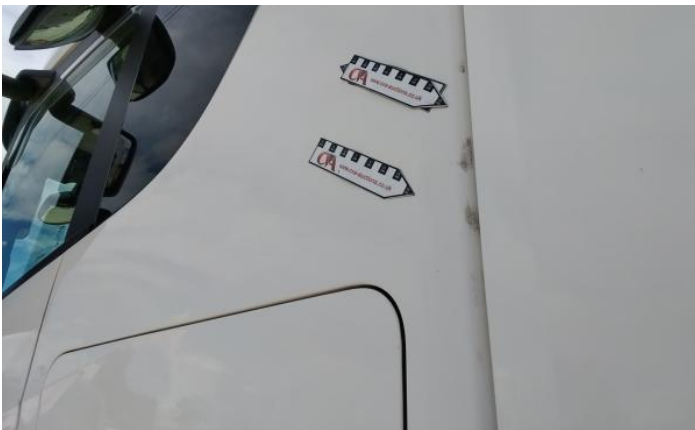
13: B Post ns  
Scratched  
Over 25mm Thru Paint

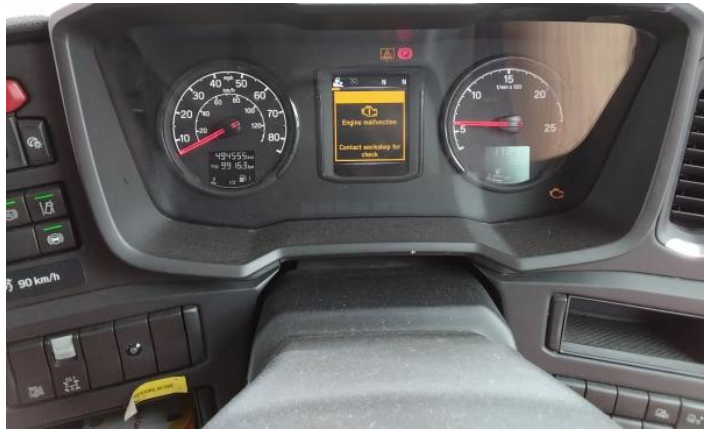
16: Dash Warning Lights  
Displayed  
No Action
