VEHICLE INSPECTION REPORT

FV22HYH

Ford Transit 2.0 ECOBLUE 130PS

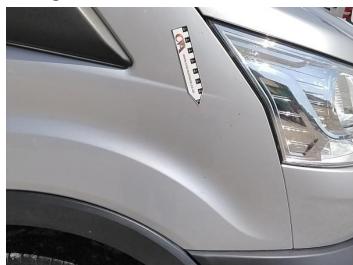
1: Wing osf Scratched Over 25mm Thru Paint

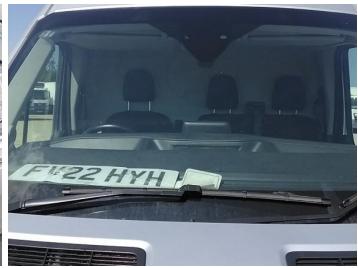
2: Screen Front Chipped UpTo 10mm

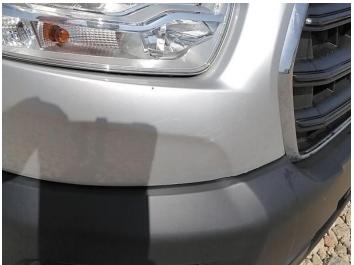
3: Panel Front Scratched Over 25mm Thru Paint

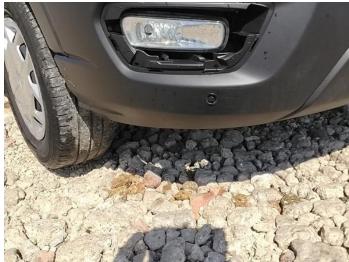
4: Fog Lamp Surround os Missing Replace

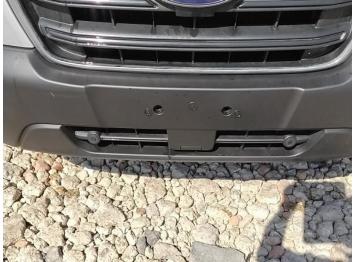
5: Number Plate Front Missing Replace

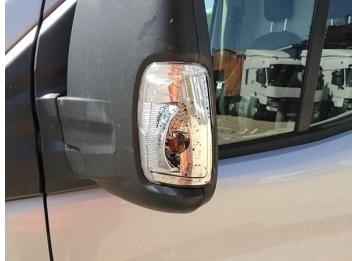
6: Door Mirror Assy nsf Broken Replace

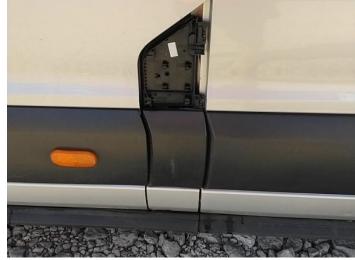
7: Fuel Flap Missing Replace

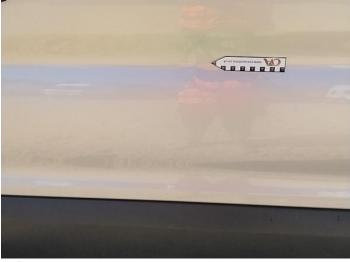
8: Door nsr Dented With Paint Damage

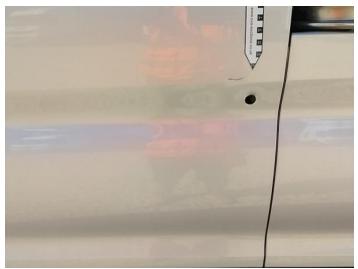
9: Door nsr Hole Over 10mm

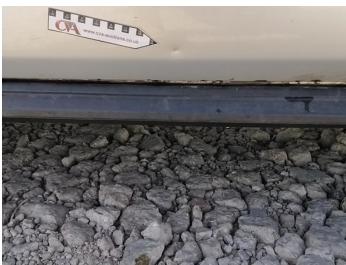
10: Door nsr Dented 2 Or Less UpTo 10mm

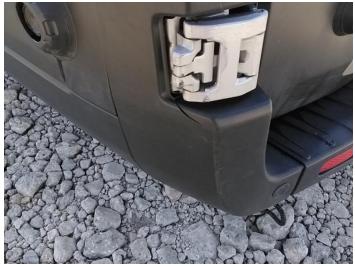
11: Bumper Rear Cracked Over 25mm

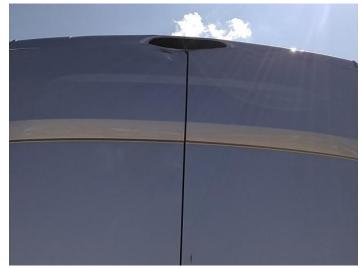
13: Door nsr Dented Over 30mm

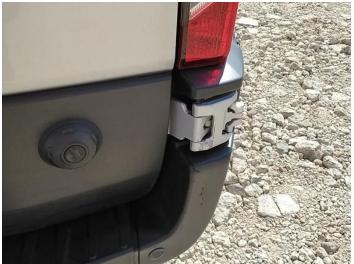
15: Bumper Rear Cracked Over 25mm

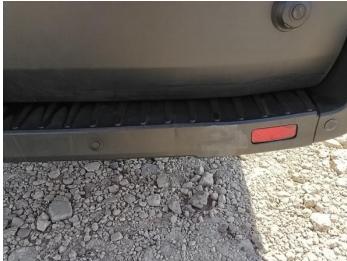
16: Bumper RearScratchedOver 25mm Not Thru Paint

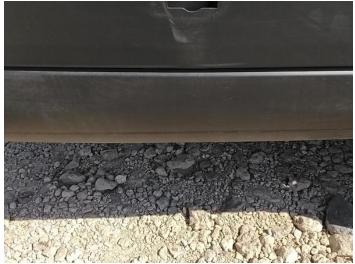
17: Qtr Panel nsr Missing Replace

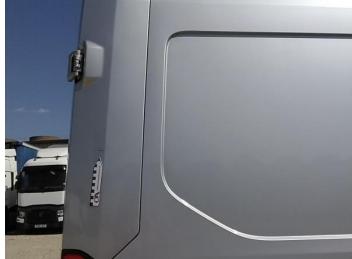
18: Qtr Panel osr Scratched Over 25mm Thru Paint

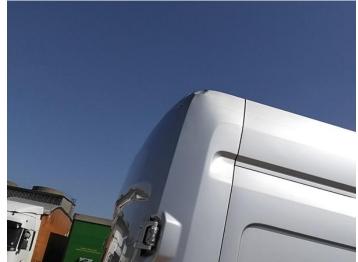
19: Qtr Panel osr Dented With Paint Damage

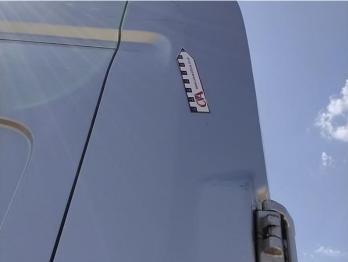
20: Qtr Panel nsr Dented With Paint Damage

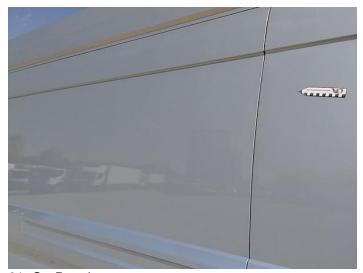
21: Qtr Panel osr Scratched Over 25mm Not Thru Paint

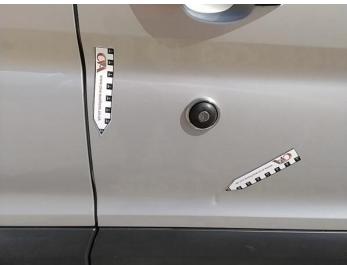
22: Door osf Dented With Paint Damage

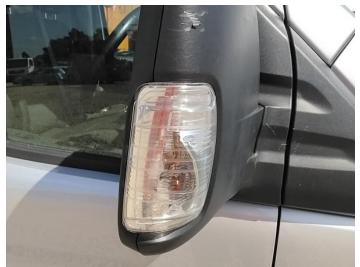
23: Door Mirror Assy osf Scuffed (Unpainted) Over 100mm

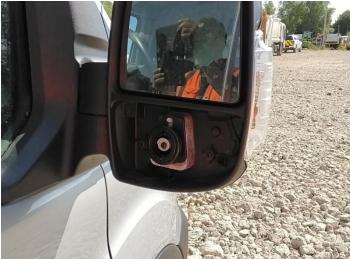
24: Door Mirror Glass os Missing Replace

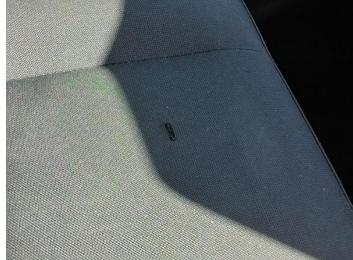
26: Seat Base Cover nsf Holed Over 3mm
