# VEHICLE INSPECTION REPORT

**HX73YSL**

## Mercedes-Benz Atego 816

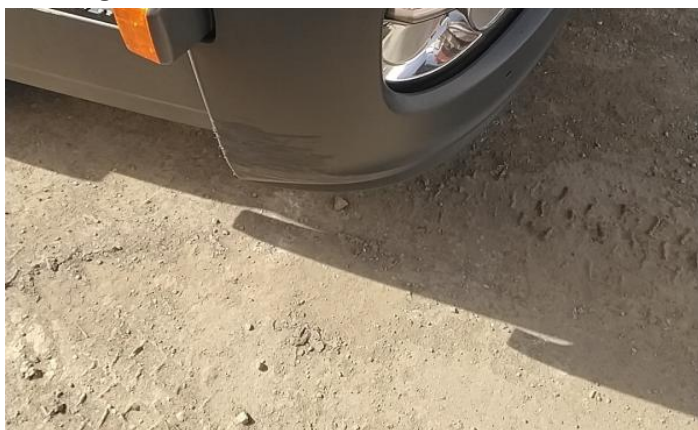
1: Bumper Front  
Scratched  
Over 100mm Thru Paint

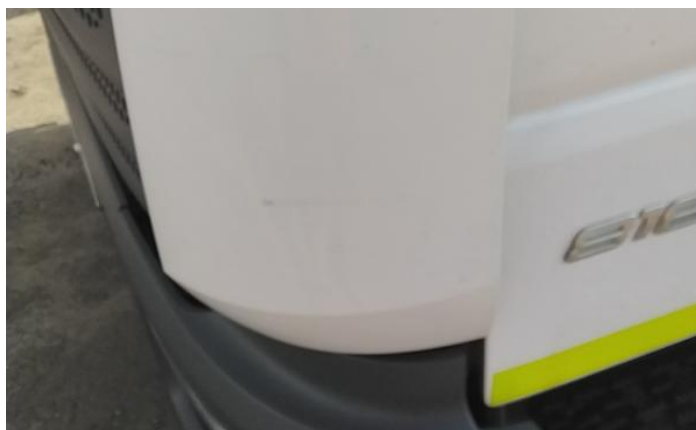
2: Panel Front  
Scratched  
Over 25mm Thru Paint

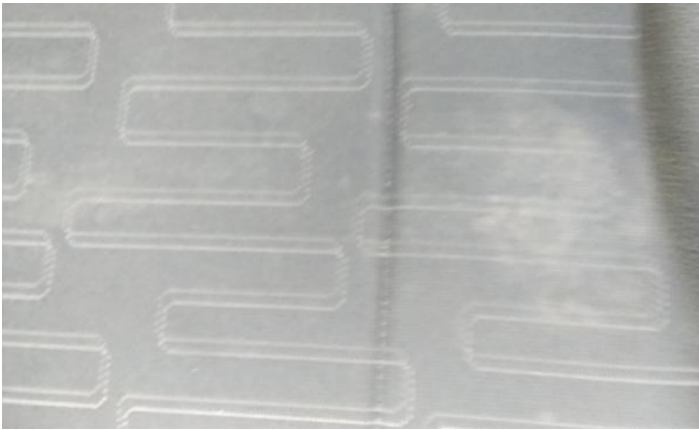
3: Seat Base Cover osf  
Soiled  
Heavy

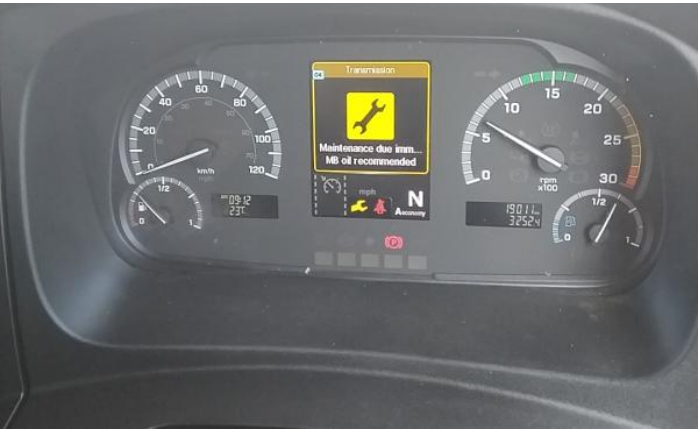
4: Dash Warning Lights  
Displayed  
No Action

| ABS light illuminated | OK | | Service indicator light illuminated | Fault | |
