VEHICLE INSPECTION REPORT

PE70UNH

Fiat Ducato 35 MAXI 2.3 MULTIJET 140PS

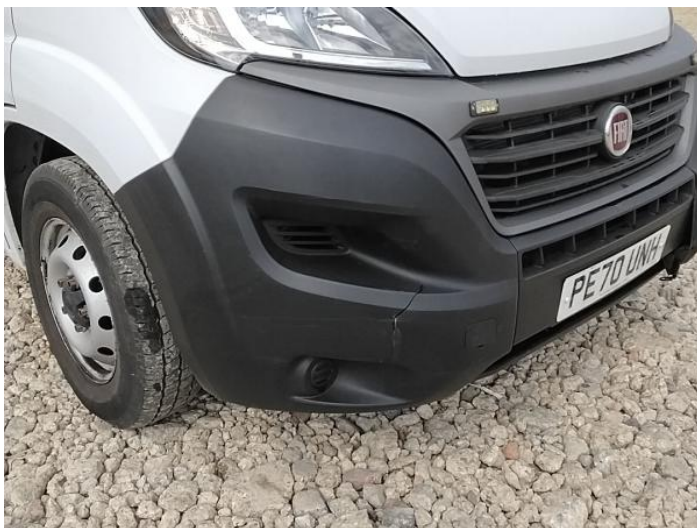
1: Bumper Front
Cracked
Over 25mm

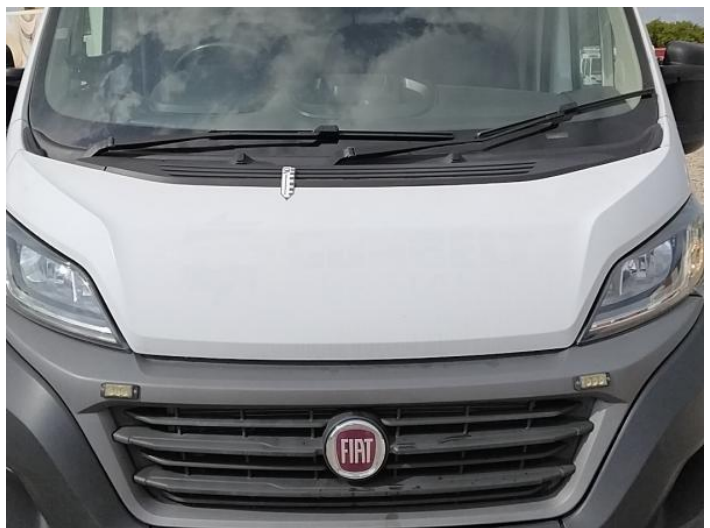
2: Bonnet
Chipped
Multiple Chips

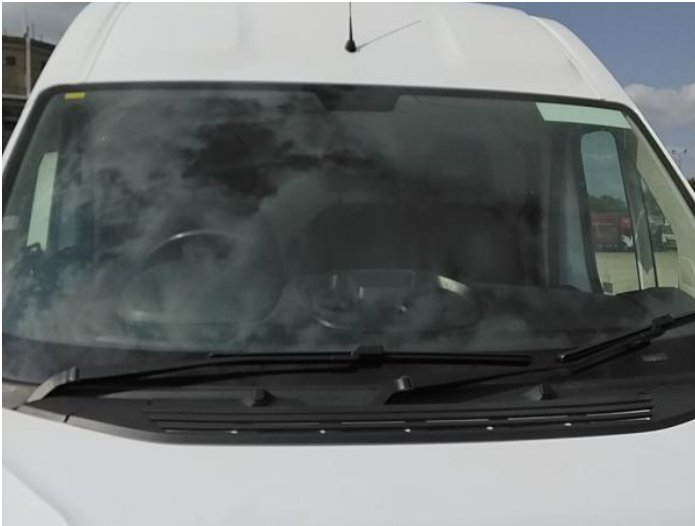
3: Screen Front
Chipped
UpTo 10mm

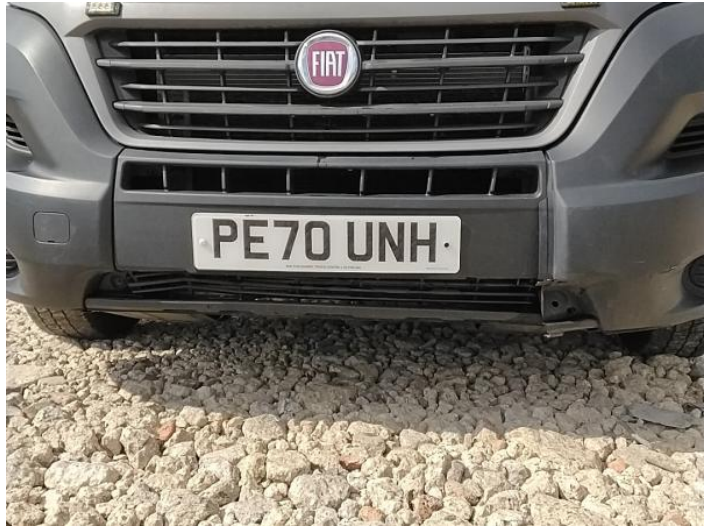
4: Bumper Front
Cracked
Over 25mm

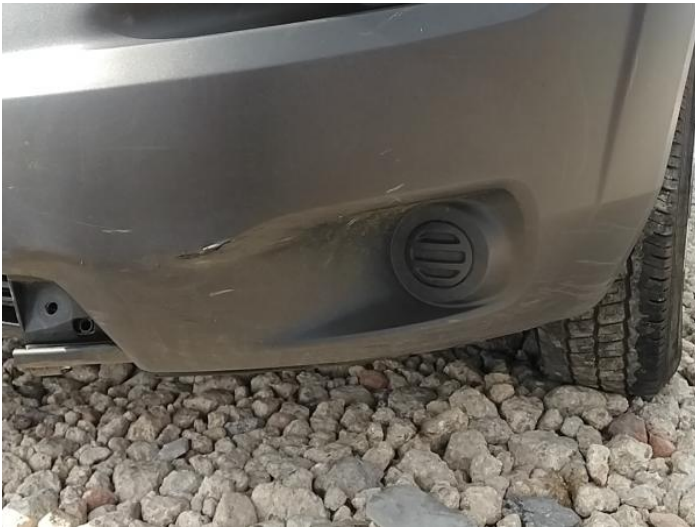
5: Bumper Front
Scratched
Over 25mm Not Thru Paint

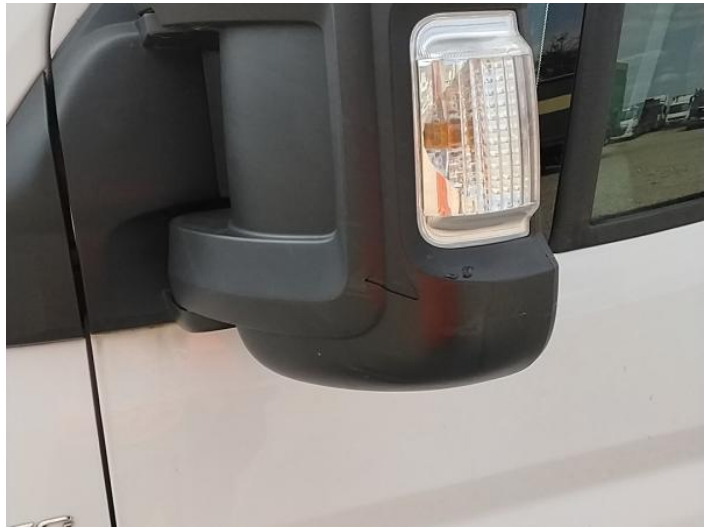
6: Door Mirror Assy nsf
Broken
Replace

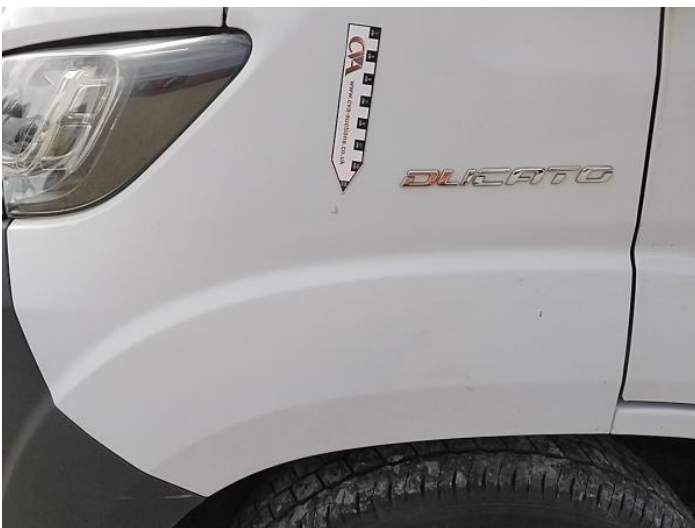
7: Wing nsf
Chipped
1 To 5

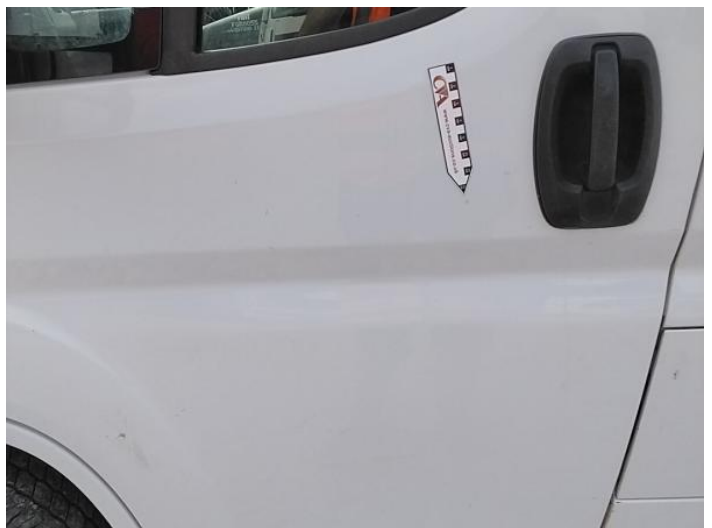
8: Door nsf
Chipped
Multiple Chips

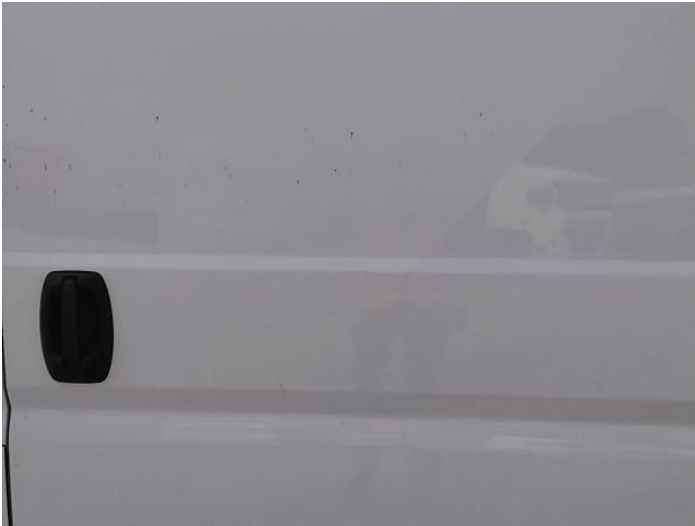
9: Door nsr
Chipped
Multiple Chips

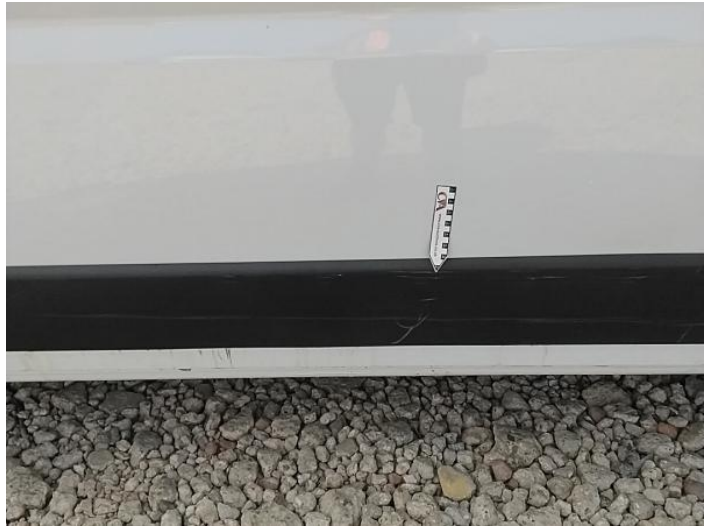
10: Door Moulding nsr
Scuffed (Unpainted)
Over 100mm

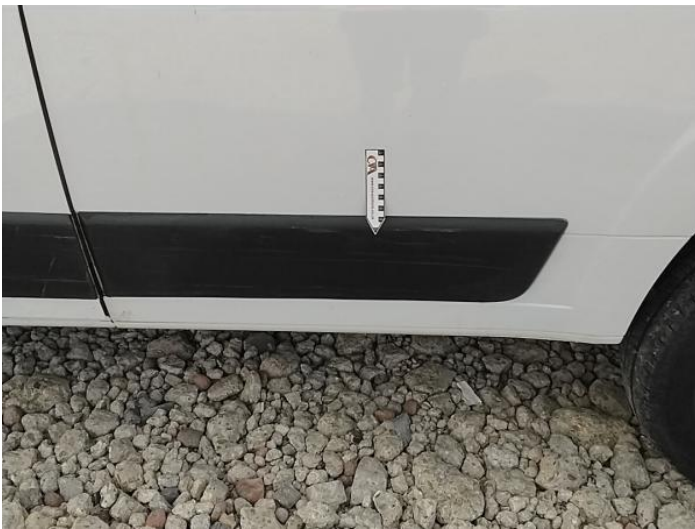
11: Qtr Panel Trim ns
Scuffed
Over 25mm

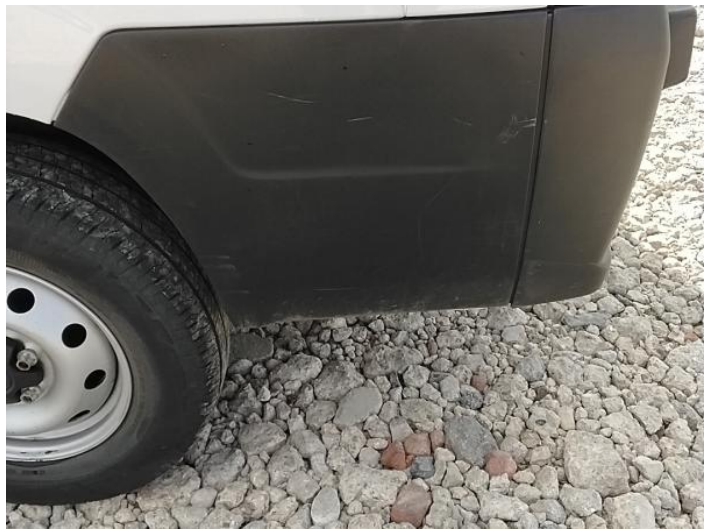
12: Qtr Panel Trim ns
Scuffed
Over 25mm

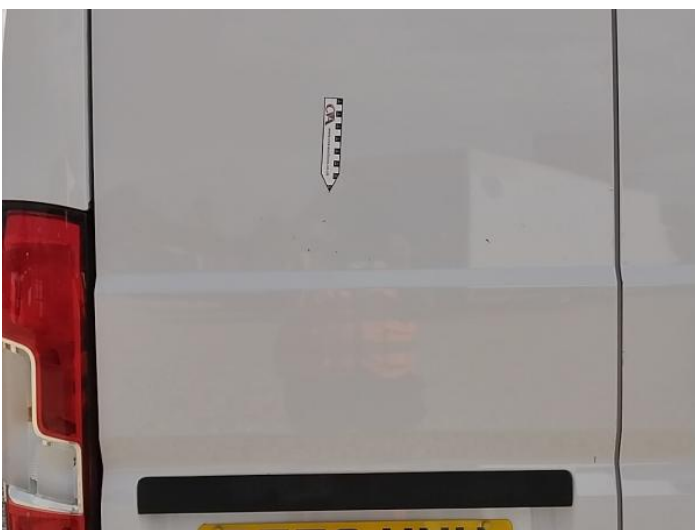
13: Door nsr
Chipped
Multiple Chips

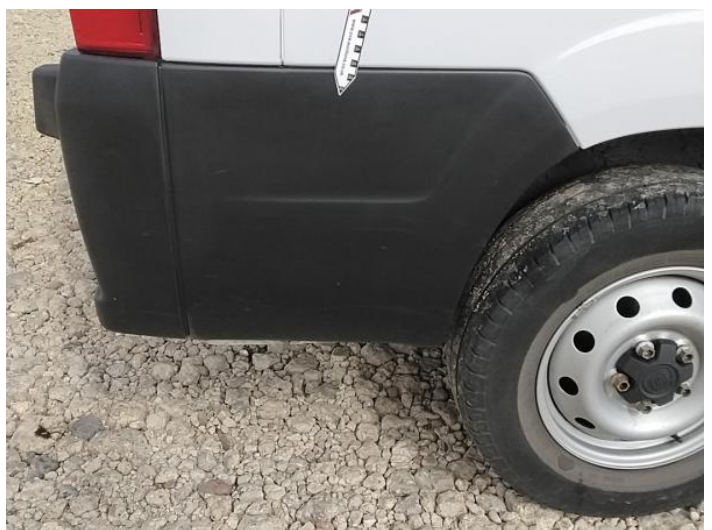
14: Qtr Panel Moulding os
Scuffed (Unpainted)
Over 100mm

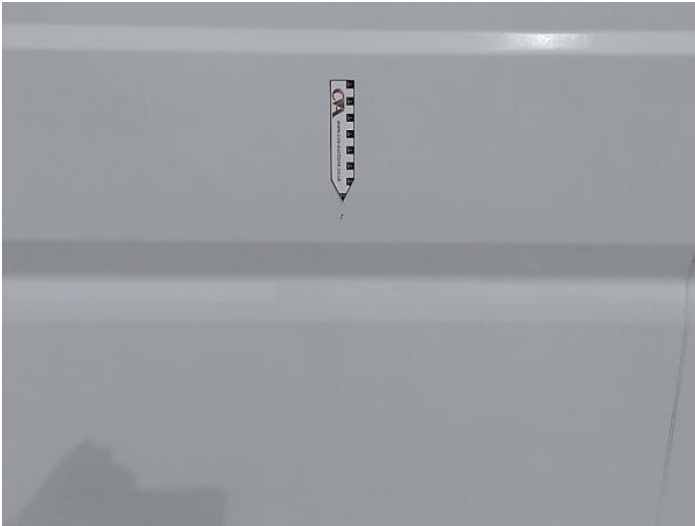
15: General Exterior
Soiled
Light

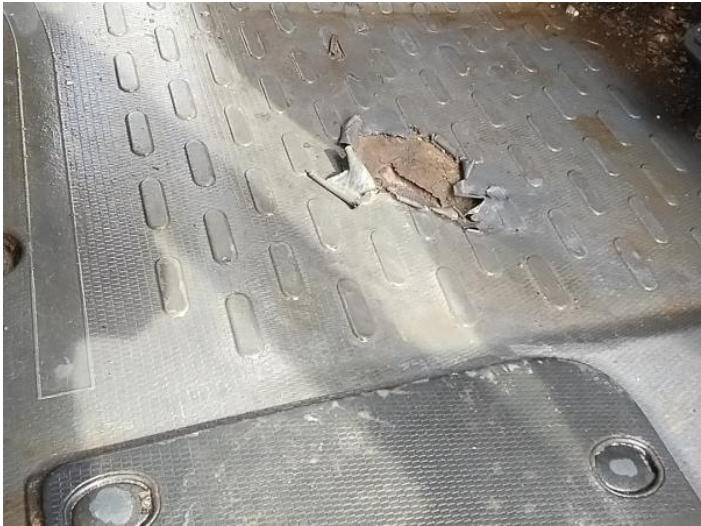
16: Carpets Front
Holed
Over 3mm
