# VEHICLE INSPECTION REPORT

**PA19DFL**

## Mercedes-Benz Sprinter 316 CDI

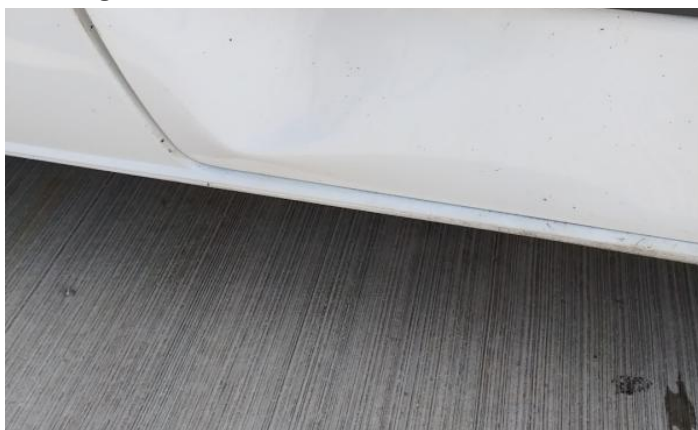
1: Door osf  
Dented  
Over 30% Of Panel

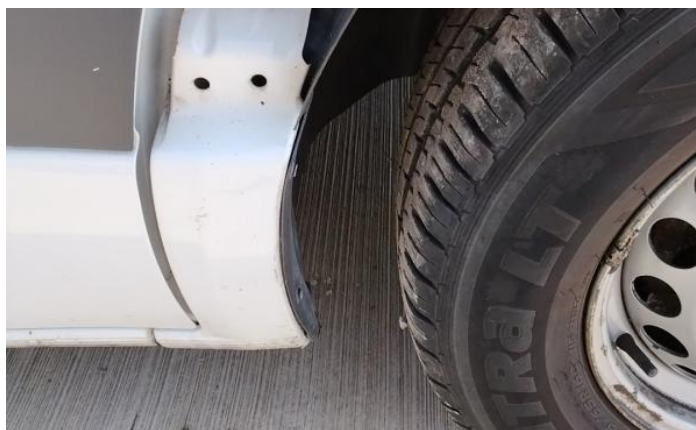
2: Wing osf  
Missing  
Replace

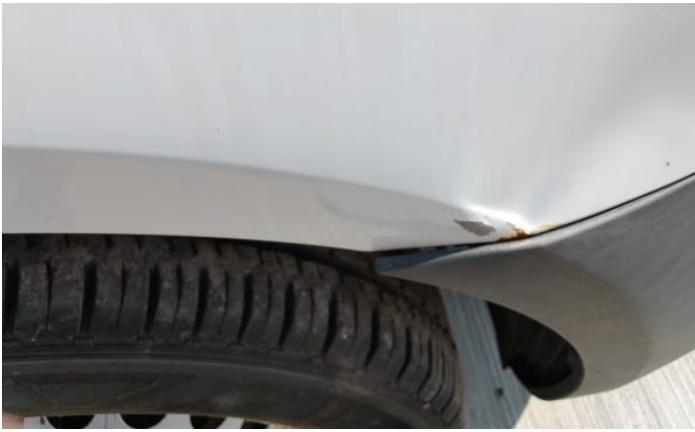
3: Wing osf  
Rusted  
UpTo 5mm

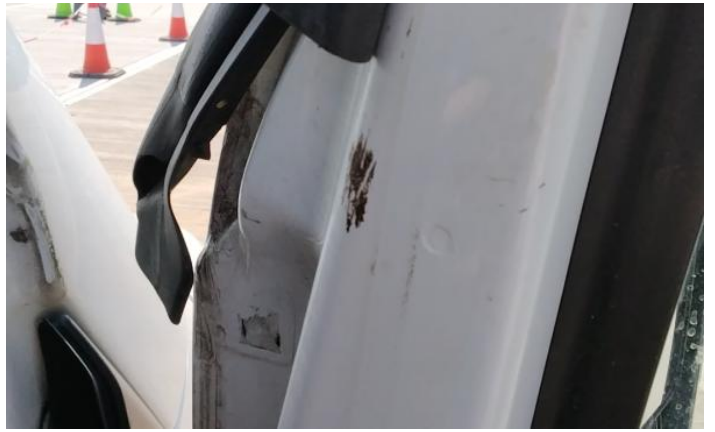
4: Door osf  
Hole  
UpTo 10mm

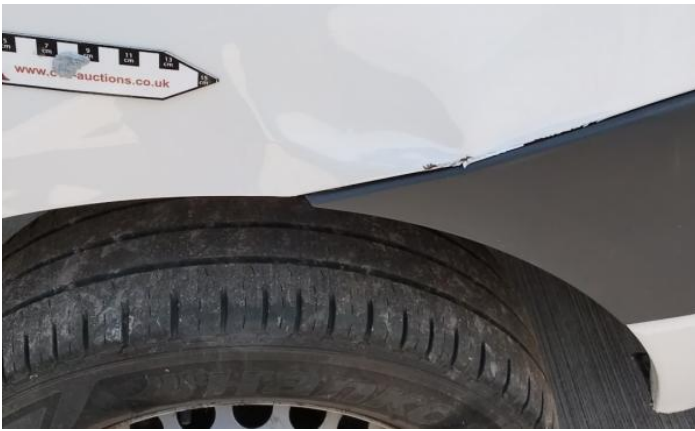
5: Qtr Panel osr  
Dented  
With Paint Damage

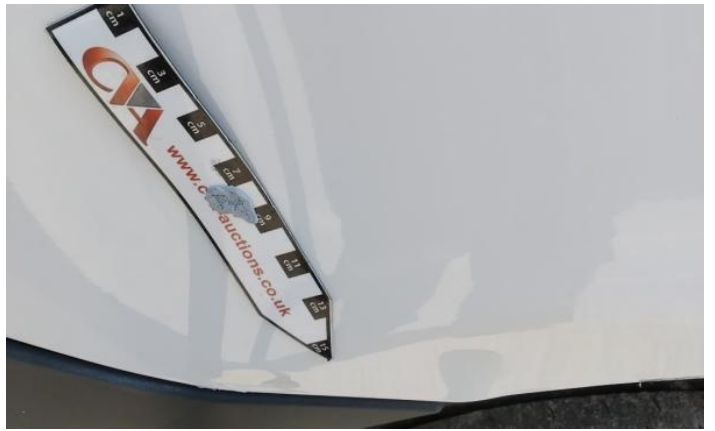
6: Qtr Panel osr  
Dented  
Over 30mm

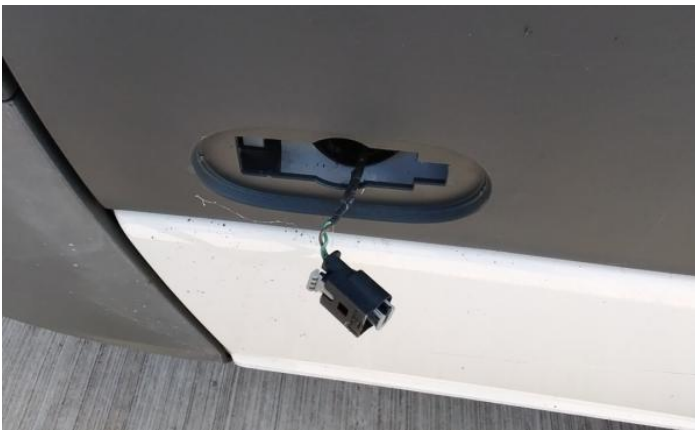
7: Qtr Panel Trim os  
Missing  
Replace

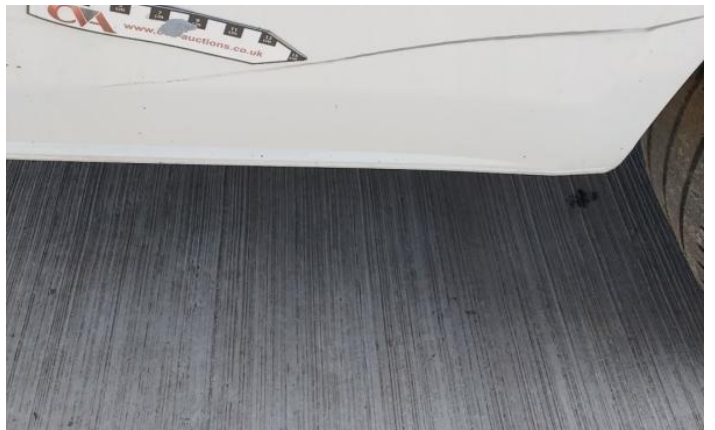
8: Qtr Panel Trim os  
Scuffed  
Over 25mm

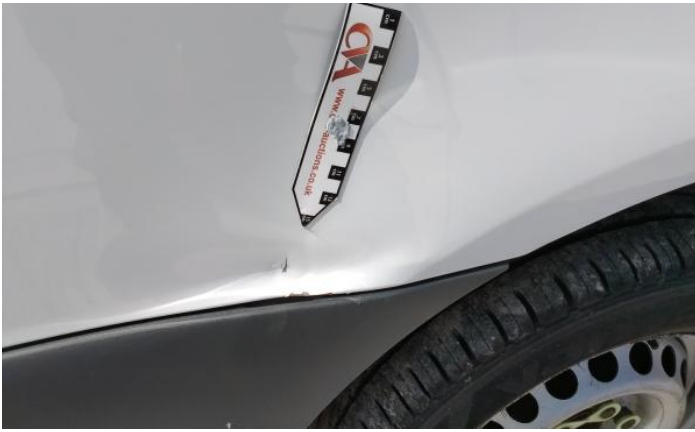
9: Qtr Panel nsr  
Dented  
Over 2 UpTo 10mm

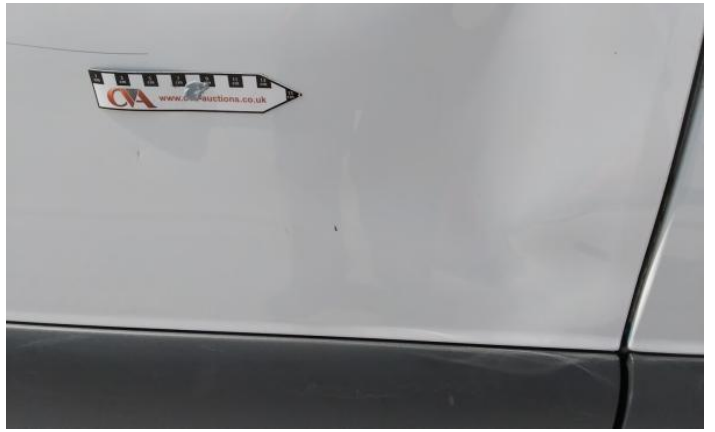
10: Door nsr  
Dented  
Over 30mm

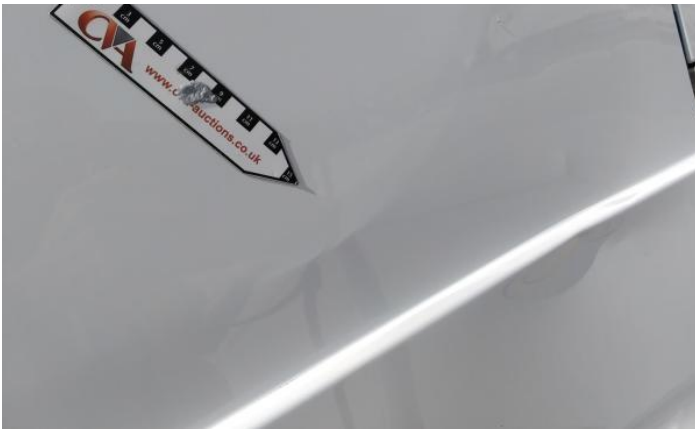
11: Door nsr  
Dented  
Over 30mm

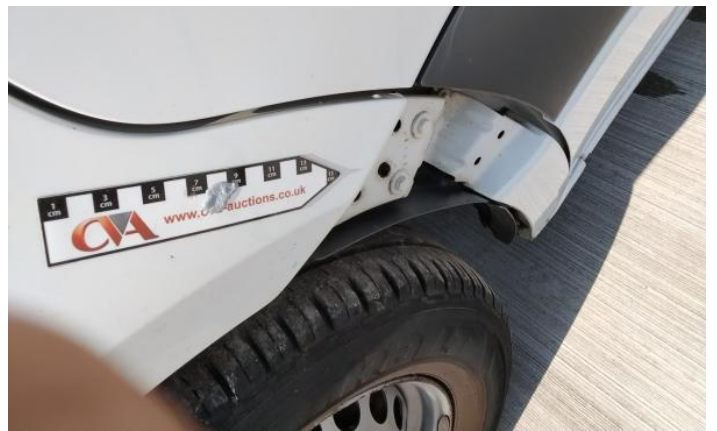
12: Wing nsf  
Missing  
Replace

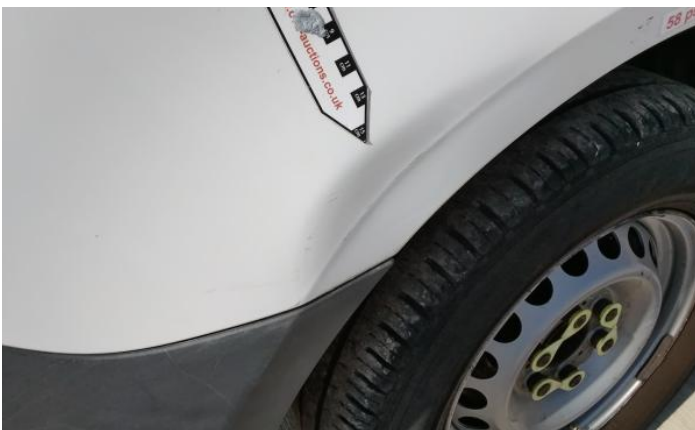
13: Wing nsf  
Dented  
Over 30mm

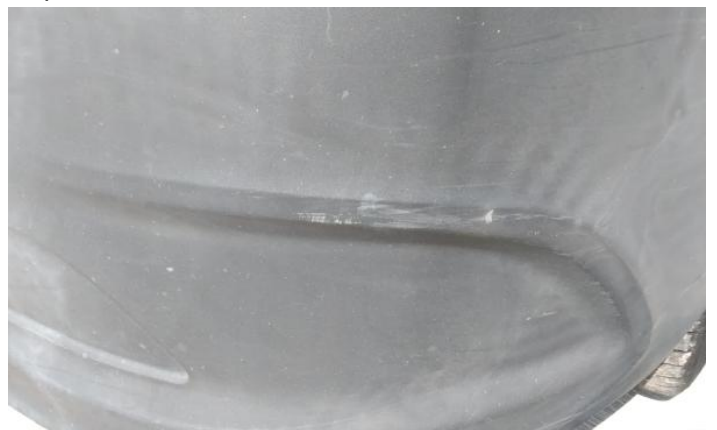
14: Bumper Front  
Scratched  
Over 100mm Thru Paint

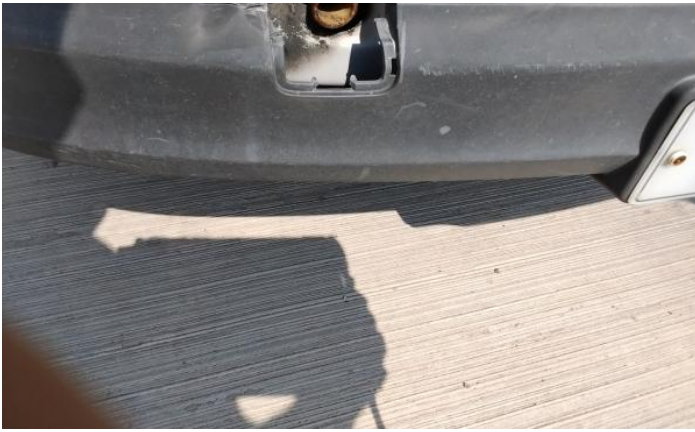
15: Bumper Front  
Missing  
Replace

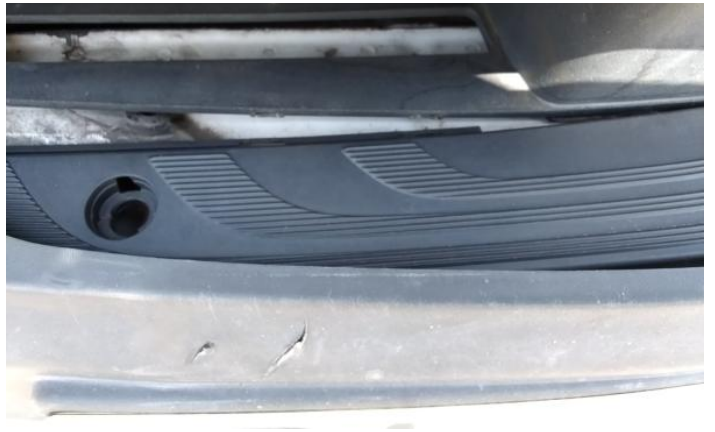
16: Bumper Front Moulding  
Broken  
Replace

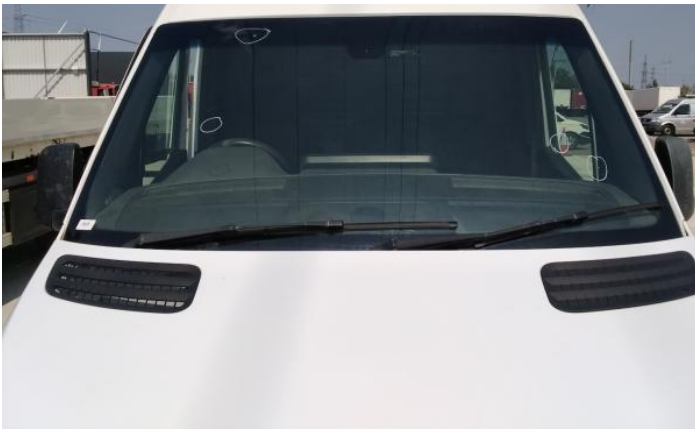
17: Screen Front  
Chipped  
Over 10mm

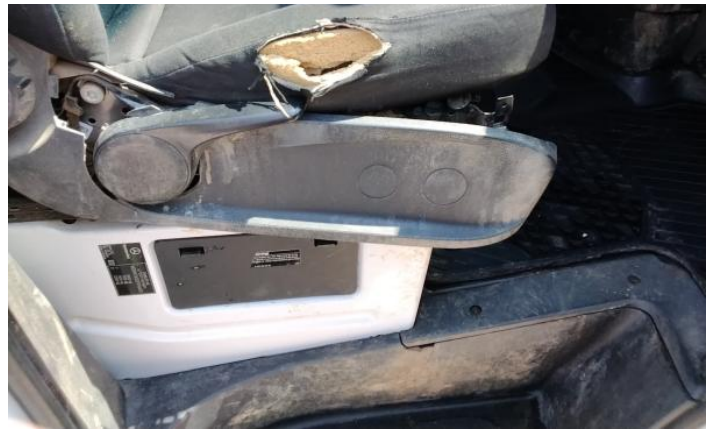
18: Seat Base Cover osf  
Torn  
Over 3mm

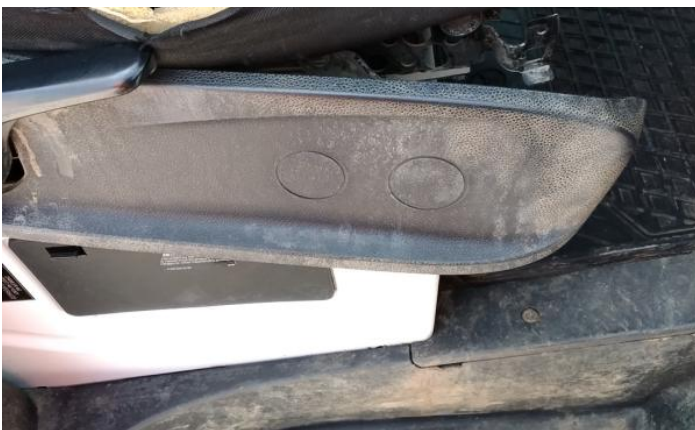
19: Seat Base Cover osf  
Missing  
Replace

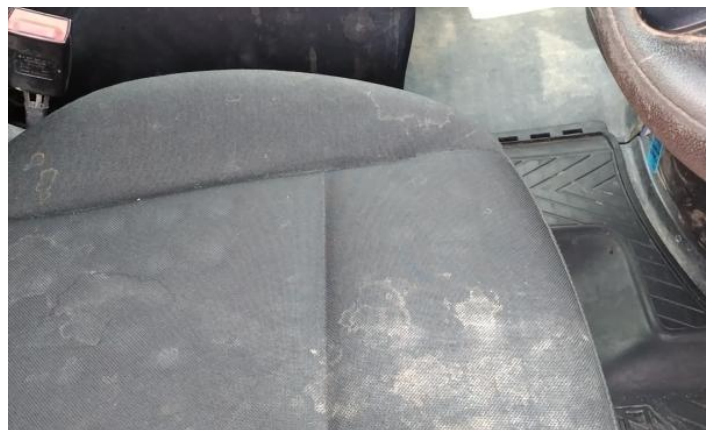
20: Seat Base Cover osf  
Soiled  
Heavy

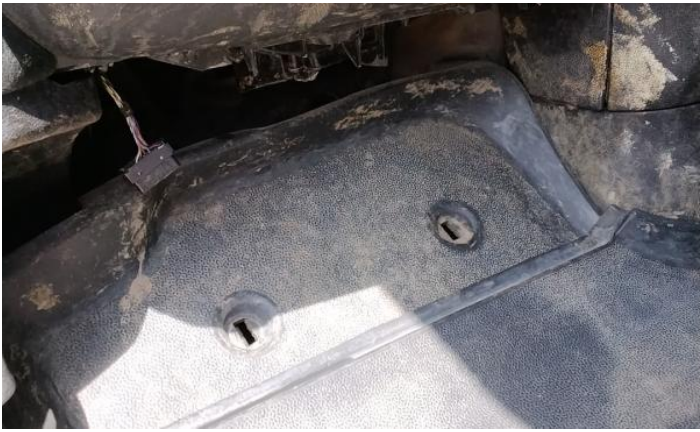
21: General Interior  
Soiled  
Light
