## VEHICLE INSPECTION REPORT

**NX23HHY**

### Fiat Doblo Maxi 1.5 BLUEHDI 1000kg PRIMO 100PS

**Non Runner**  
Inspection

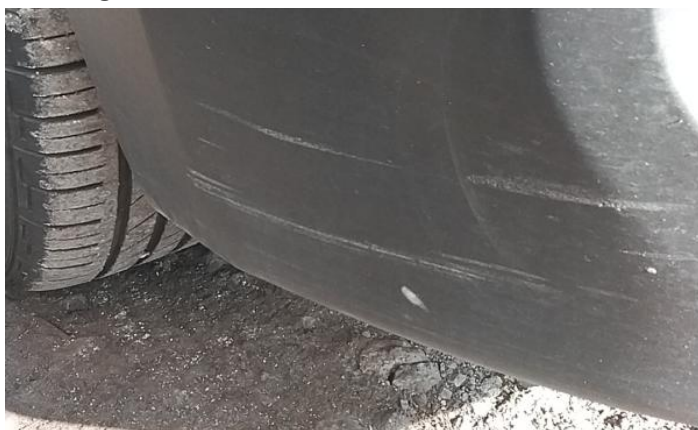
1: Bumper Front  
Scratched  
Over 100mm Thru Paint

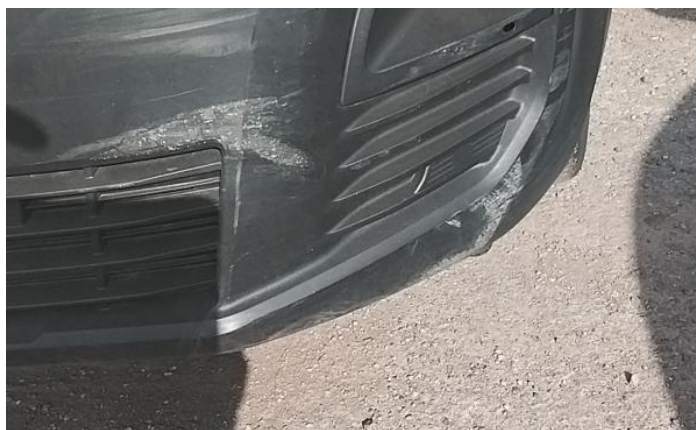
2: Bumper Front  
Scratched  
Over 100mm Thru Paint

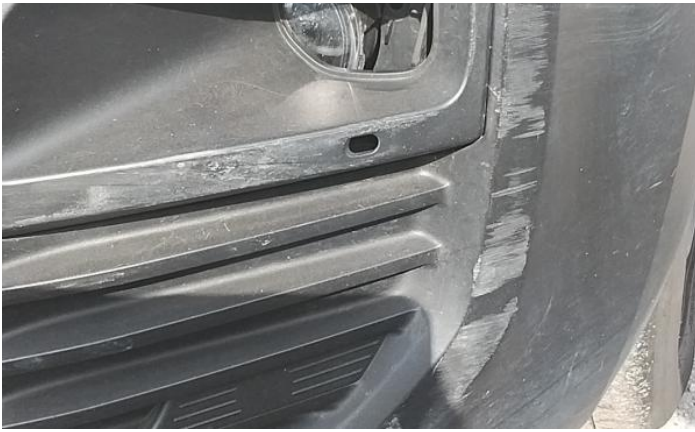
3: Fogdriving Lamp nsf  
Broken  
Replace

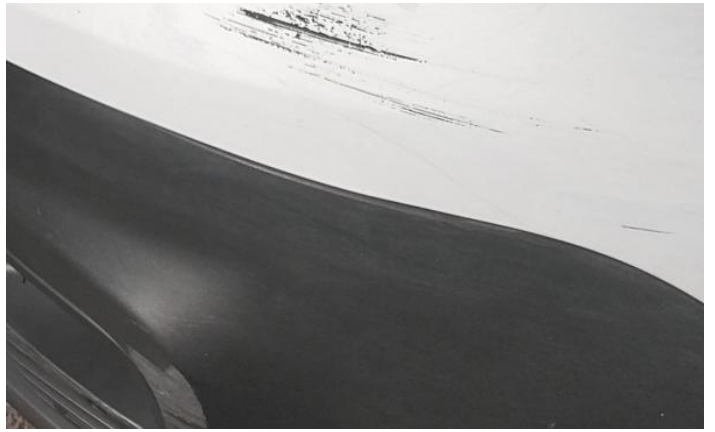
4: Panel Front  
Scratched  
Over 25mm Thru Paint

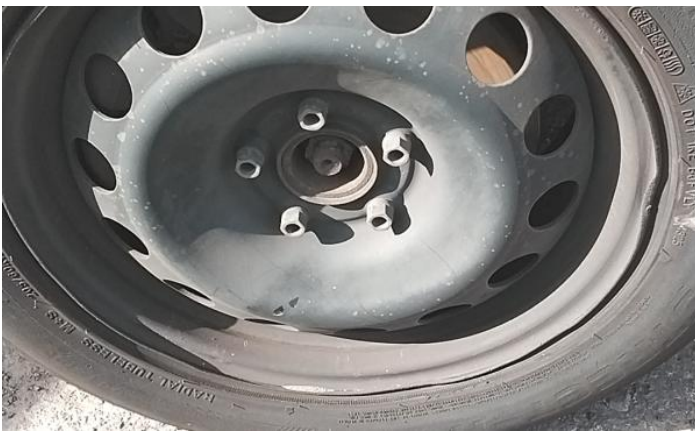
5: Wheel nsf  
Dented  
Over 30mm (Steel)

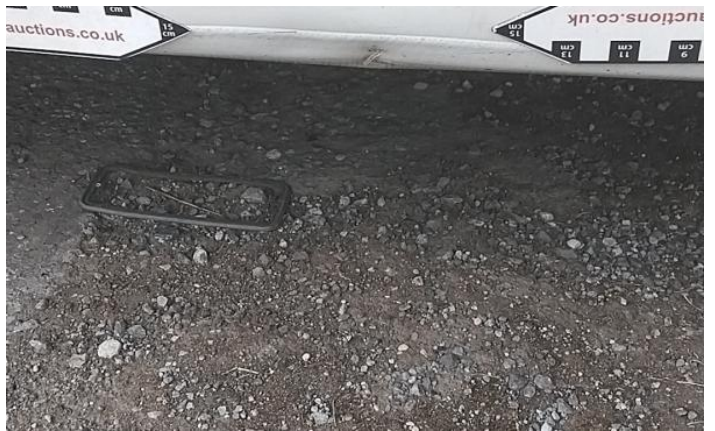
6: Sill ns  
Dented  
With Paint Damage

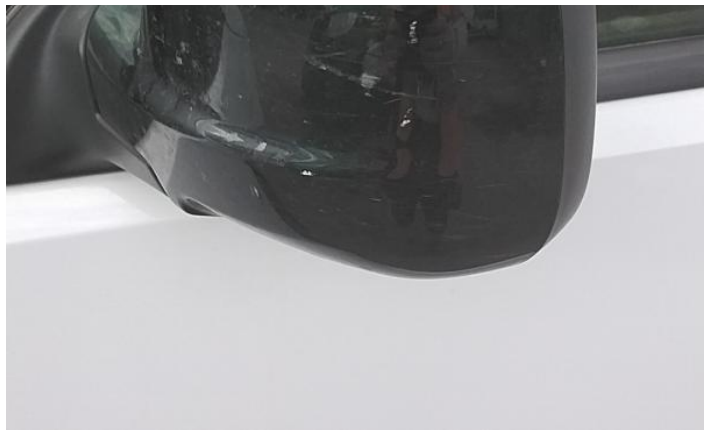
8: Door Mirror Assy nsf  
Scratched (Painted)  
UpTo 25mm Thru Paint

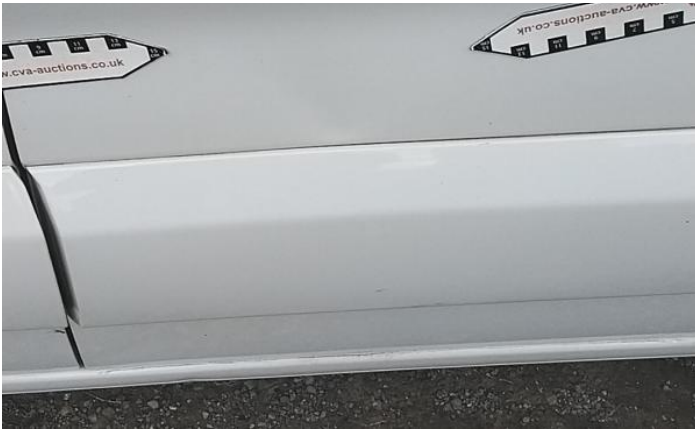
9: Qtr Panel nsr  
Dented  
Over 30mm

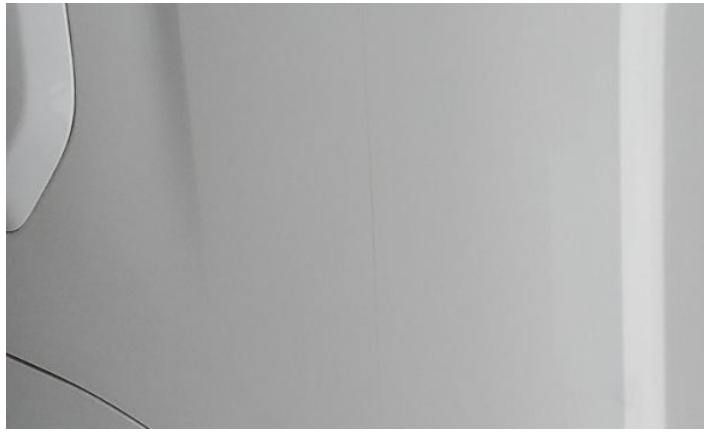
10: Qtr Panel nsr  
Scratched  
UpTo 25mm Not Thru Paint

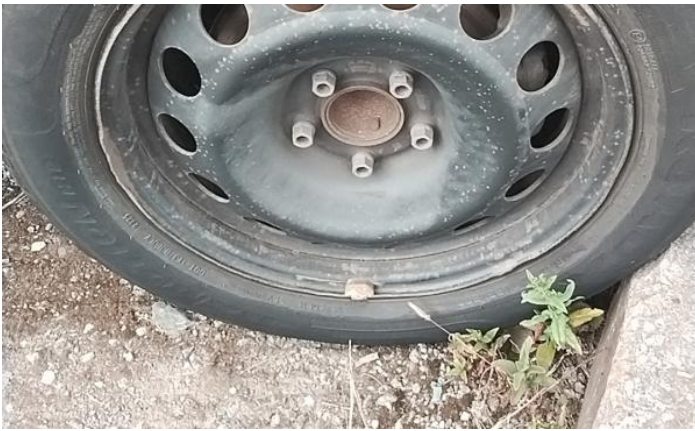
11: Wheel nsr  
Dented  
Over 30mm (Steel)

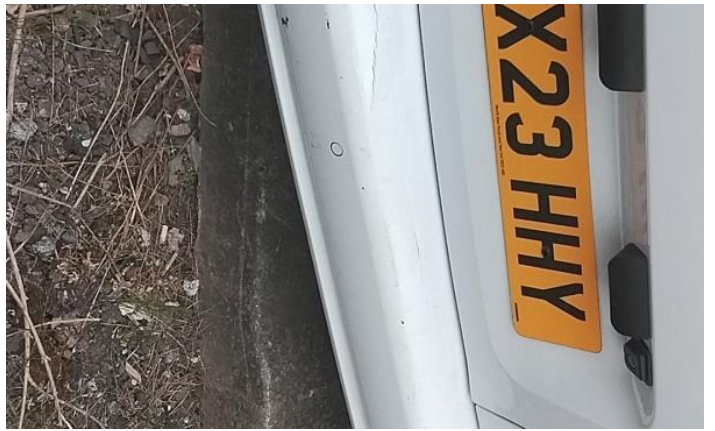
12: Bumper Rear  
Cracked  
Over 25mm

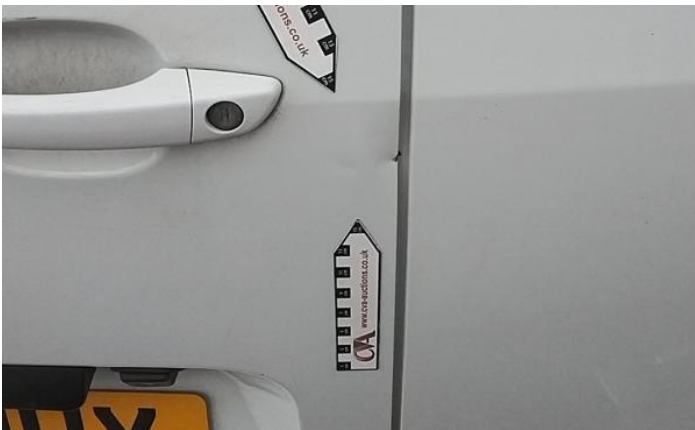
13: Door nsr  
Dented  
With Paint Damage

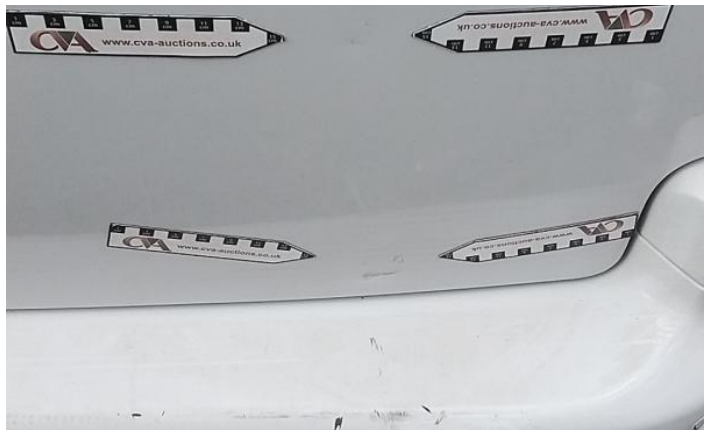
14: Door osr  
Dented  
With Paint Damage

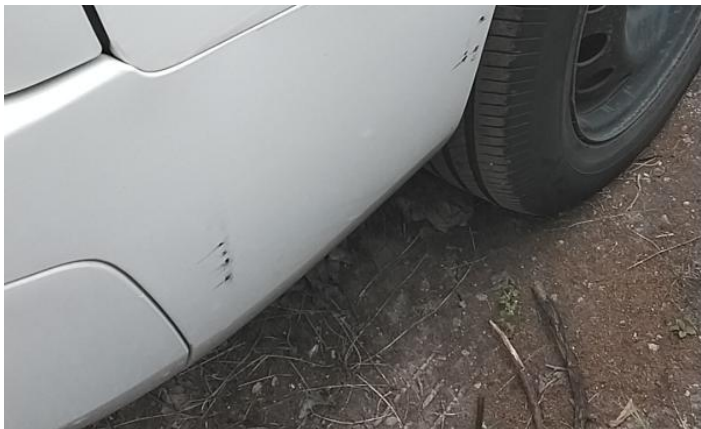
15: Bumper Rear Moulding  
Scratched (Painted)  
Over 25mm Thru Paint

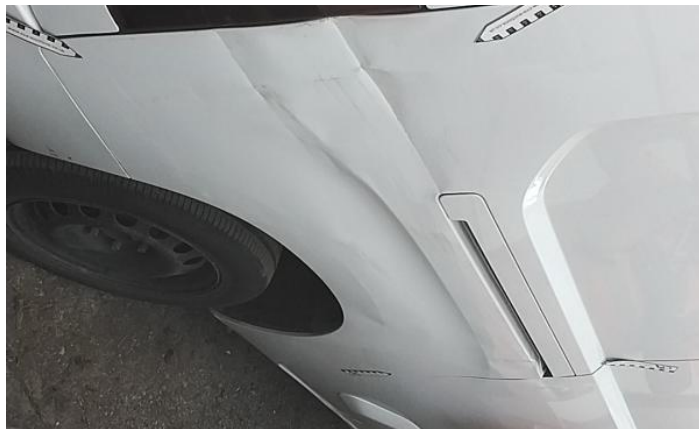
16: Qtr Panel osr  
Dented  
Over 30% Of Panel

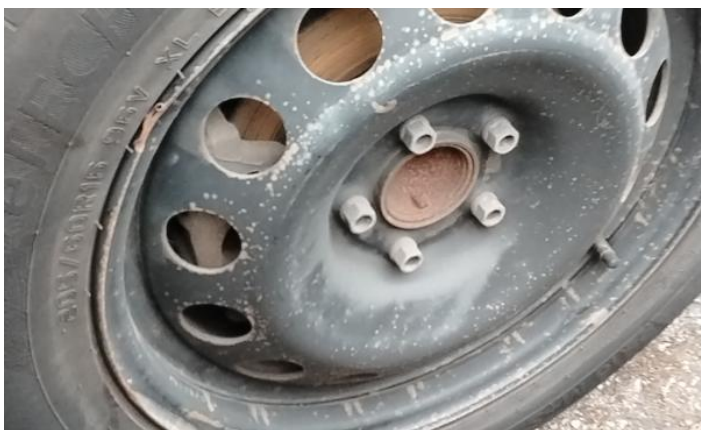
17: Wheel osr  
Dented  
Over 30mm (Steel)

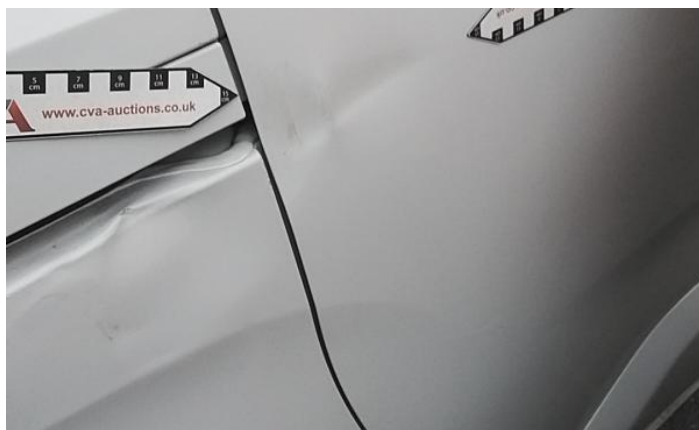
18: Door osr  
Dented  
Over 30mm

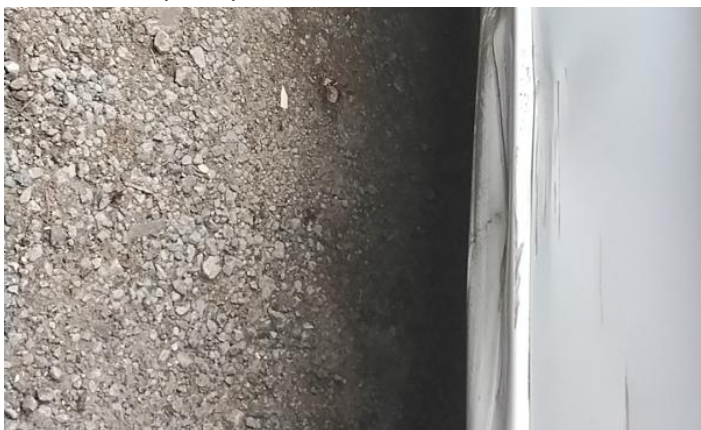
19: Sill os  
Dented  
With Paint Damage

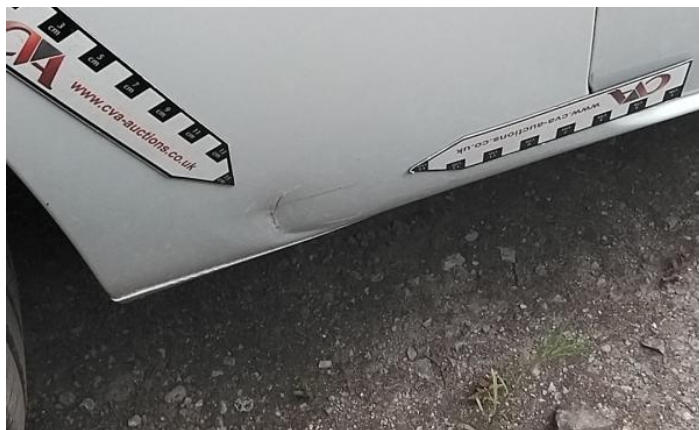
20: Qtr Panel osr  
Dented  
With Paint Damage

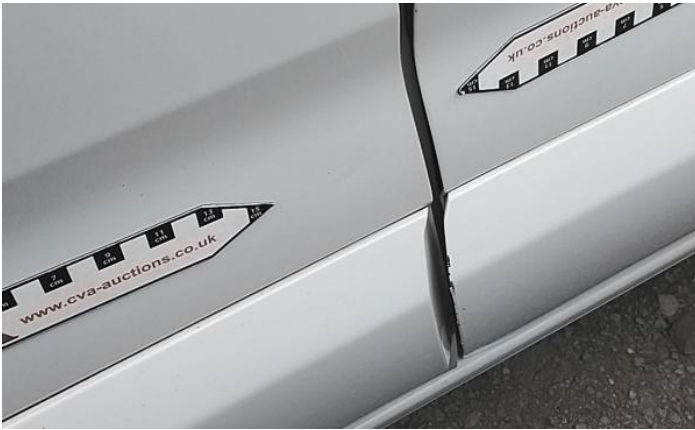
21: Qtr Panel osf  
Dented  
Over 30mm

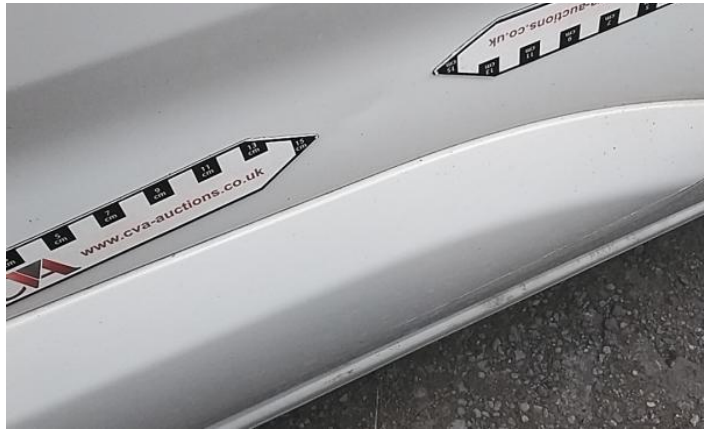
22: Door osf  
Dented  
Over 30mm

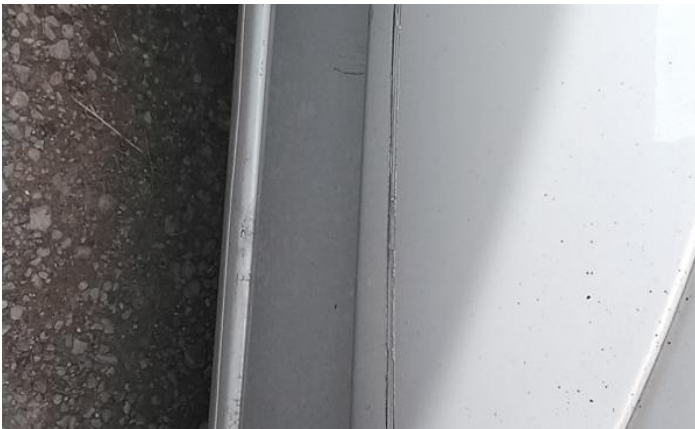
23: Door Moulding osf  
Scratched (Painted)  
Over 25mm Thru Paint

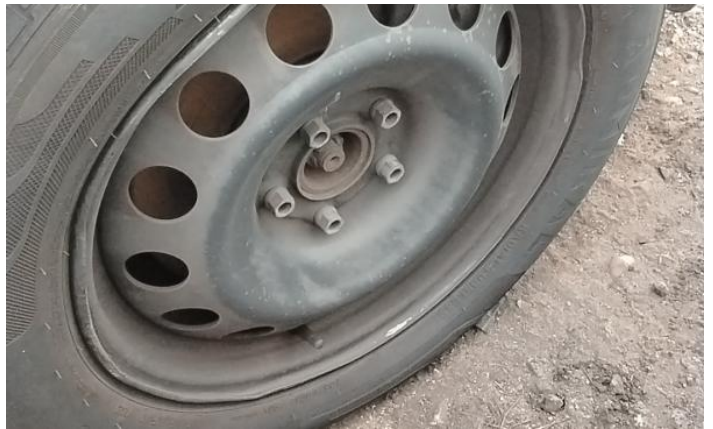
24: Wheel osf  
Dented  
Over 30mm (Steel)

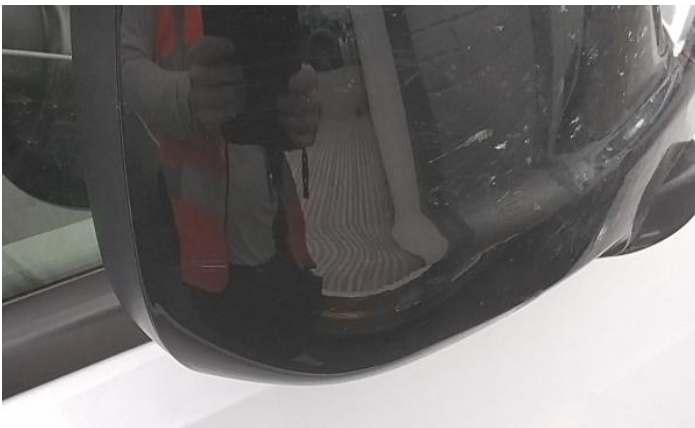
25: Door Mirror Assy osf  
Scratched (Painted)  
Over 25mm Thru Paint

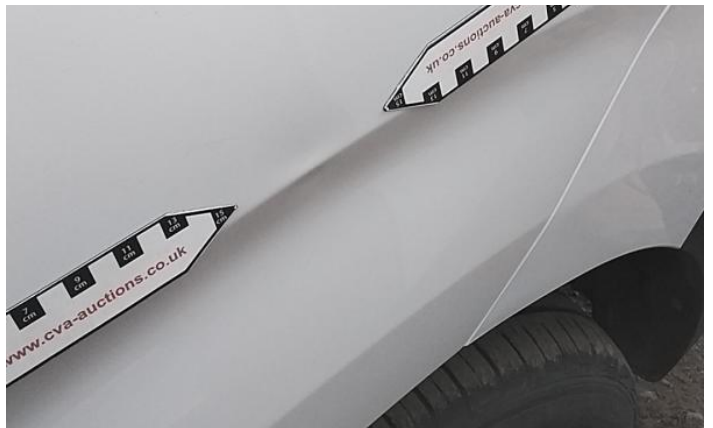
26: Wing osf  
Dented  
Over 30mm

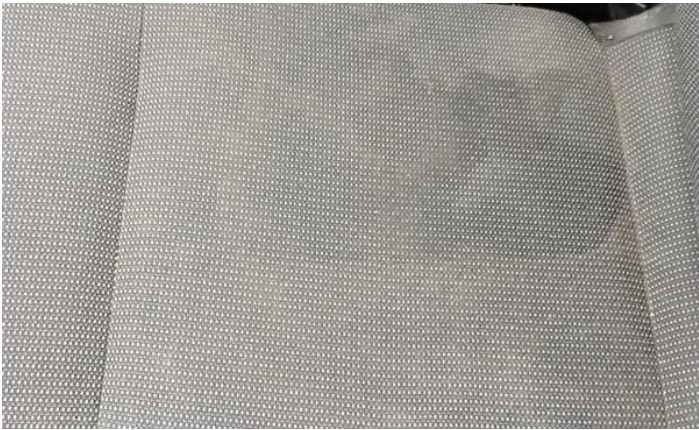
27: Seat Base Cover nsf  
Soiled  
Heavy

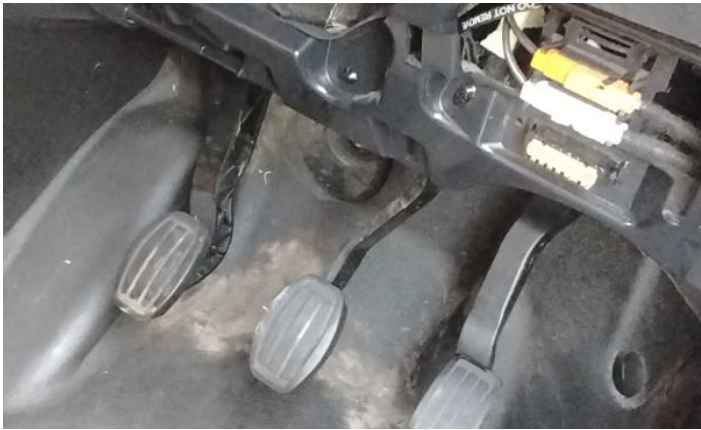
28: Fascia Panel  
Missing  
Replace
