# VEHICLE INSPECTION REPORT

**PF70CBV**

## Mercedes-Benz Sprinter 315 CDI PROGRESSIVE

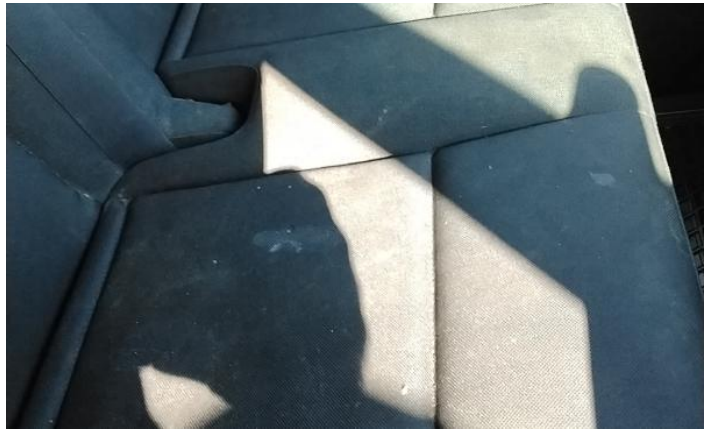
16: Seat Base Cover nsf  
Soiled  
Heavy
