VEHICLE INSPECTION REPORT

Daf LF 45.140

COLLECTED AS NON RUNNER - CORROSION, GEARBOX & CLUTCH ISSUES

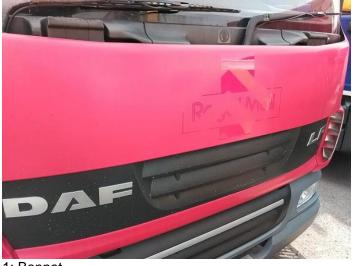
1: Bonnet Chipped Multiple Chips

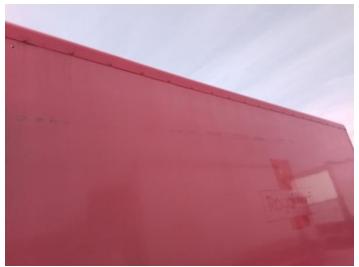
5: Qtr Panel nsr Scratched Over 25mm Not Thru Paint

Cracked

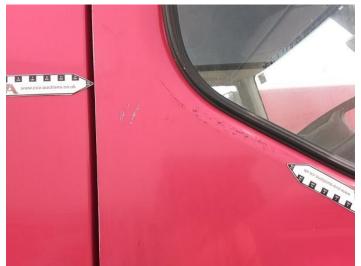
6: Qtr Panel osr Scratched Over 25mm Thru Paint

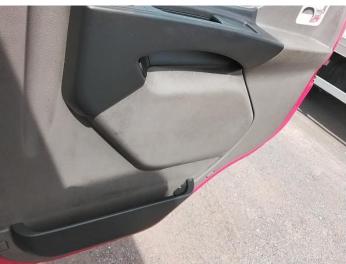
8: Door Pad osf Soiled Heavy
