# VEHICLE INSPECTION REPORT

**LL15UVK**

## Mercedes-Benz Econic 2630

Body Style Refuse Collector

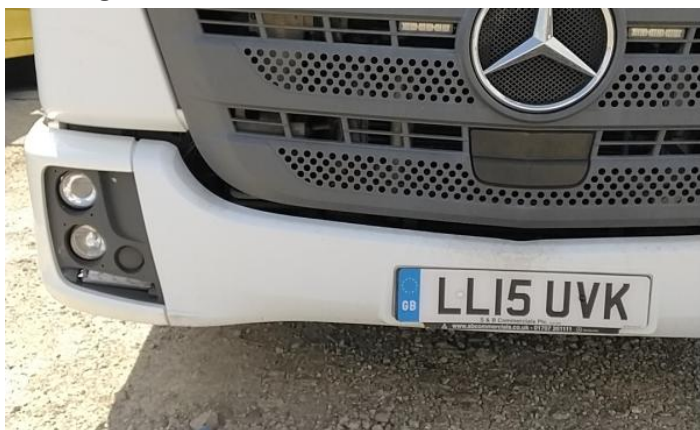
1: Bumper Front  
Cracked  
UpTo 25mm

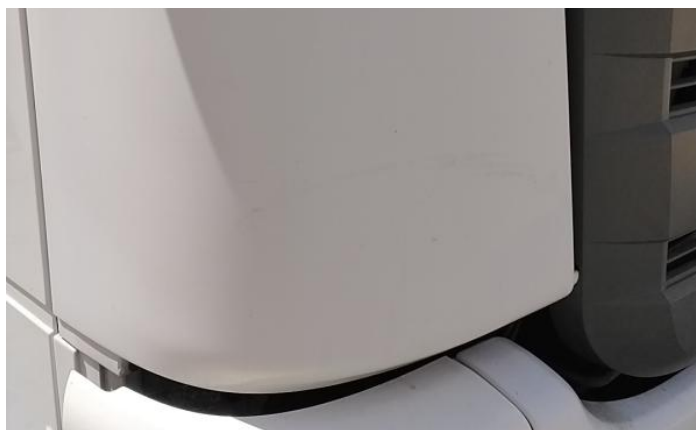
2: Wing osf  
Scratched  
Over 25mm Not Thru Paint

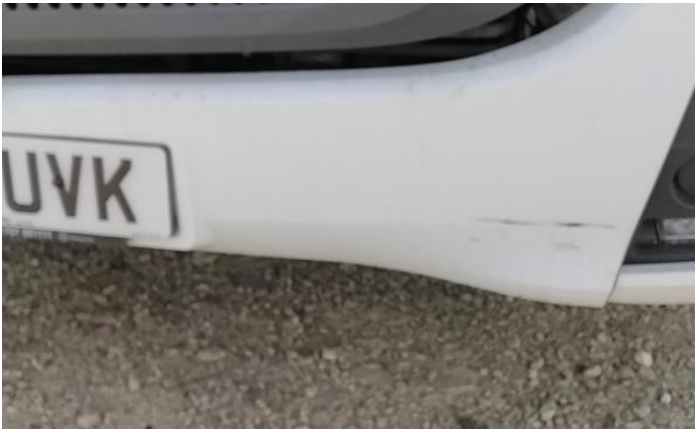
3: Bumper Front  
Scratched  
Over 25mm Not Thru Paint

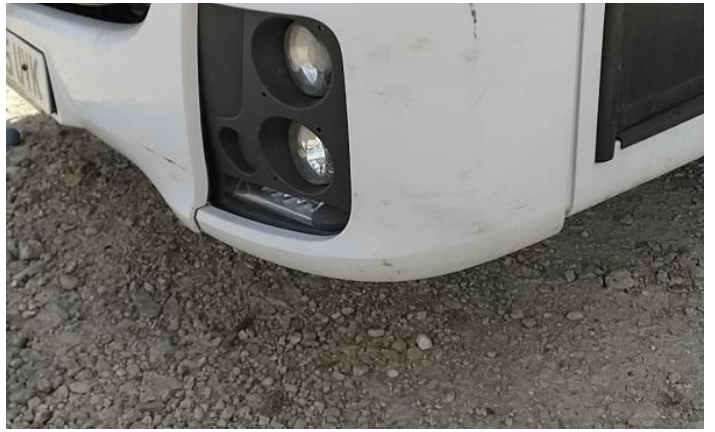
4: Bumper Front Moulding  
Scuffed (Unpainted)  
Over 100mm

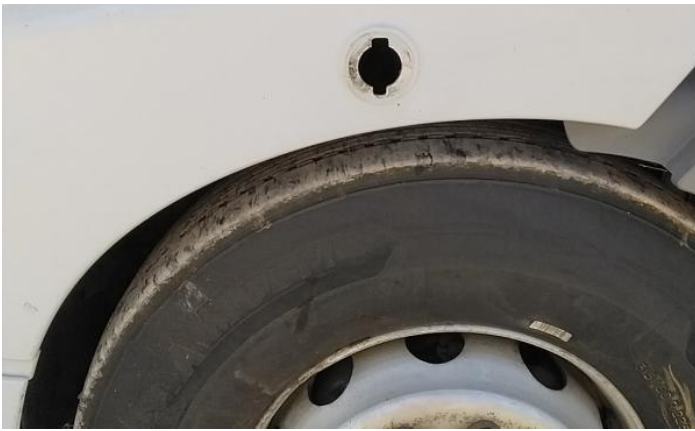
5: Flasher Side Repeater ns  
Missing  
Replace

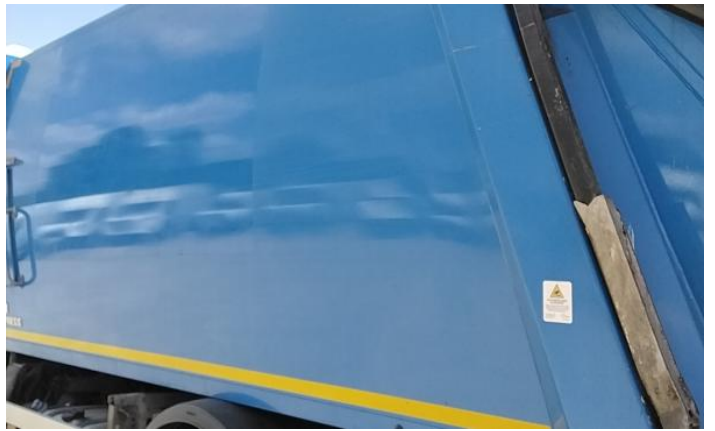
6: Qtr Panel nsr  
Scratched  
Over 25mm Not Thru Paint

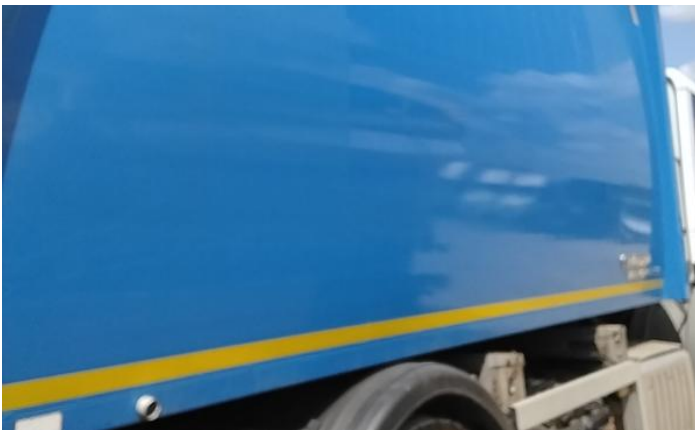
7: Qtr Panel osr  
Scratched  
Over 25mm Not Thru Paint

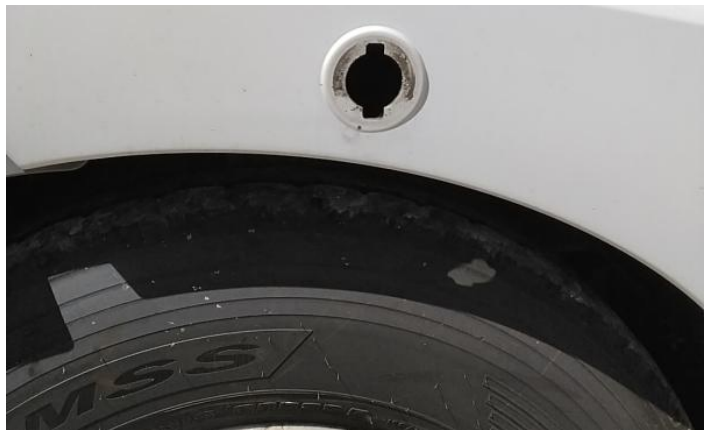
8: Flasher Side Repeater os  
Missing  
Replace

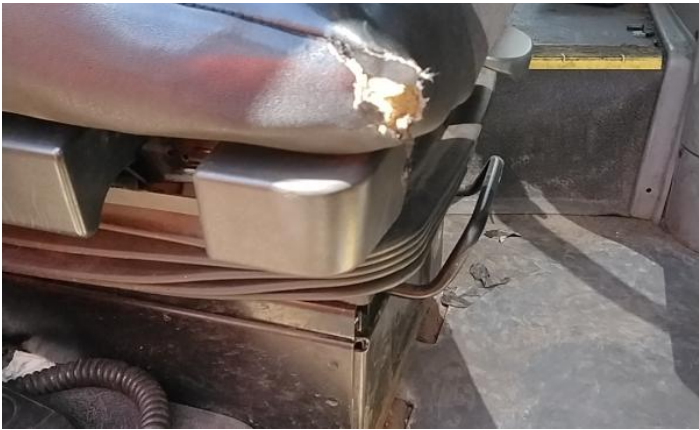
9: Seat Base Cover osf  
Holed  
Over 3mm

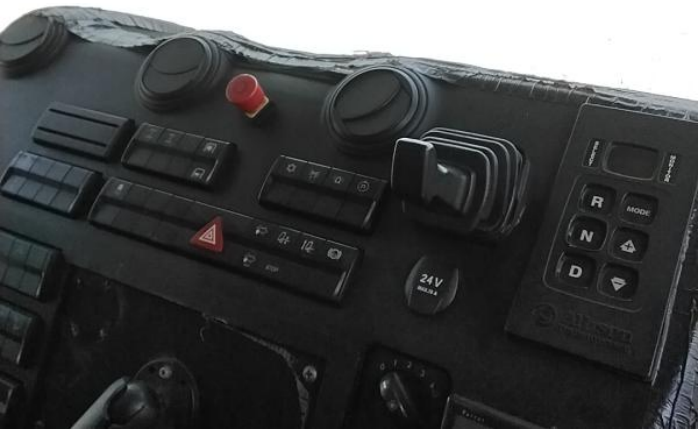
10: Centre Console Front  
Broken  
Replace
