# VEHICLE INSPECTION REPORT

**PG66UES**

## Daf CF 440

**Non Runner  
Inspection**

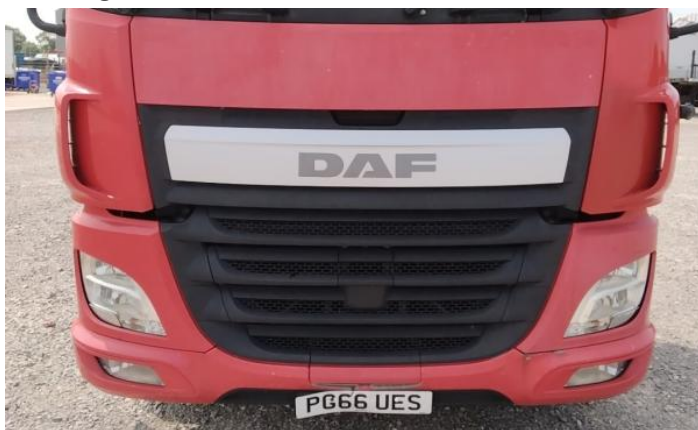
1: Bonnet  
Chipped  
Multiple Chips

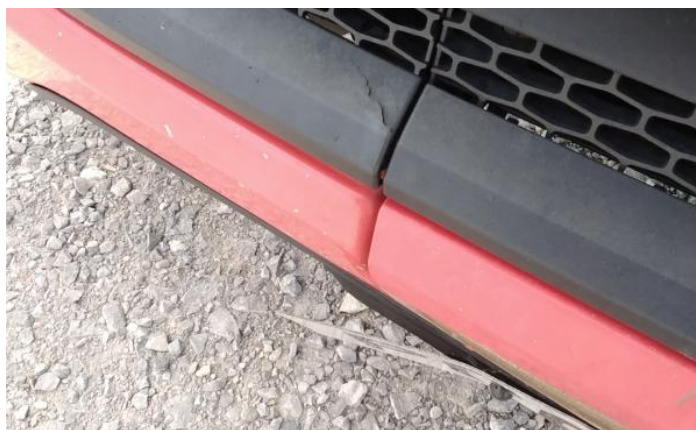
2: Bumper Front Grill  
Broken  
Replace

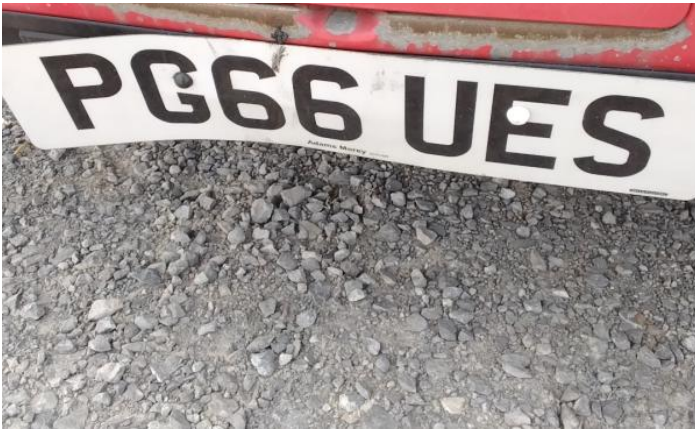
3: Bumper Front  
Rusted  
Over 5mm

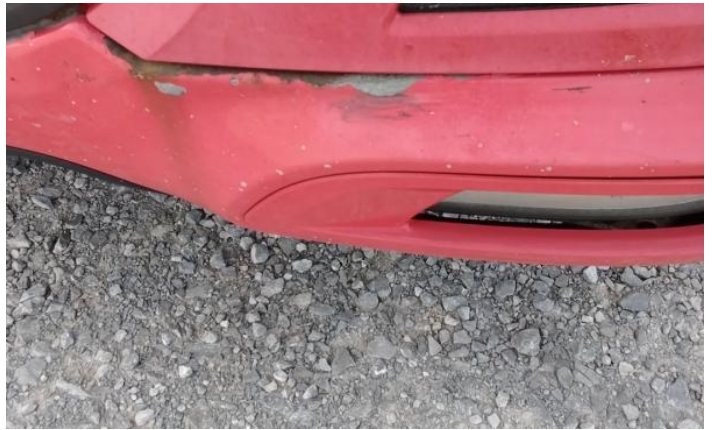
4: Bumper Front  
Rusted  
Over 5mm

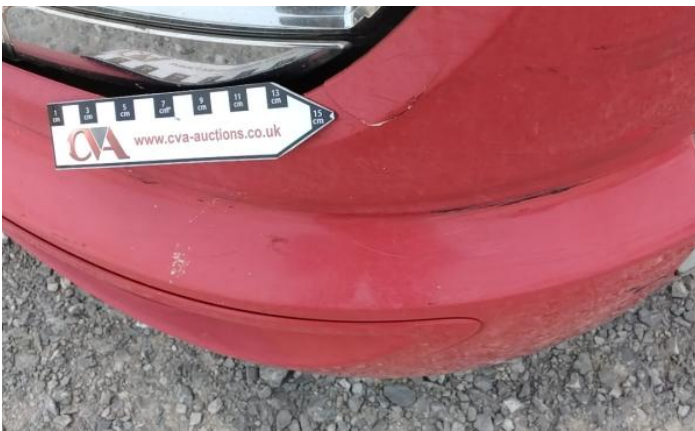
5: Wing nsf  
Cracked  
Replace

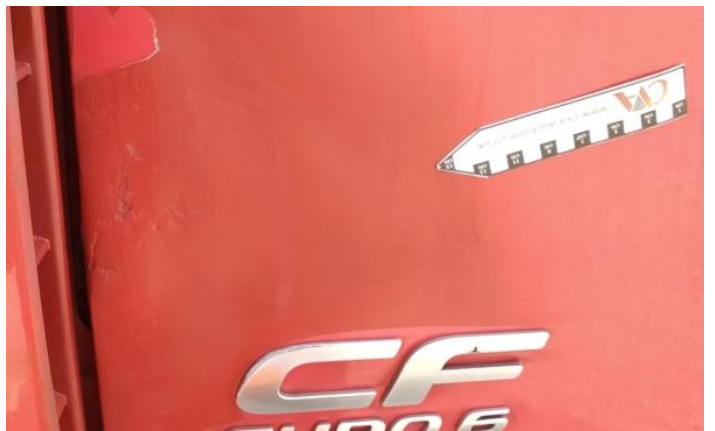
6: Door nsf  
Poor Previous Repair  
Poor Colour

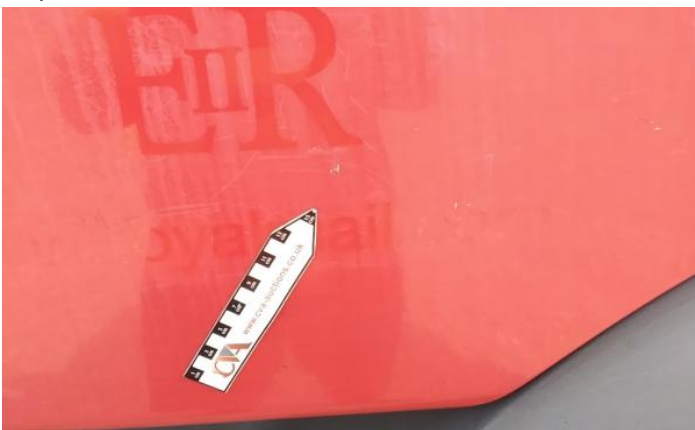
7: Door nsf  
Scratched  
Over 25mm Thru Paint

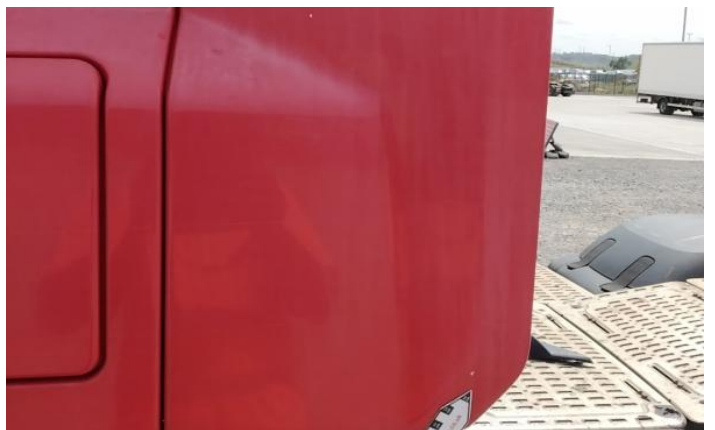
8: Qtr Panel nsr  
Scratched  
Over 25mm Thru Paint

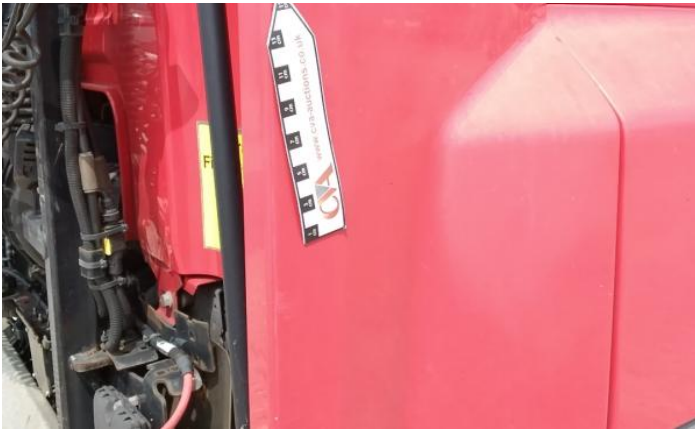
9: Qtr Panel osr  
Scratched  
Over 25mm Thru Paint

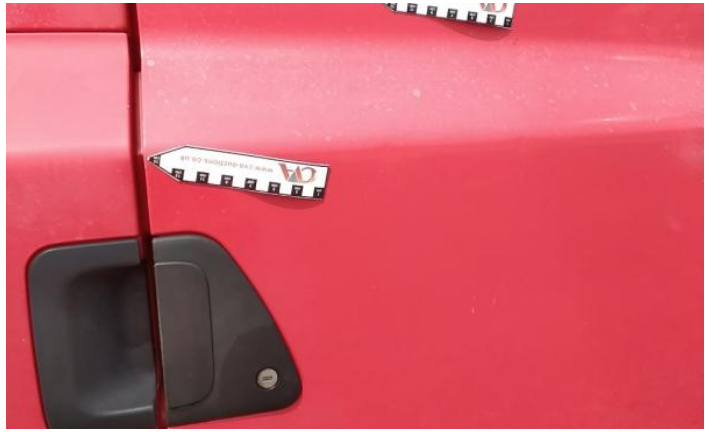
10: Door osf  
Scratched  
Over 25mm Thru Paint

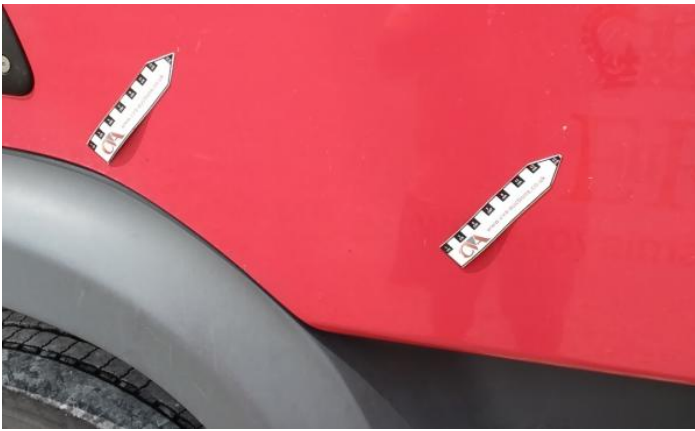
11: Door osf  
Scratched  
Over 25mm Thru Paint

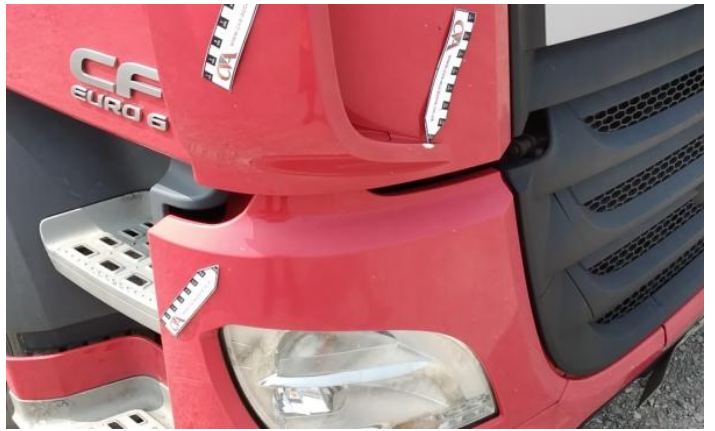
12: Moulding osf Wing  
Scratched (Painted)  
Over 25mm Thru Paint

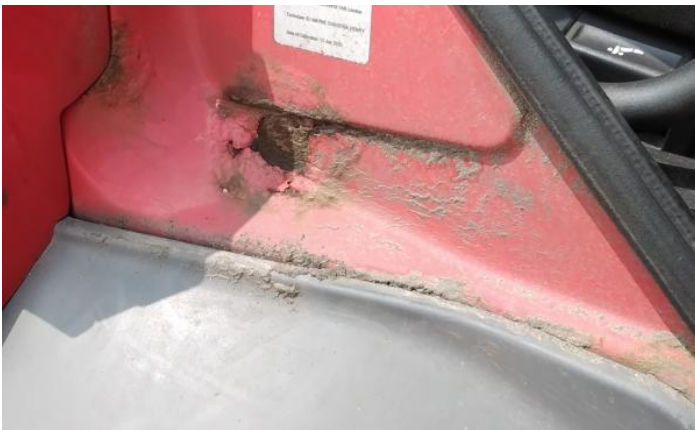
13: B Post os  
Rusted  
Over 5mm

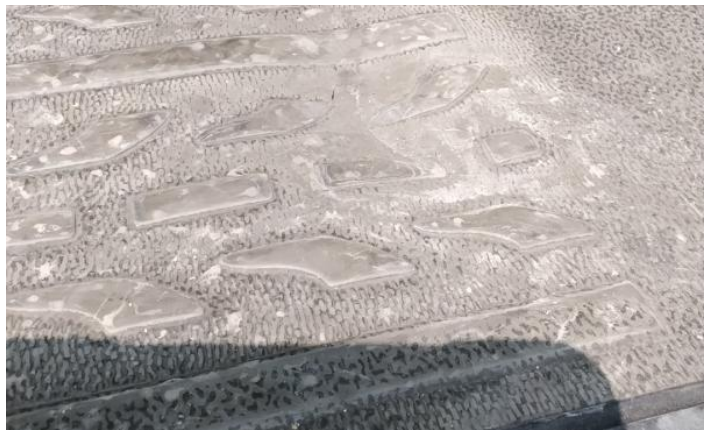
14: Carpets Front  
Holed  
Over 3mm

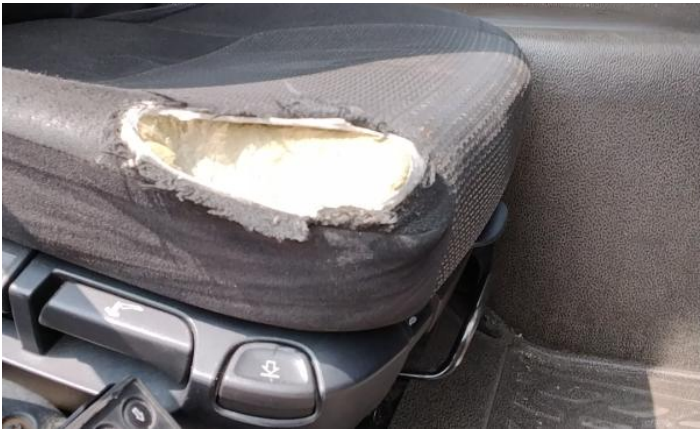
15: Seat Base Cover osf  
Holed  
Over 3mm

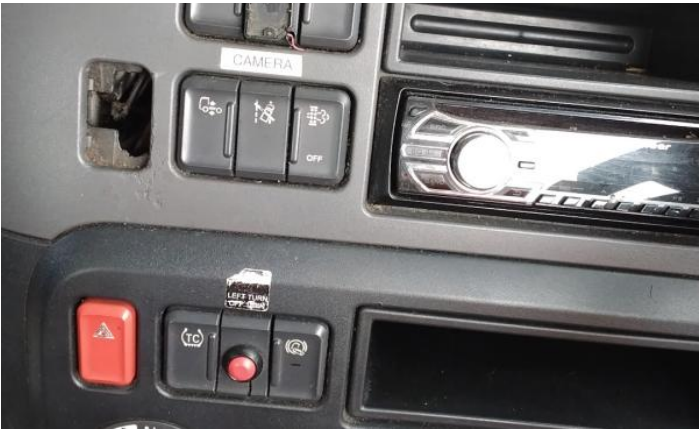
16: Switches And Controls  
Missing  
Replace
