## VEHICLE INSPECTION REPORT

**NL72HZX**

### Renault Master LM35 2.3 DCI 135PS BUSINESS

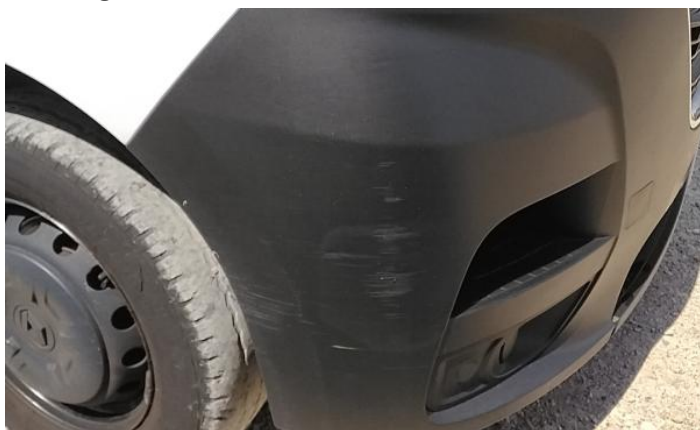
1: Bumper Front Moulding  
Scuffed (Unpainted)  
Over 100mm

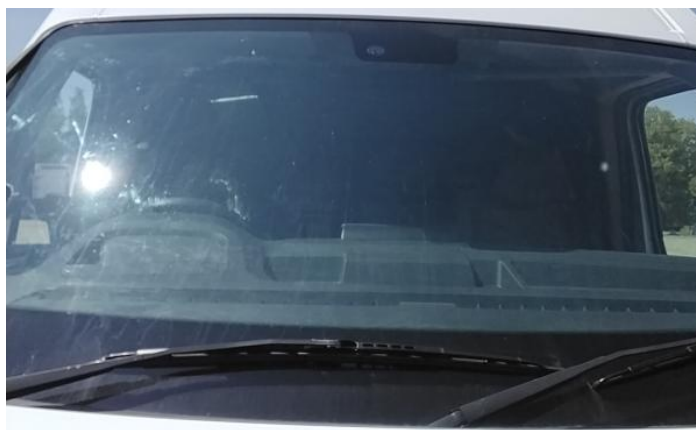
2: Screen Front  
Cracked  
Replace

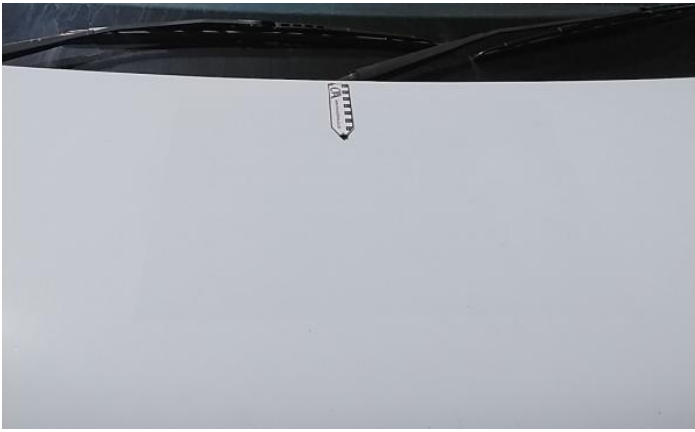
3: Bonnet  
Chipped  
Multiple Chips

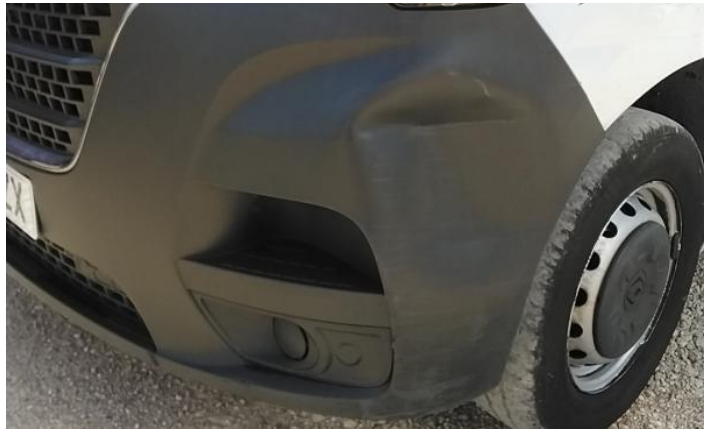
4: Bumper Front  
Dented  
Over 30mm

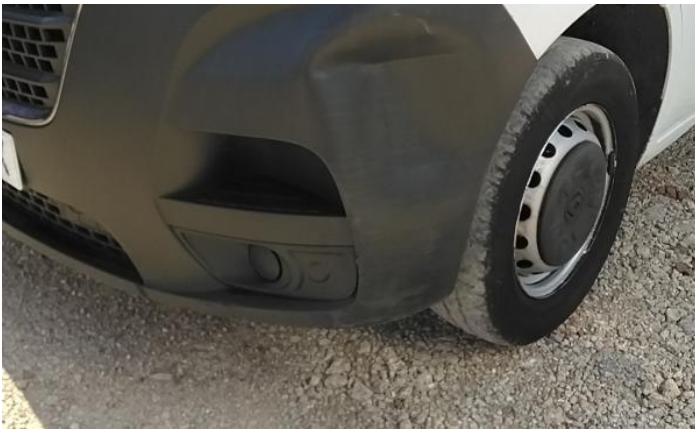
5: Bumper Front Moulding  
Scuffed (Unpainted)  
Over 100mm

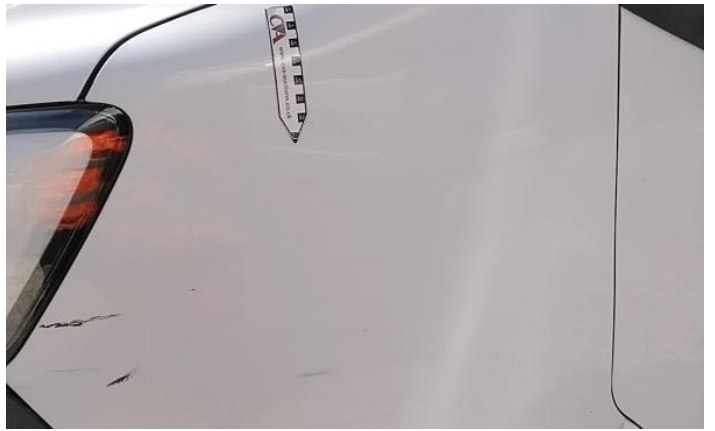
6: Wing nsf  
Dented  
With Paint Damage

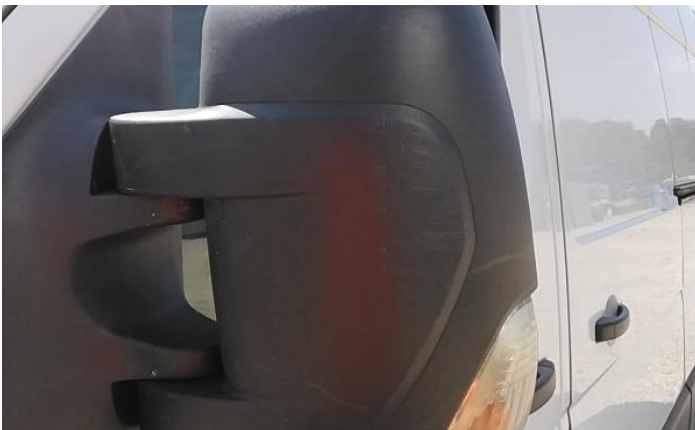
7: Door Mirror Assy nsf  
Scuffed (Unpainted)  
Over 100mm

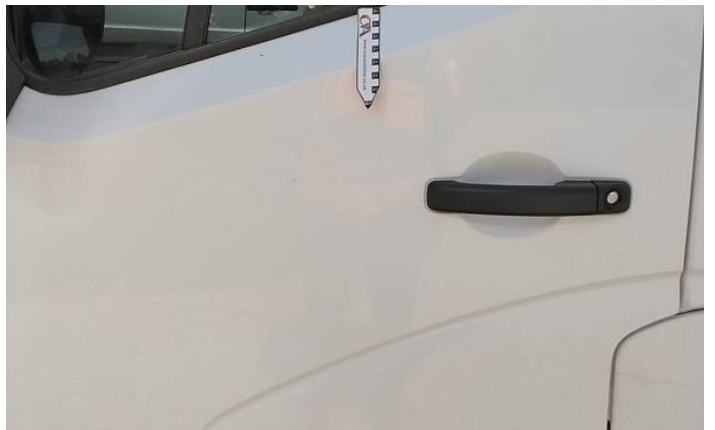
8: Door nsf  
Scratched  
Over 25mm Not Thru Paint

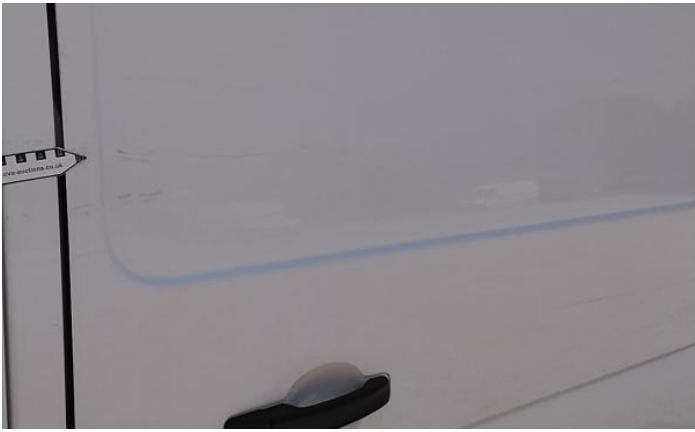
9: Door nsr  
Scratched  
Over 25mm Not Thru Paint

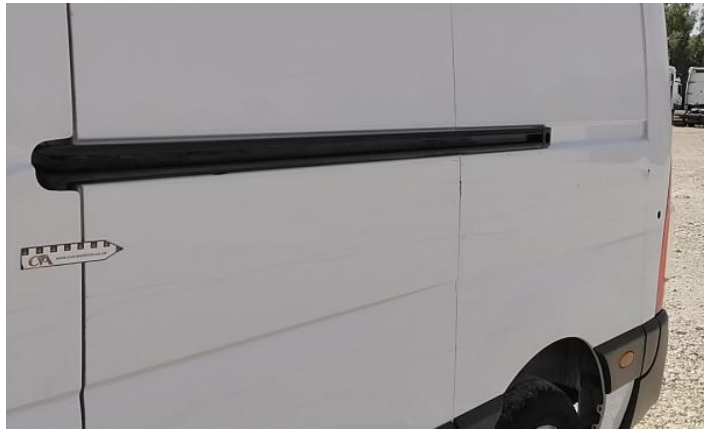
10: Qtr Panel nsr  
Scratched  
Over 25mm Not Thru Paint

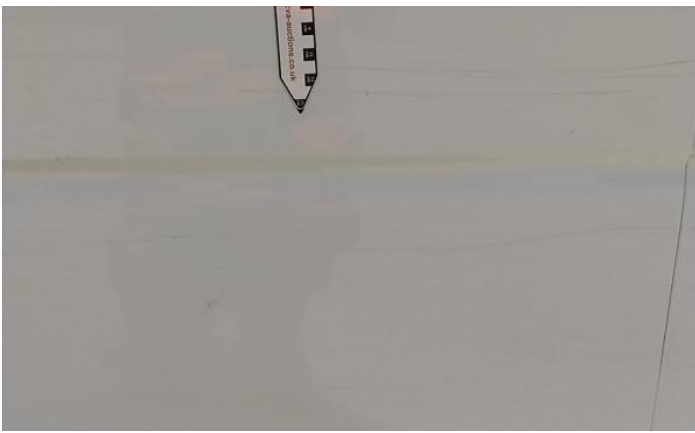
11: Qtr Panel nsr  
Dented  
Between 10mm + 30mm

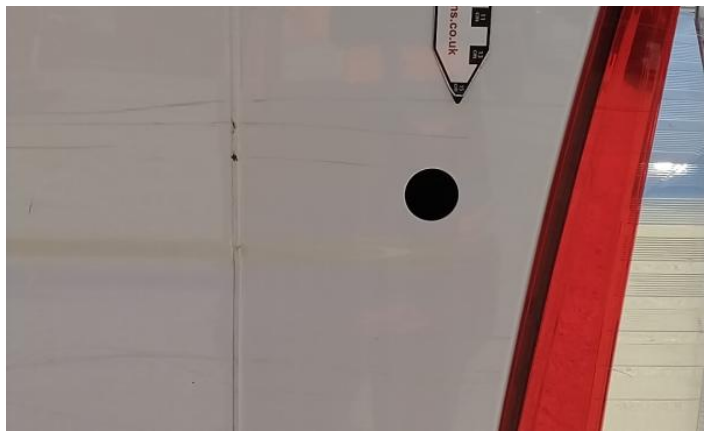
12: Qtr Panel nsr  
Hole  
Over 10mm

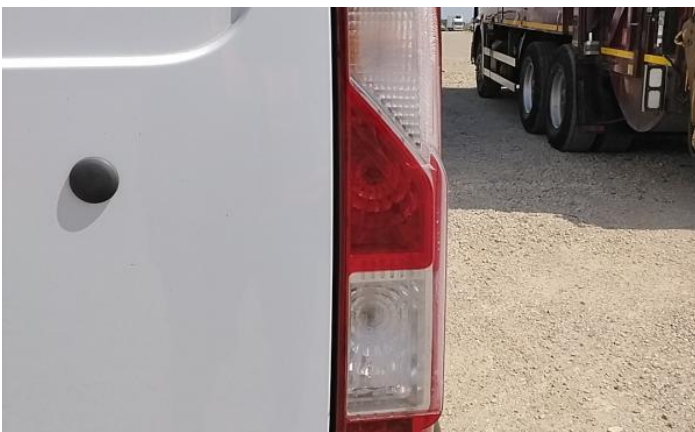
13: Lamp osr  
Broken  
Replace

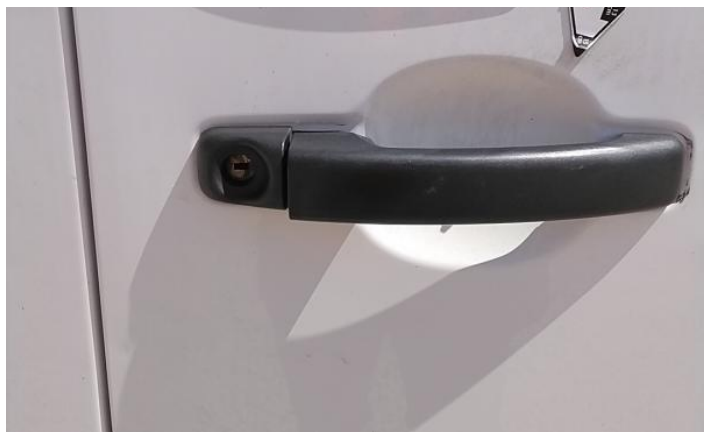
14: Handle Outer osr  
Broken  
Replace

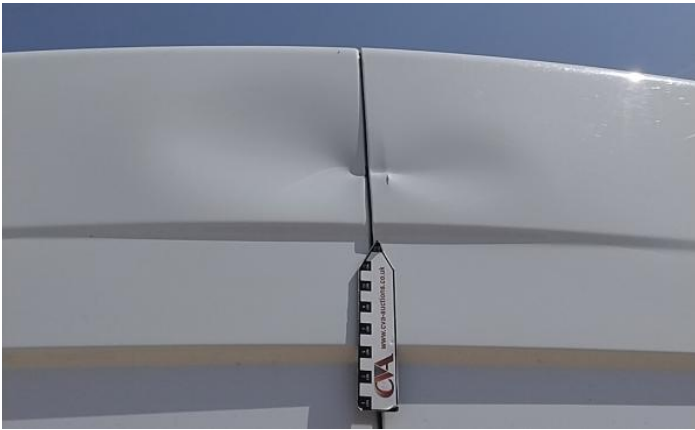
15: Door osr  
Dented  
With Paint Damage

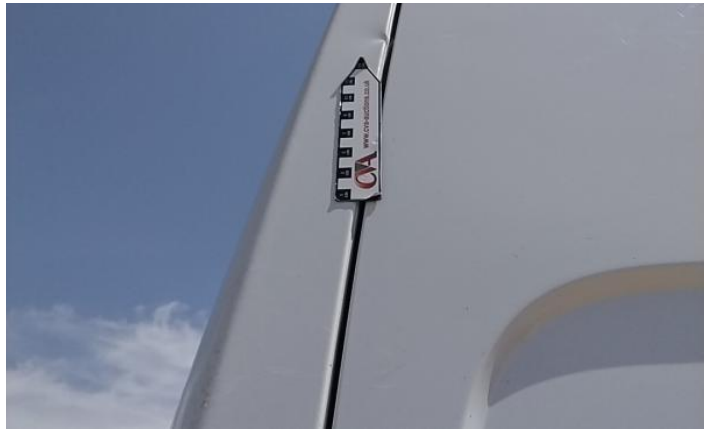
16: Qtr Panel nsr  
Dented  
With Paint Damage

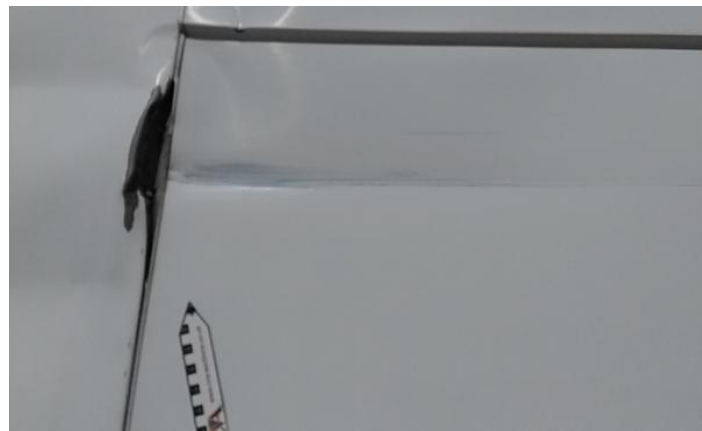
17: Qtr Panel osr  
Hole  
Over 10mm

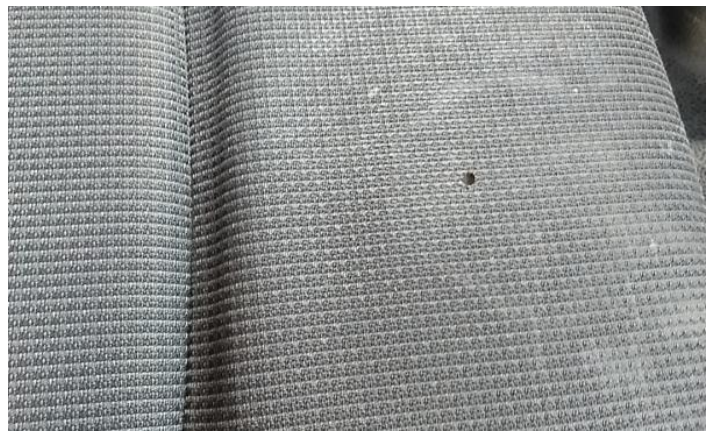
18: Seat Base Cover osf  
Burn  
Over 3mm
