## VEHICLE INSPECTION REPORT

**NL72JCU**

### Renault Master LM35 2.3 DCI 135PS BUSINESS

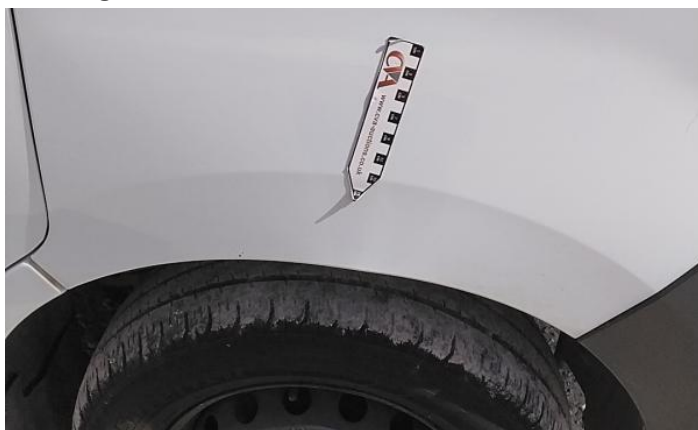
1: Wing osf  
Dented  
Between 10mm + 30mm

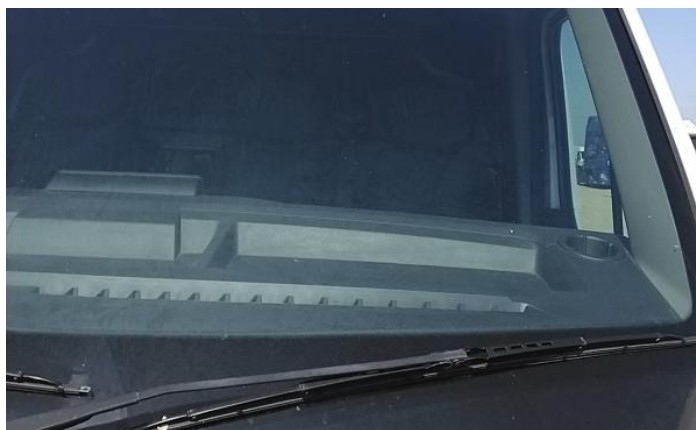
2: Screen Front  
Chipped  
Over 10mm

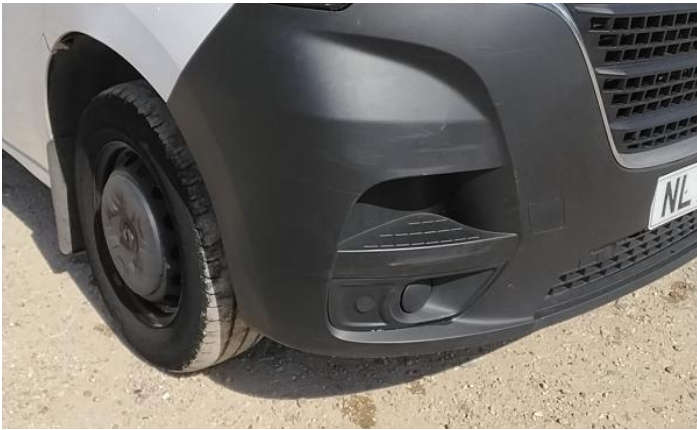
3: Bumper Front Moulding  
Scuffed (Unpainted)  
Over 100mm

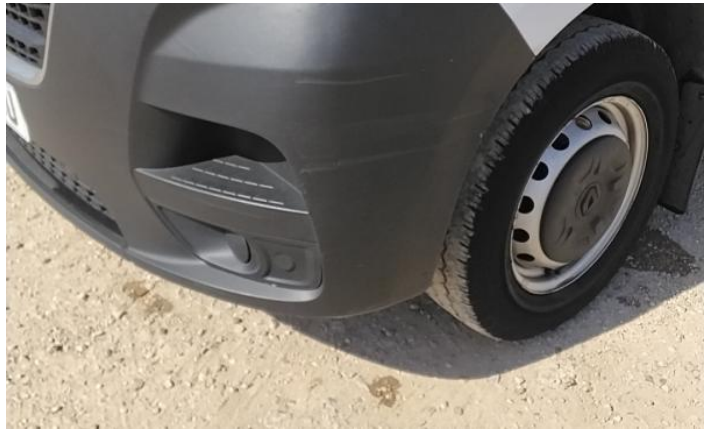
4: Bumper Front Moulding  
Scuffed (Unpainted)  
Over 100mm

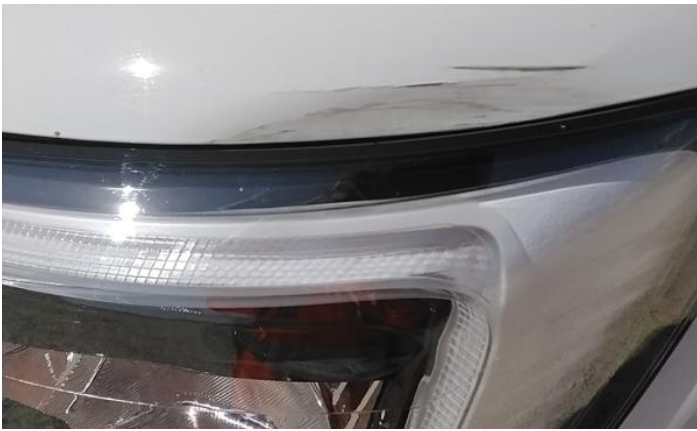
5: Bonnet  
Dented  
With Paint Damage

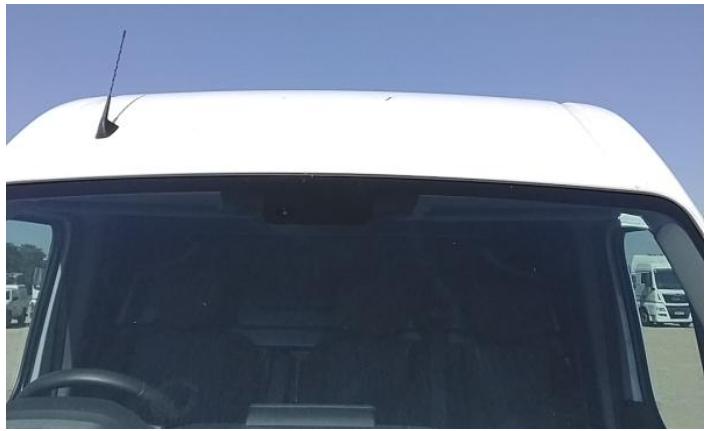
6: Roof  
Rusted  
Over 5mm

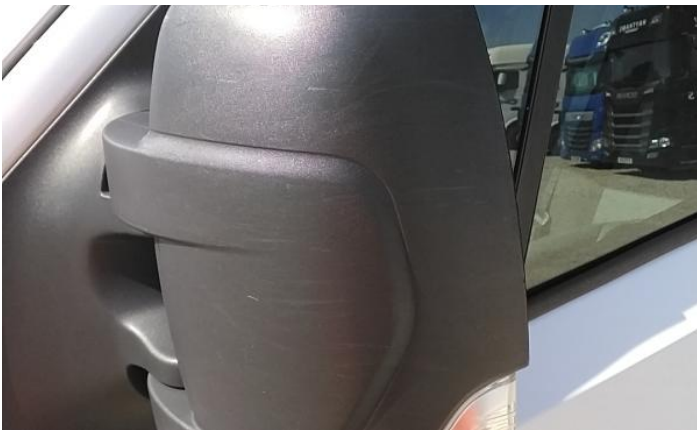
7: Door Mirror Assy nsf  
Broken  
Replace

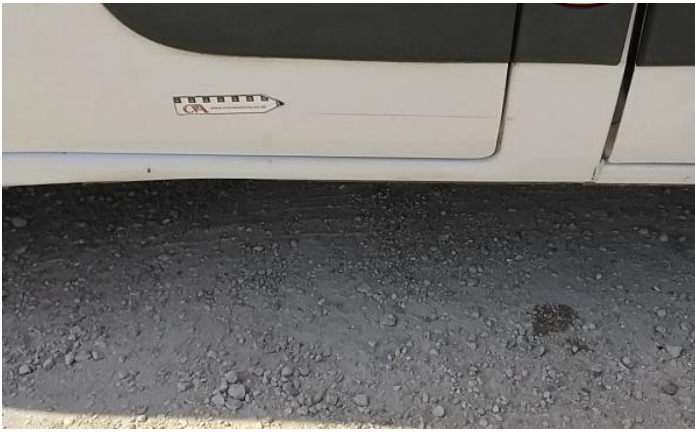
9: Door nsf  
Scratched  
Over 25mm Not Thru Paint

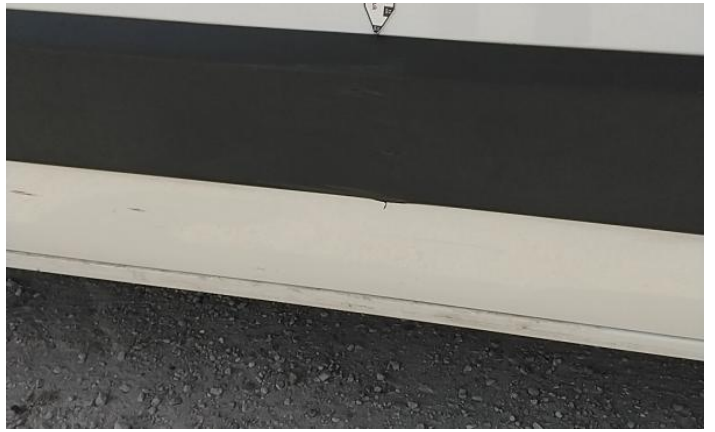
10: Door Moulding nsr  
Scuffed (Unpainted)  
Over 100mm

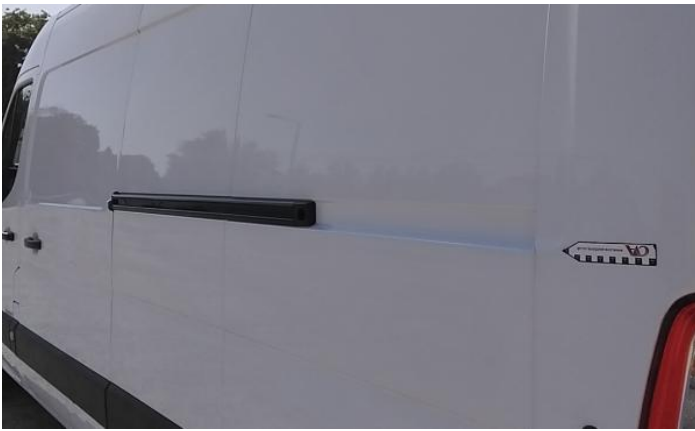
11: Qtr Panel nsr  
Scratched  
Over 25mm Not Thru Paint

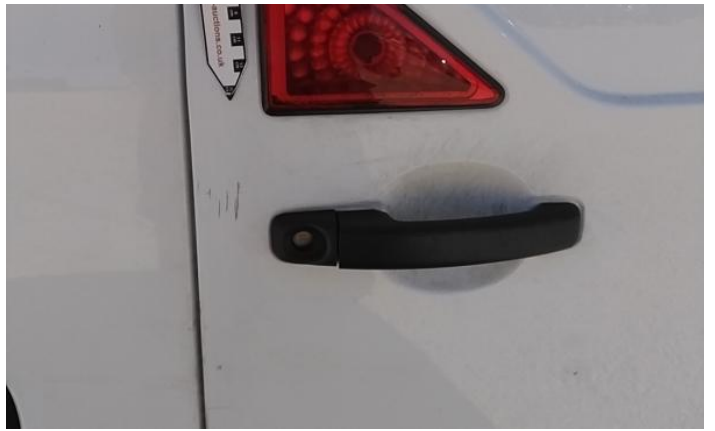
12: Door osr  
Scratched  
Over 25mm Thru Paint

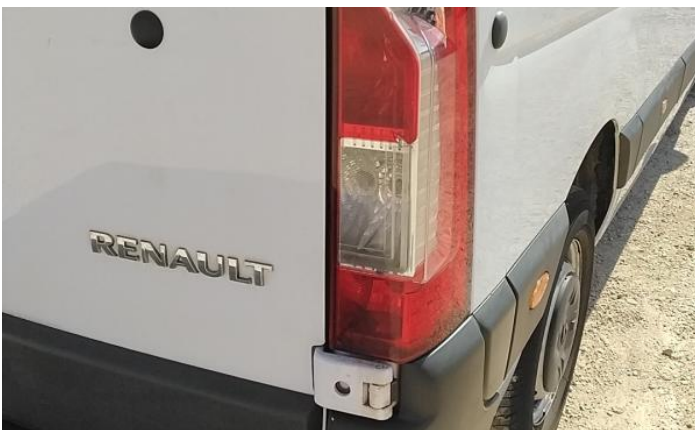
13: Lamp osr  
Broken  
Replace

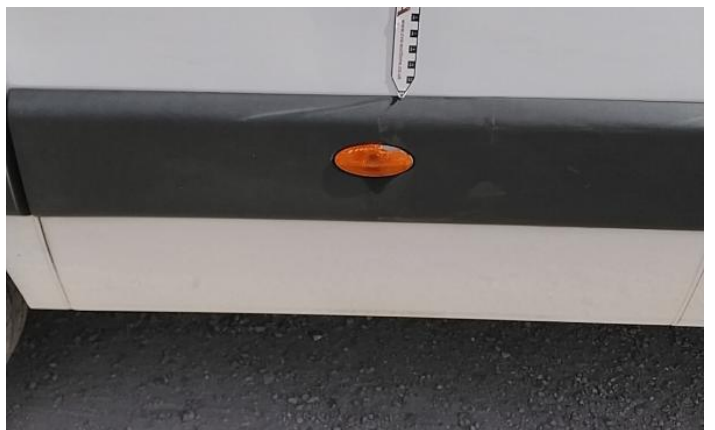
14: Qtr Panel Moulding os  
Scuffed (Unpainted)  
Over 100mm

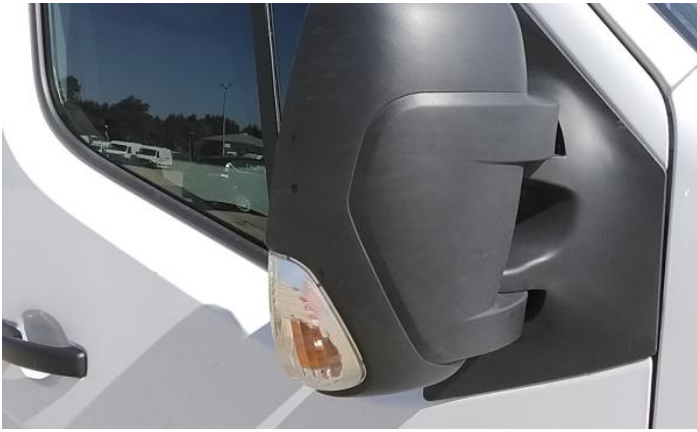
15: Door Mirror Assy osf  
Scuffed (Unpainted)  
UpTo 100mm

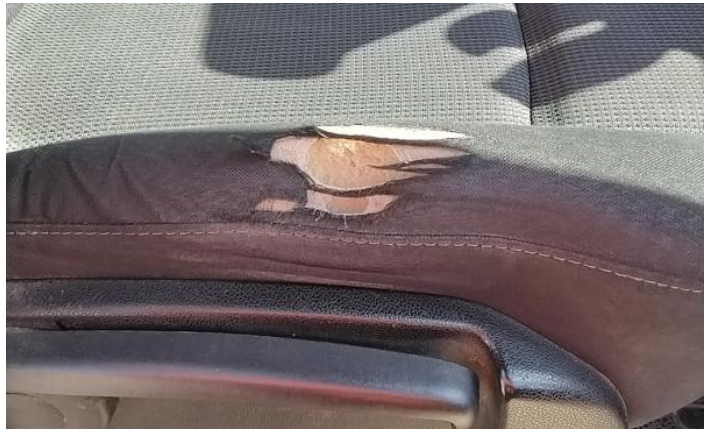
16: Seat Base Cover osf  
Holed  
Over 3mm

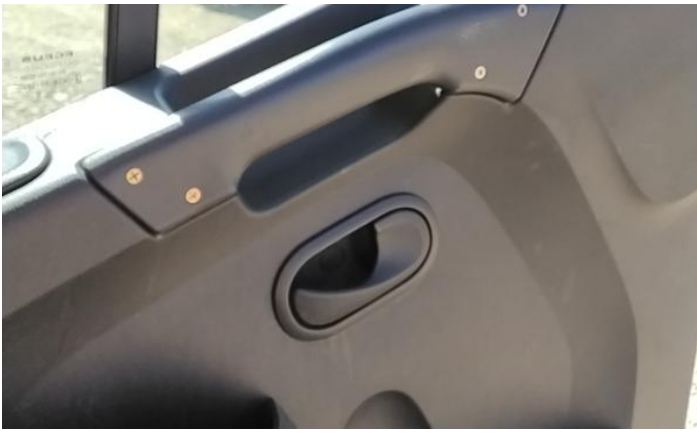
17: Door Pad osf  
Broken  
Replace
