VEHICLE INSPECTION REPORT

NK15ZVG

Scania P250

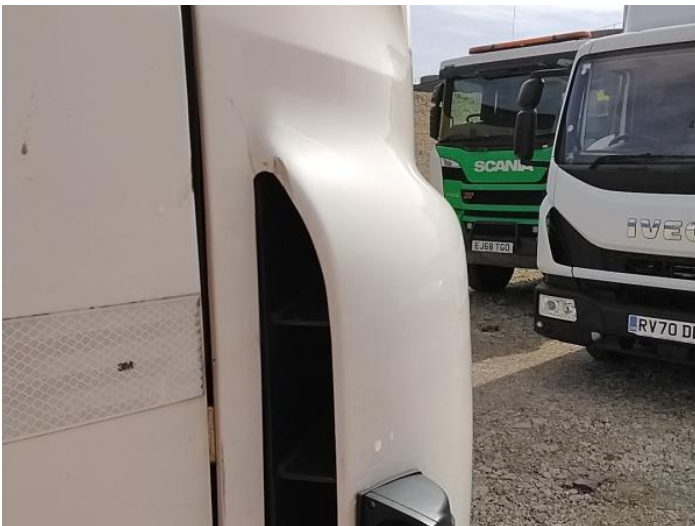
1: Moulding onf Wing
Scratched (Painted)
Over 25mm Thru Paint

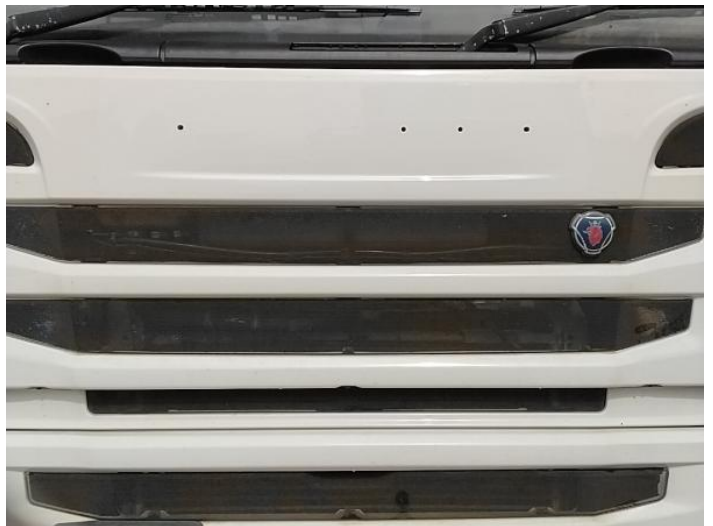
2: General Exterior
Soiled
Light

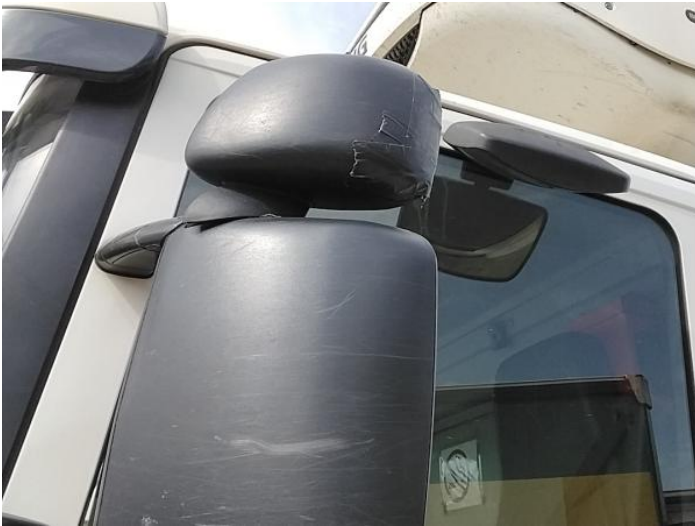
3: Door Mirror Assy nsf
Broken
Replace

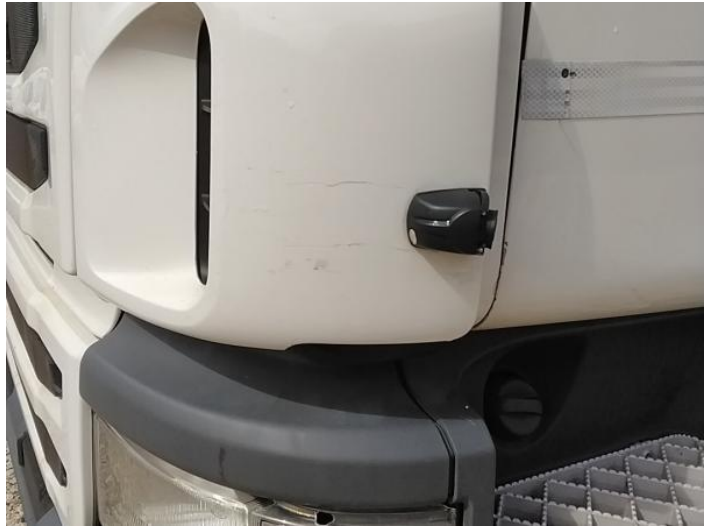
4: Moulding nsf Wing
Scratched (Painted)
Over 25mm Thru Paint

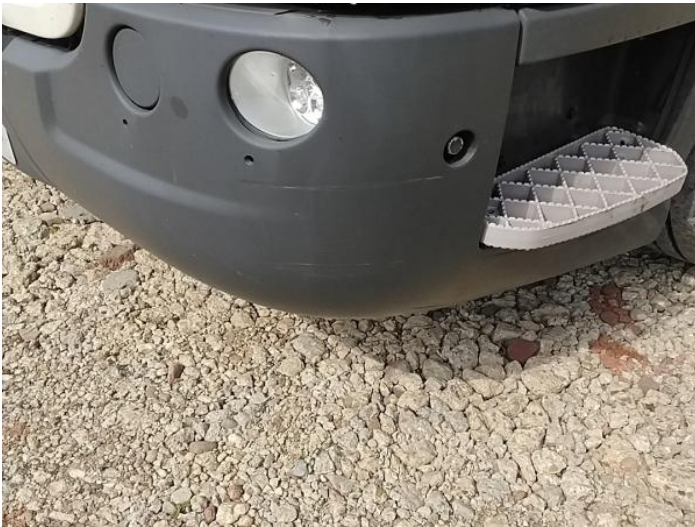
5: Bumper Front
Scratched
Over 25mm Not Thru Paint

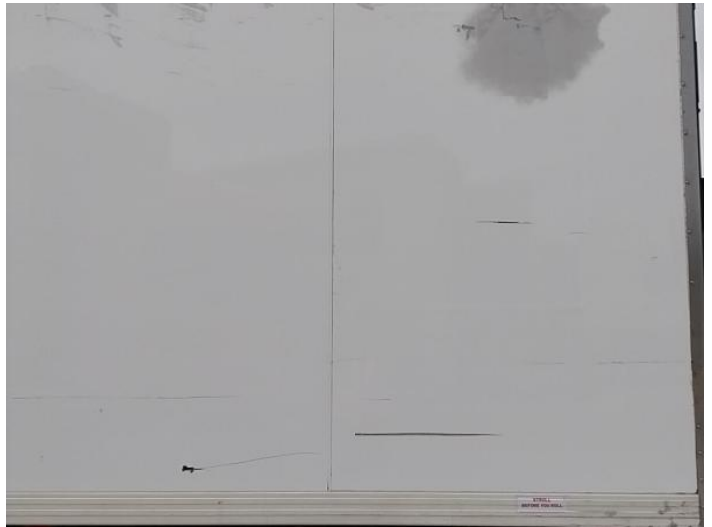
6: Qtr Panel nsr
Hole
Over 10mm

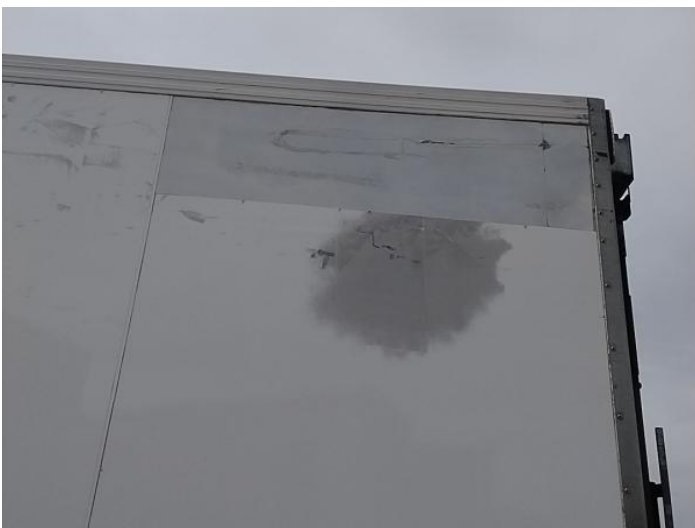
7: Qtr Panel nsr
Hole
Over 10mm

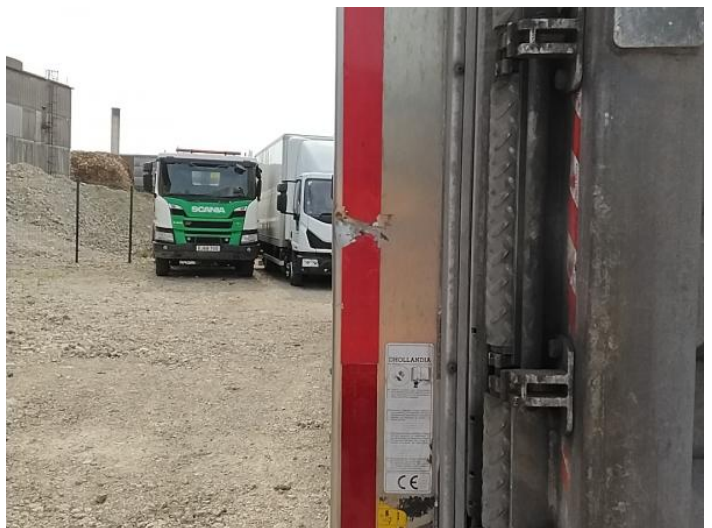
8: General Exterior
Soiled
Light

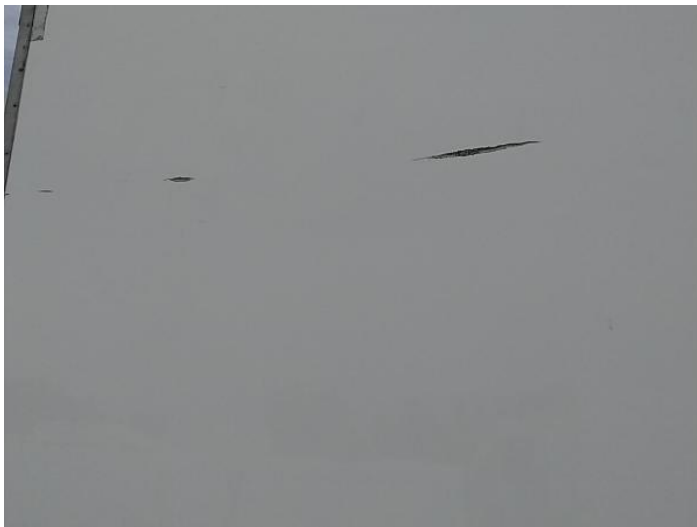
9: Qtr Panel osr
Scratched
Over 25mm Thru Paint

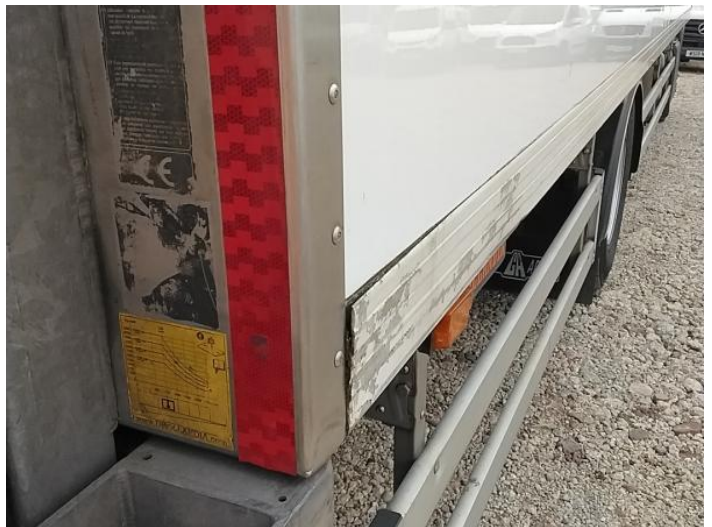
10: Qtr Panel osr
Scratched
Over 25mm Thru Paint

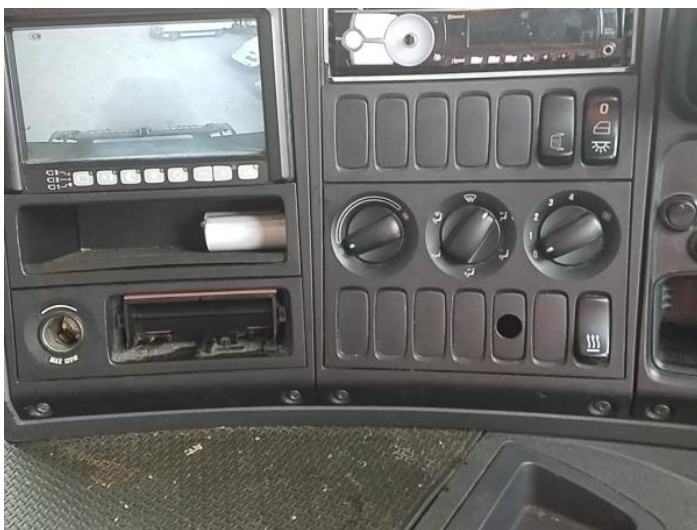
11: In Car Entertainment
Missing
Replace
