# VEHICLE INSPECTION REPORT

**AY18JVP**

## Mercedes-Benz Actros 1840

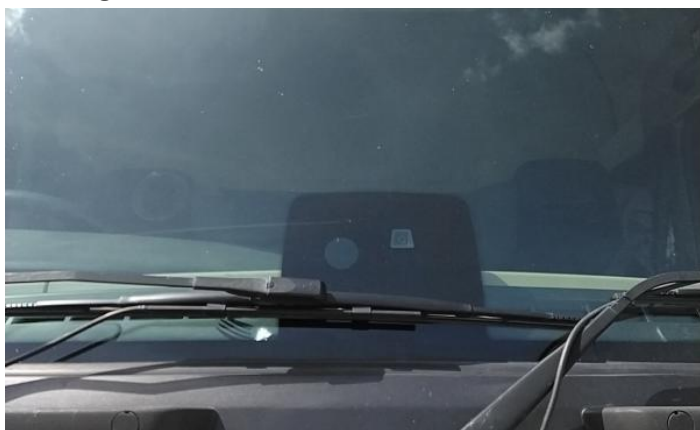
1: Screen Front  
Chipped  
UpTo 10mm

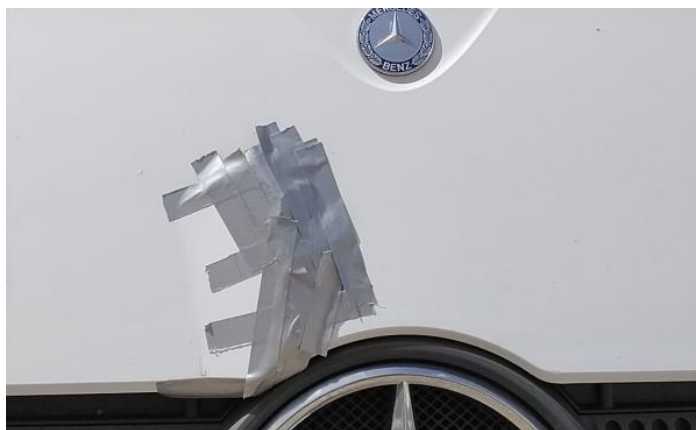
2: Bonnet  
Cracked  
Replace

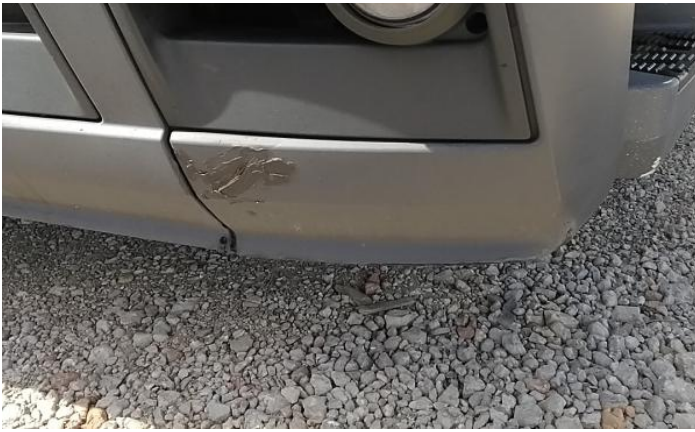
3: Bumper Front Moulding  
Scuffed (Unpainted)  
Over 100mm

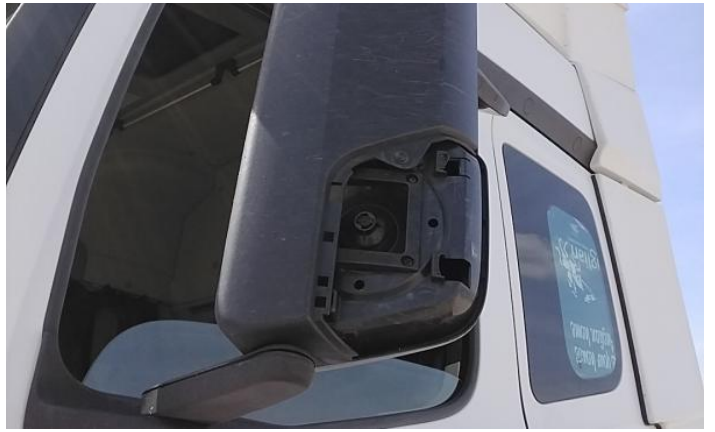
4: Door Mirror Assy nsf  
Broken  
Replace

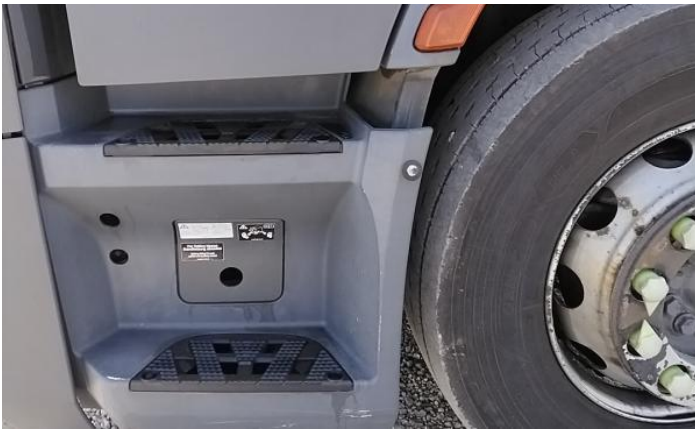
5: Wing Front Arch Extension ns  
Scuffed (Unpainted)  
Over 100mm

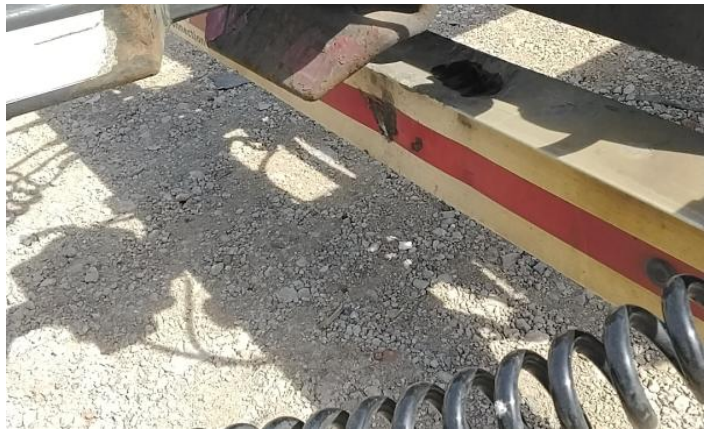
6: Bumper Rear  
Dented  
Between 10mm + 30mm

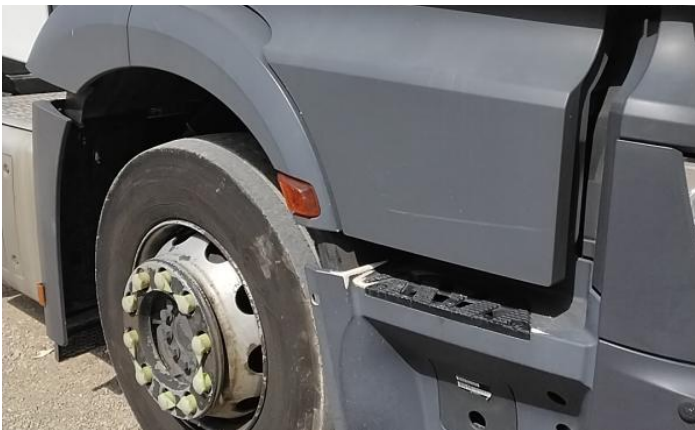
7: Wing Front Arch Extension os  
Scuffed (Unpainted)  
Over 100mm

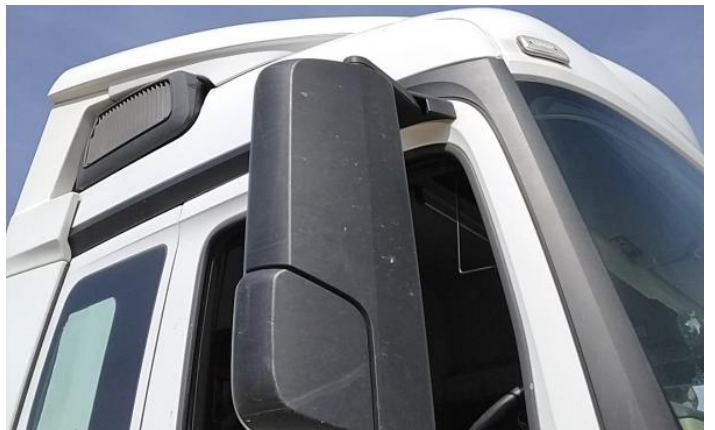
8: Door Mirror Assy osf  
Scuffed (Unpainted)  
Over 100mm
