# VEHICLE INSPECTION REPORT

**NL72JCV**

## Renault Master LM35 2.3 DCI 135PS BUSINESS

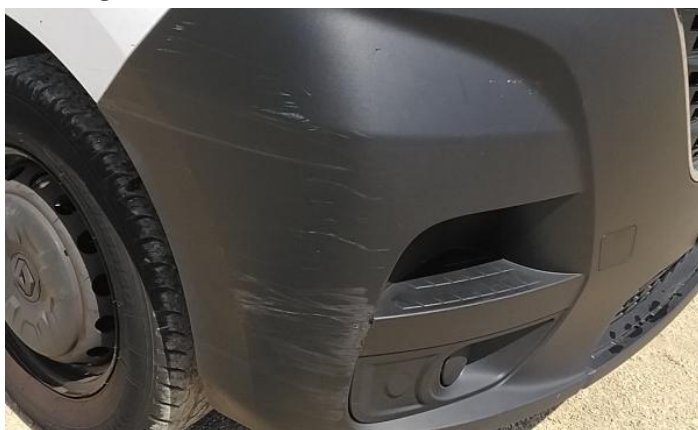
1: Bumper Front Moulding  
Scuffed (Unpainted)  
Over 100mm

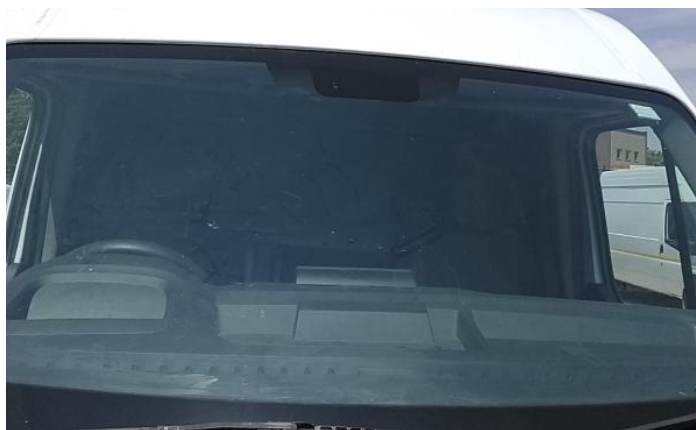
2: Screen Front  
Chipped  
UpTo 10mm

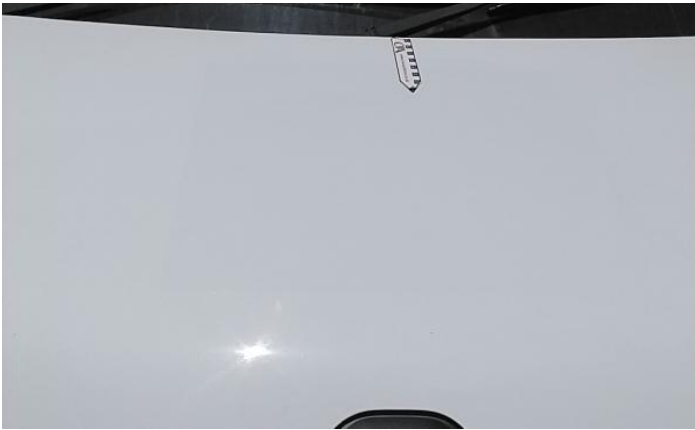
3: Bonnet  
Chipped  
Multiple Chips

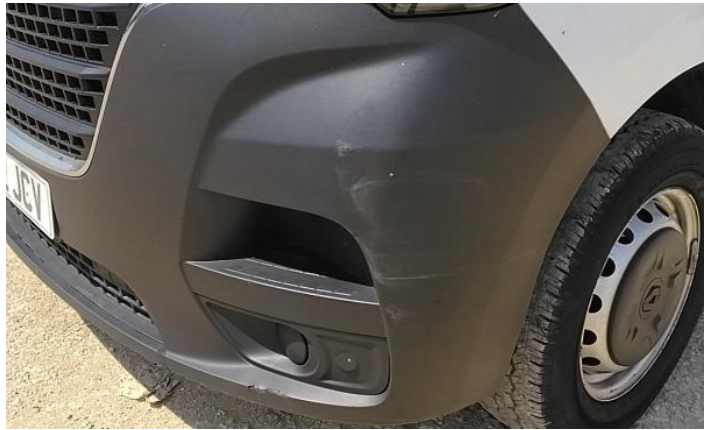
4: Bumper Front Moulding  
Scuffed (Unpainted)  
Over 100mm

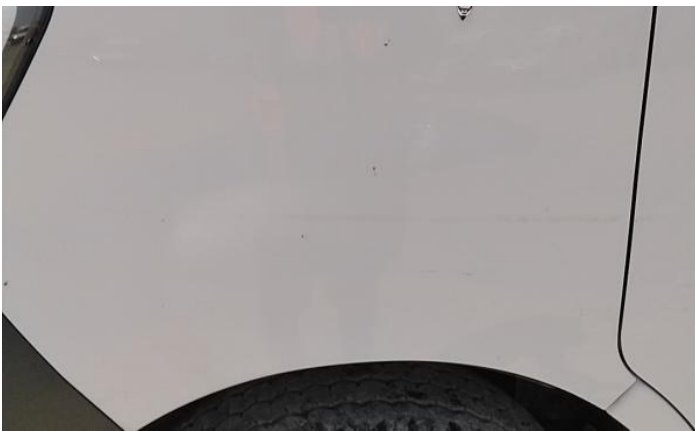
5: Wing nsf  
Scratched  
Over 25mm Not Thru Paint

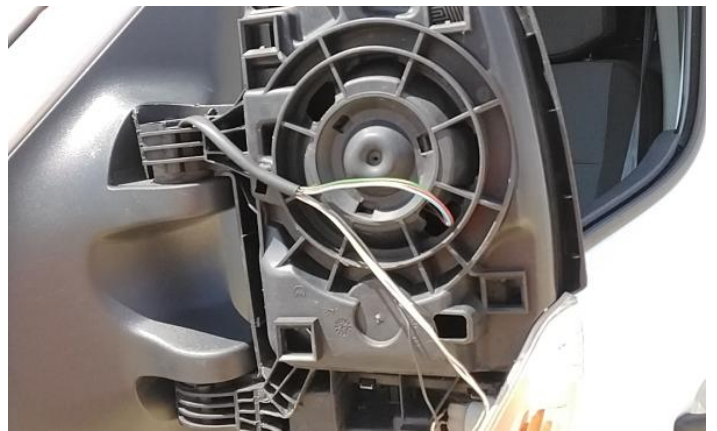
6: Door Mirror Assy nsf  
Broken  
Replace

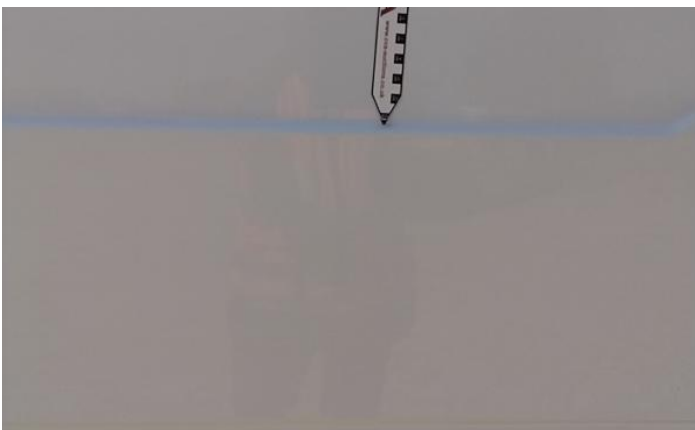
7: Door nsr  
Dented  
Between 10mm + 30mm

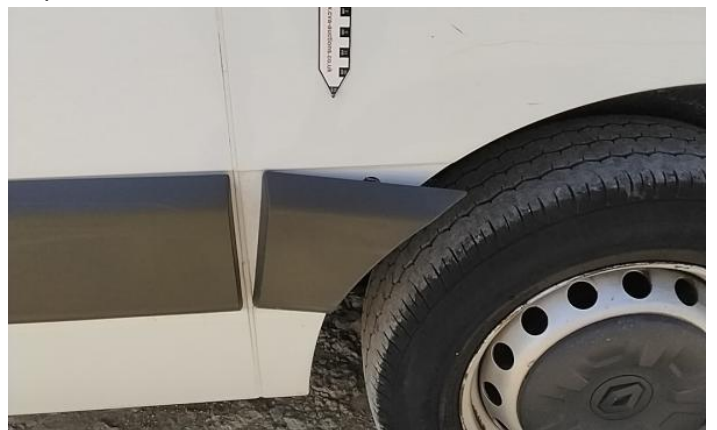
8: Qtr Panel Moulding ns  
Broken  
Replace

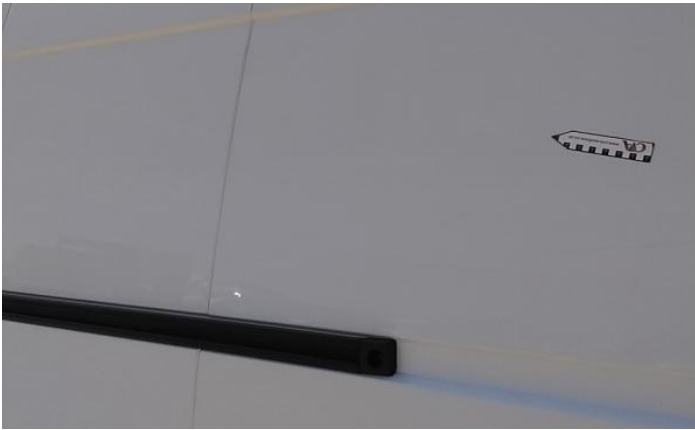
9: Qtr Panel nsr  
Scratched  
Over 25mm Not Thru Paint

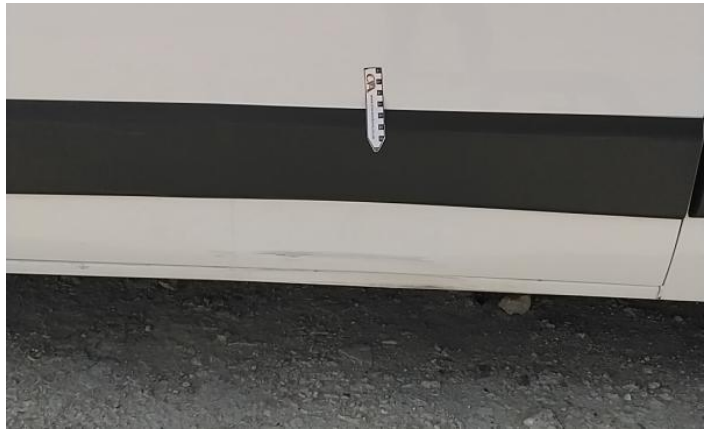
10: Door nsr  
Dented  
With Paint Damage

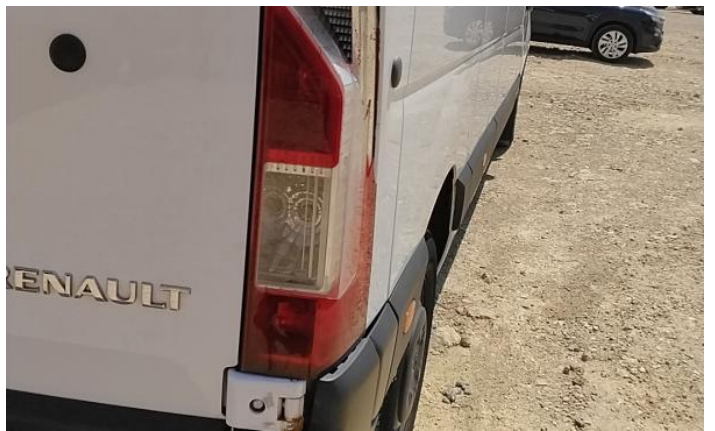
12: Lamp osr  
Broken  
Replace

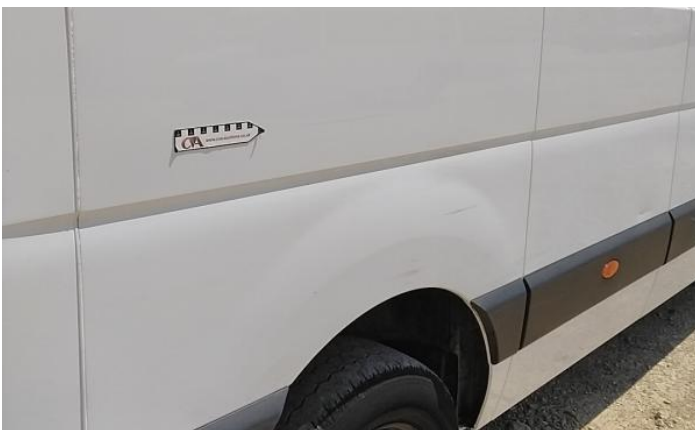
13: Qtr Panel osr  
Scratched  
Over 25mm Not Thru Paint

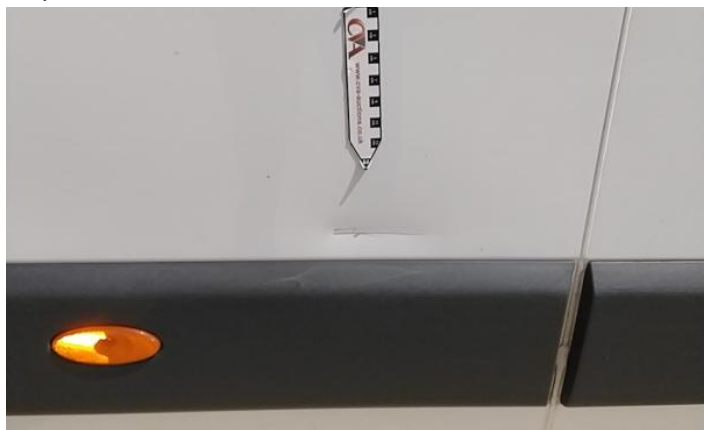
14: Qtr Panel osr  
Dented  
With Paint Damage

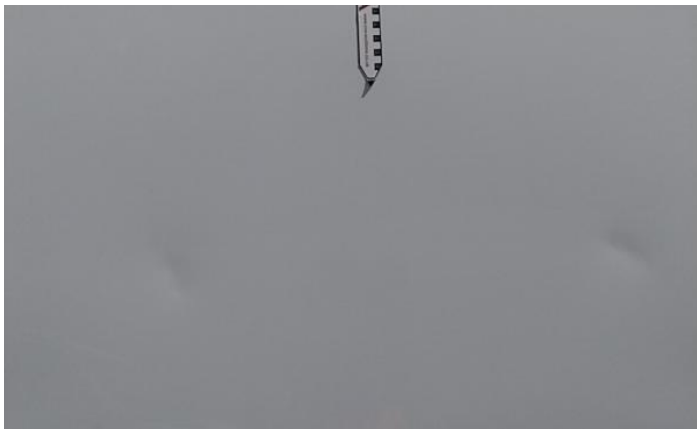
15: Qtr Panel osr  
Dented  
Between 10mm + 30mm

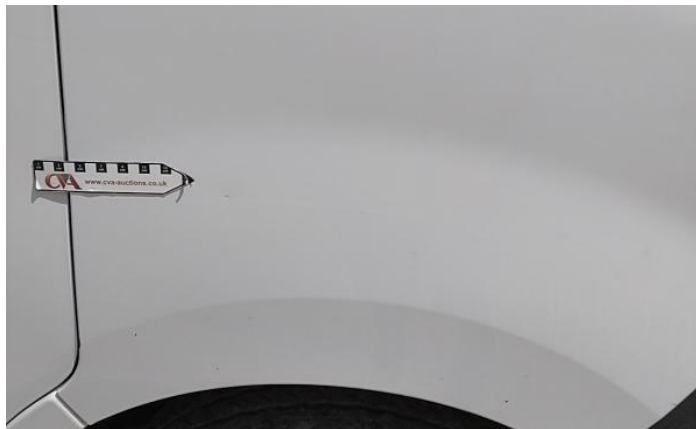
16: Wing osf  
Scratched  
Over 25mm Not Thru Paint

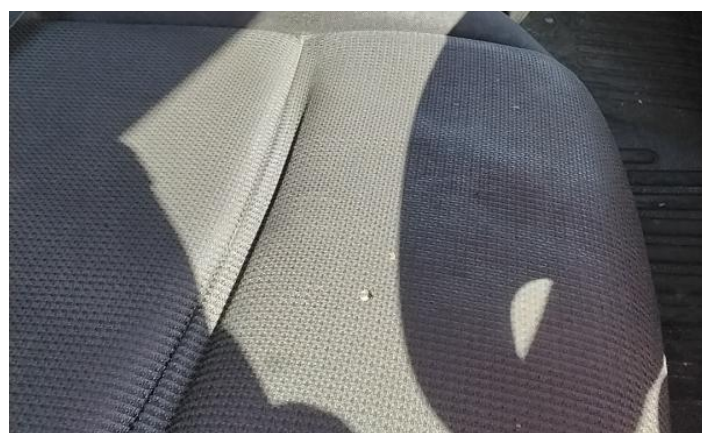
17: Seat Base Cover osf  
Burn  
Over 3mm

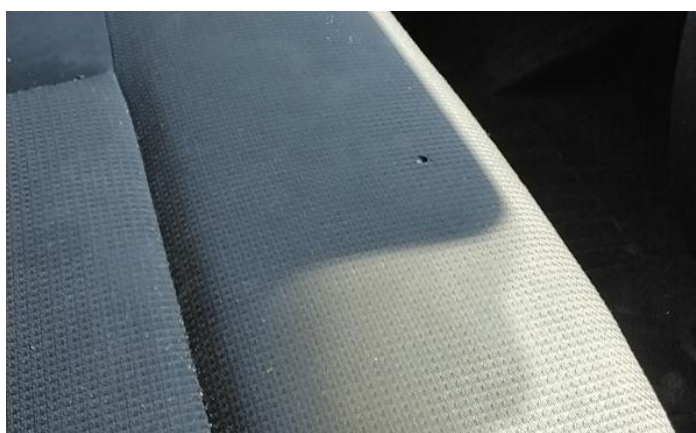
18: Seat Base Cover nsf  
Burn  
Over 3mm
