# VEHICLE INSPECTION REPORT

**FJ68XHZ**

## Mercedes-Benz Actros 2530

**Non Runner**  
Inspection

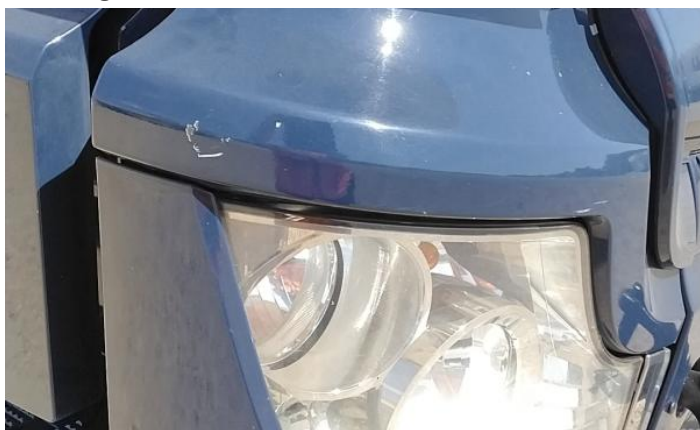
1: Fog Lamp Surround os  
Scratched (Painted)  
UpTo 25mm Thru Paint

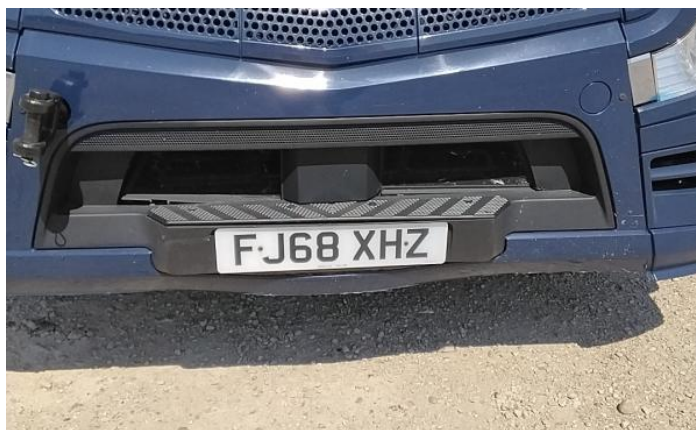
2: Grille Front  
Scratched (Painted)  
Over 25mm Thru Paint

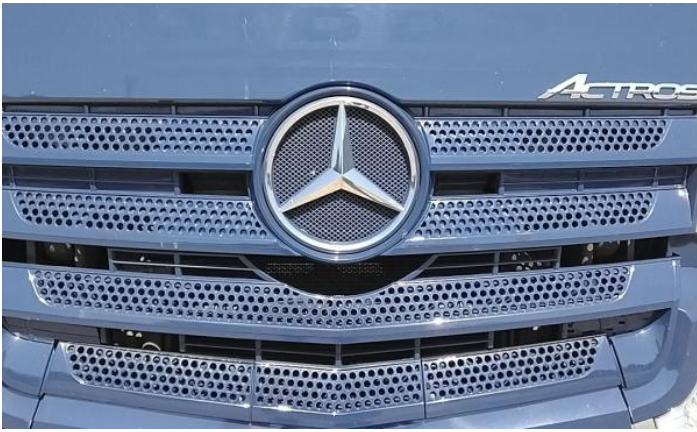
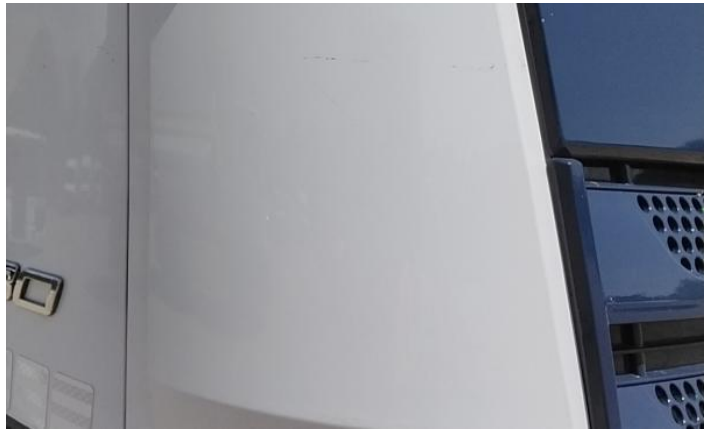
3: Bonnet  
Chipped  
Multiple Chips

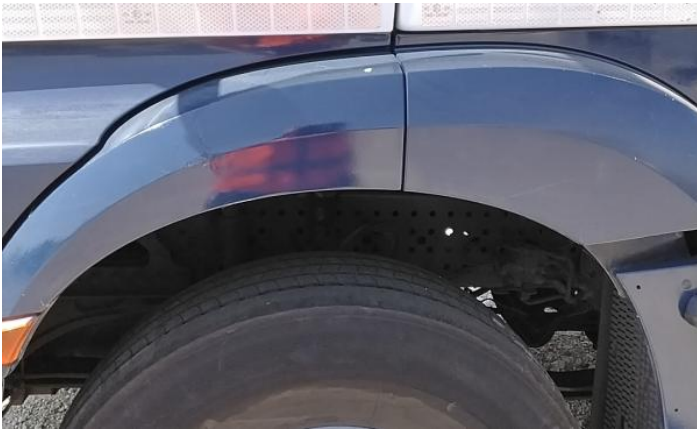
9: Wing Front Arch Extension ns  
Scratched (Painted)  
Over 25mm Thru Paint

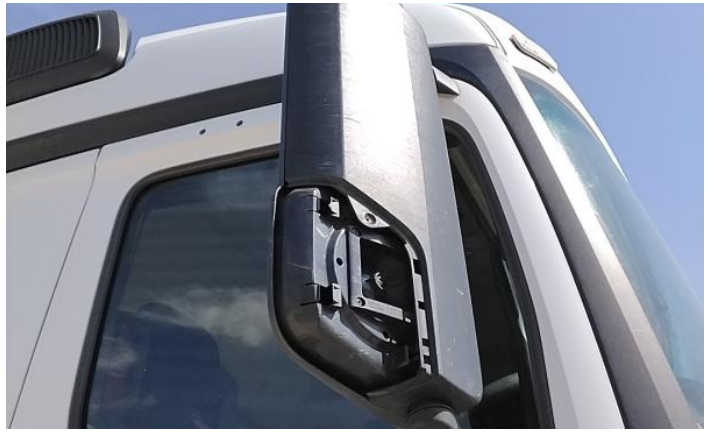
10: Door Mirror Assy osf  
Broken  
Replace

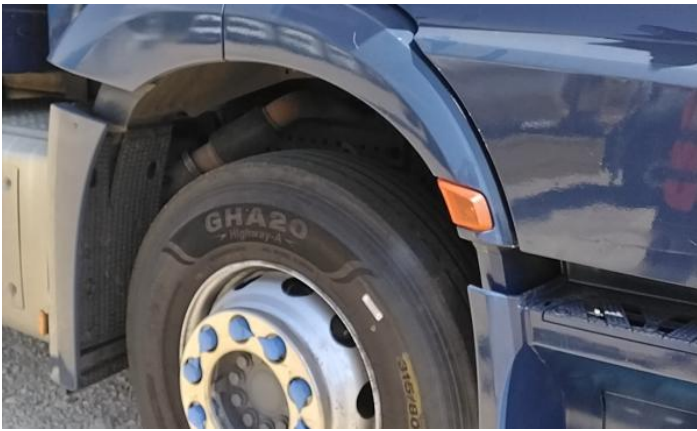
11: Wing Front Arch Extension os  
Scratched (Painted)  
Over 25mm Not Thru Paint

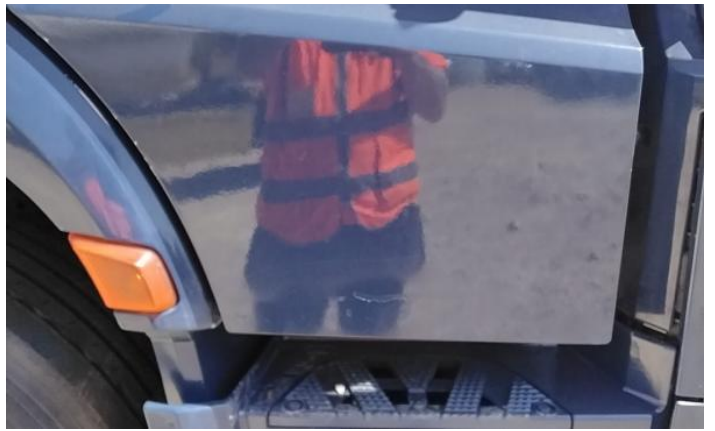
12: Door osf  
Scratched  
Over 25mm Not Thru Paint

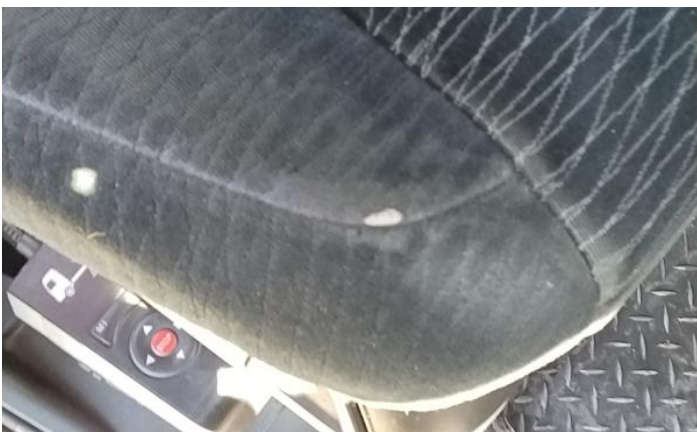
13: Seat Base Cover osf  
Holed  
Over 3mm
