# VEHICLE INSPECTION REPORT

**KT15YZN**

## Mercedes-Benz Sprinter 313 CDI

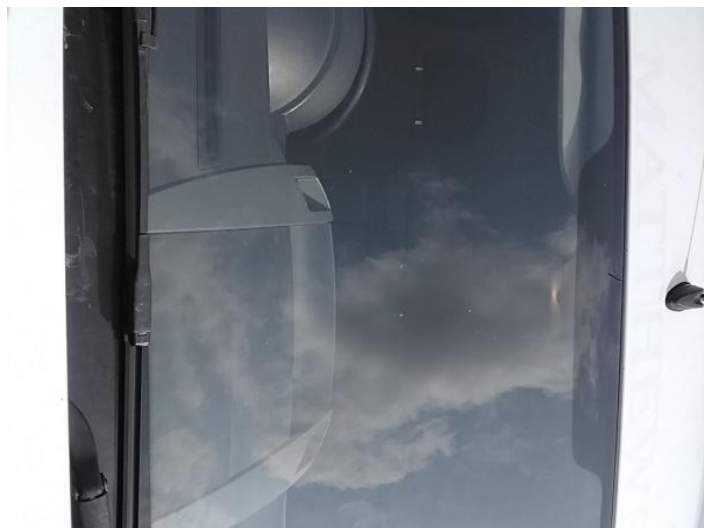
1: Screen Front  
Chipped  
UpTo 10mm

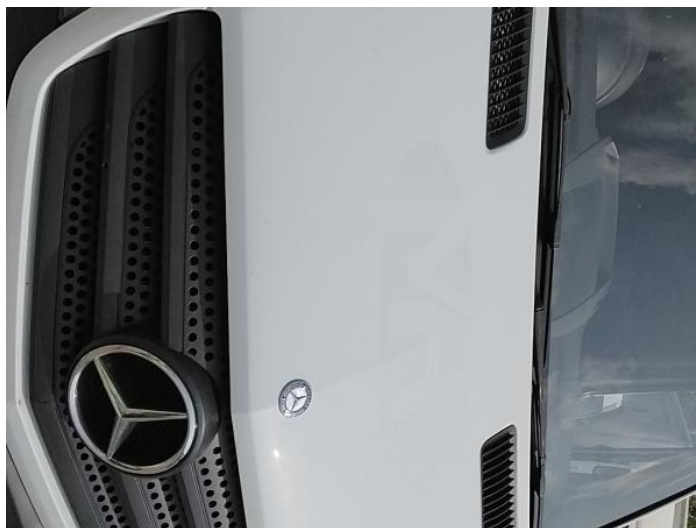
2: Bonnet  
Rusted  
Over 5mm

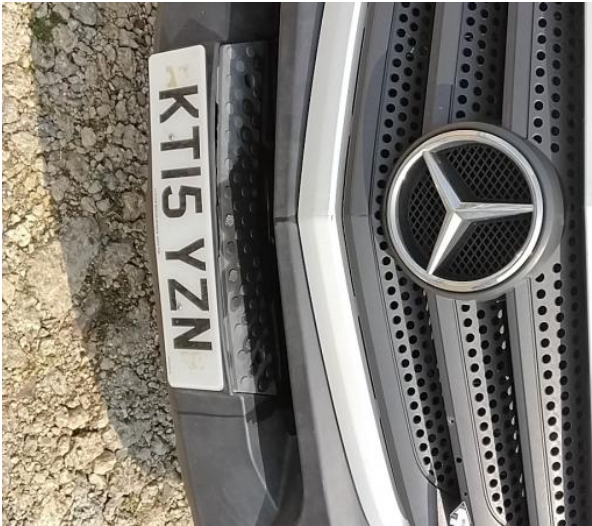
3: Grille Front  
Broken  
Replace

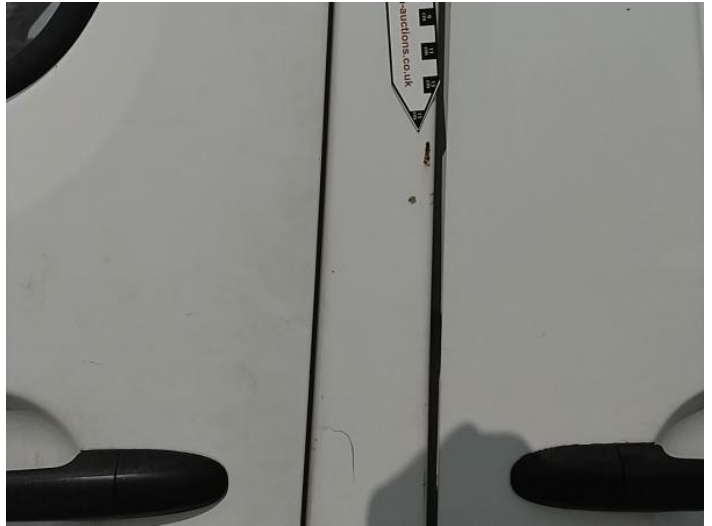
4: B Post ns  
Rusted  
Over 5mm

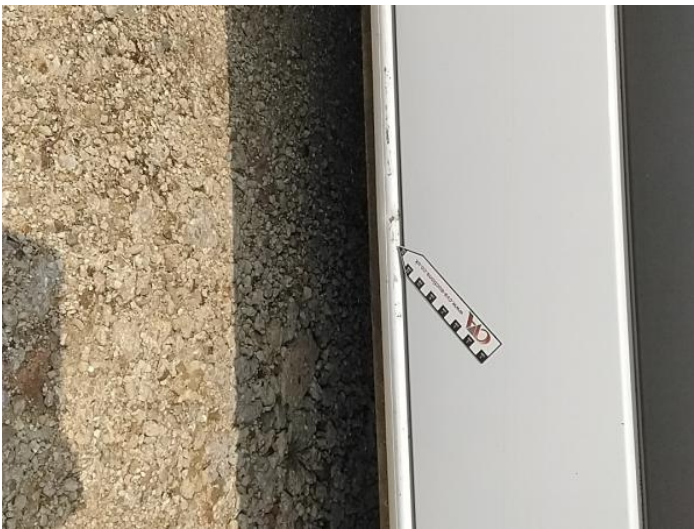
5: Sill ns  
Dented  
With Paint Damage

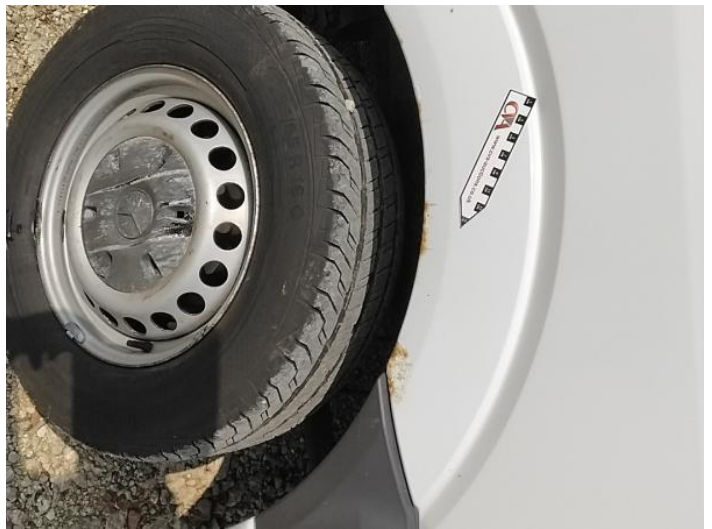
6: Qtr Panel nsr  
Rusted  
Over 5mm

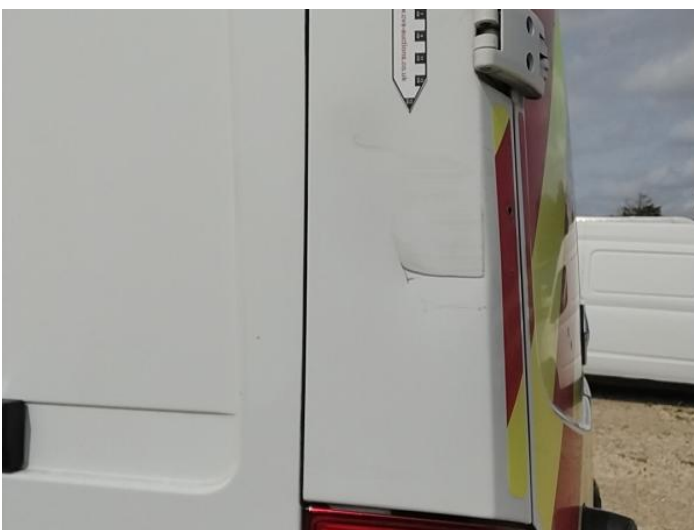
7: Qtr Panel nsr  
Dented  
With Paint Damage

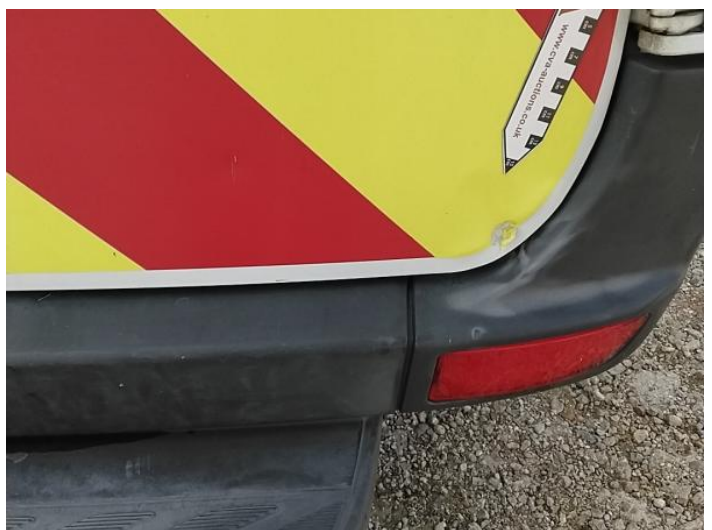
8: Door osr  
Dented  
With Paint Damage

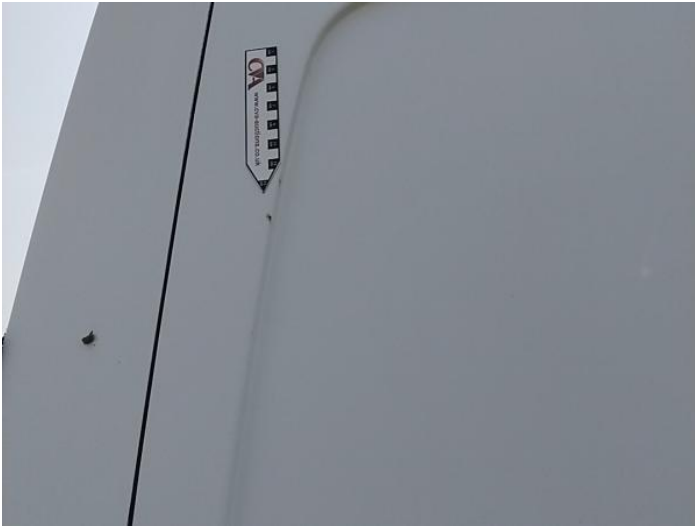
9: Qtr Panel osr  
Rusted  
UpTo 5mm

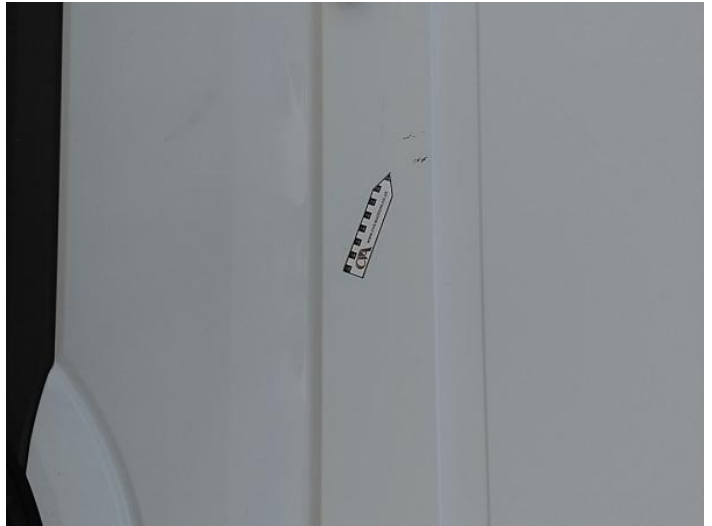
10: Qtr Panel osr  
Scratched  
Over 25mm Thru Paint

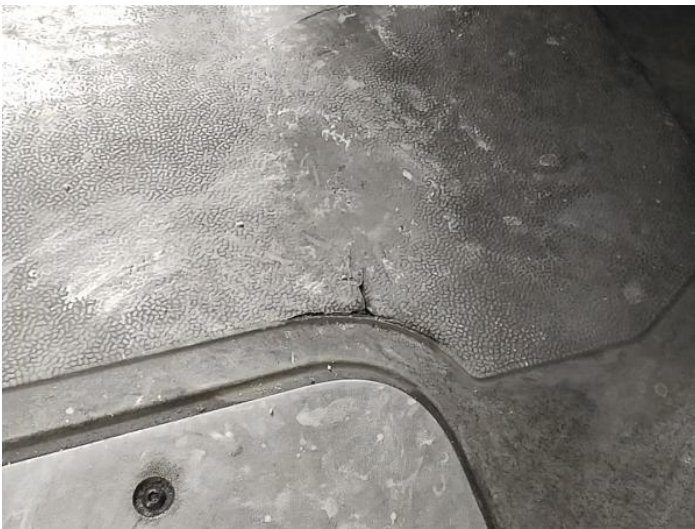
11: Carpets Front  
Holed  
Over 3mm

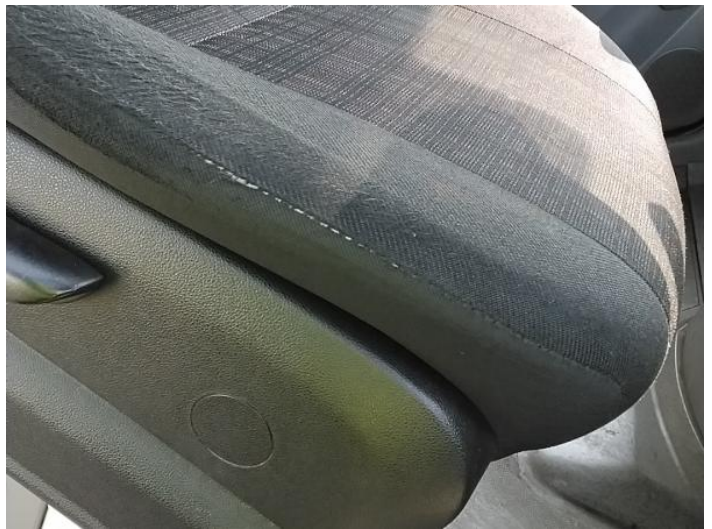
12: Seat Base Cover osf  
Torn  
Over 3mm

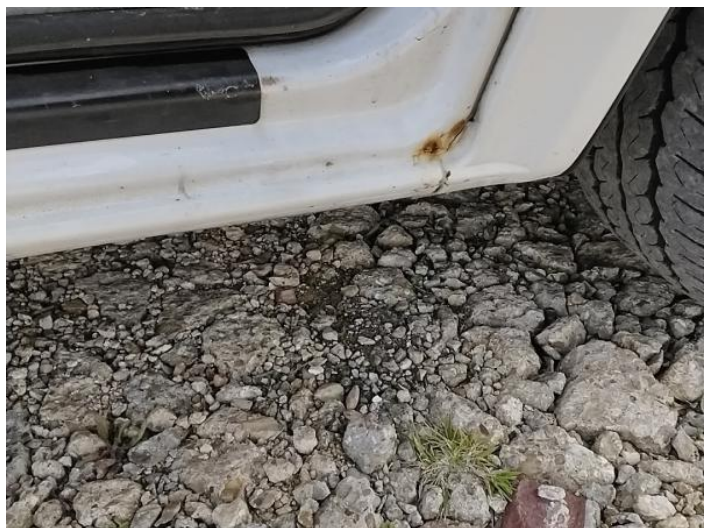
14: Sill os  
Rusted  
Over 5mm
