# VEHICLE INSPECTION REPORT

**BF19WAU**

## Volvo FMX 450

### Inspection

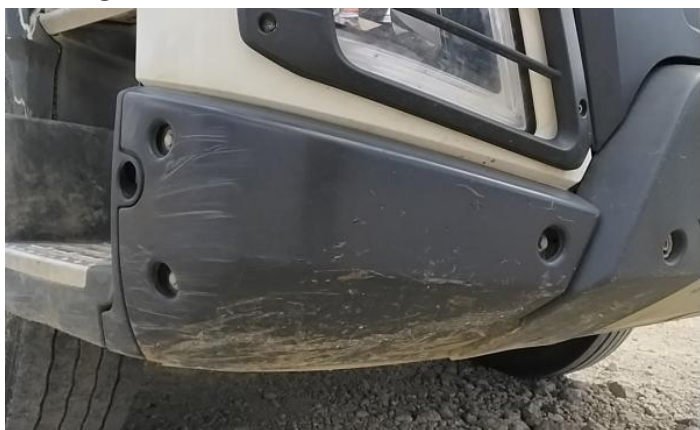
1: Bumper Front  
Scratched  
Over 100mm Thru Paint

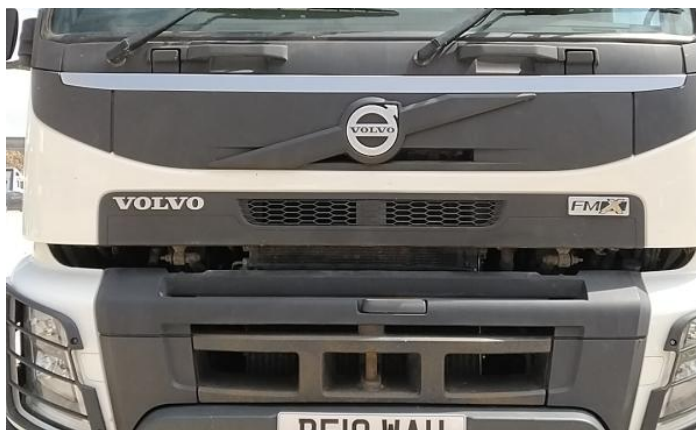
2: Bonnet  
Chipped  
Multiple Chips

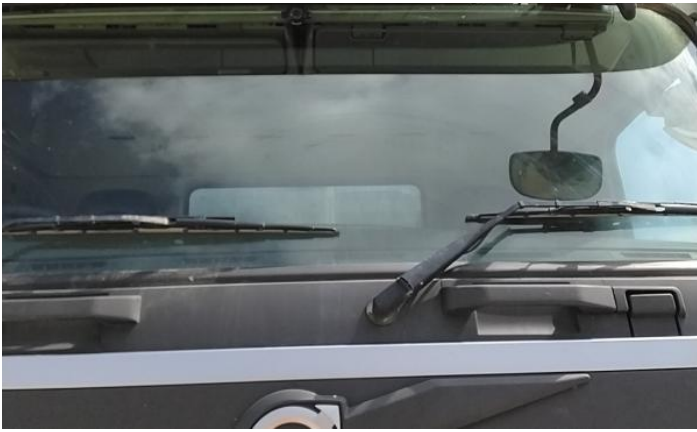
3: Screen Front  
Chipped  
Over 10mm

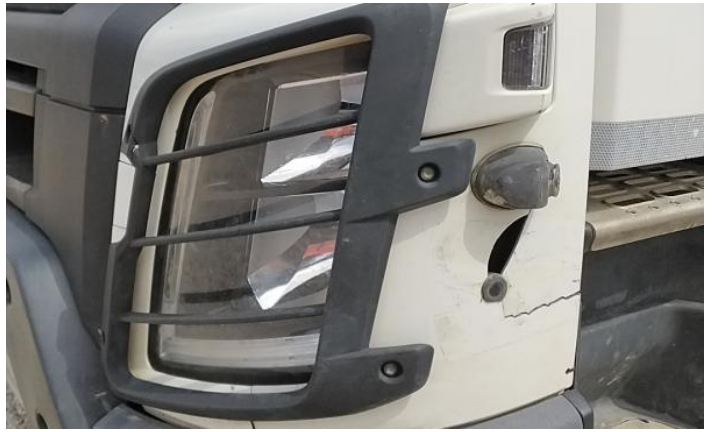
4: Fog Lamp Surround ns  
Broken  
Replace

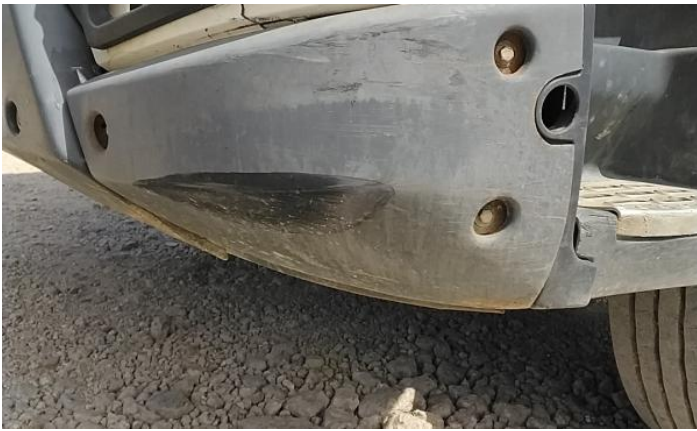
5: Bumper Front  
Scratched  
Over 100mm Thru Paint

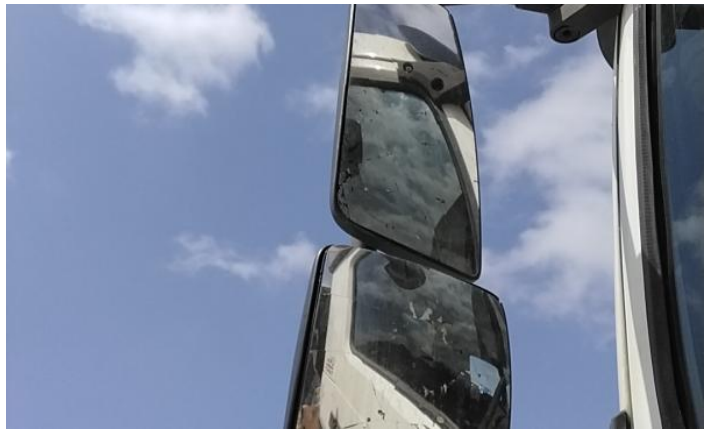
6: Door Mirror Glass ns  
Broken  
Replace

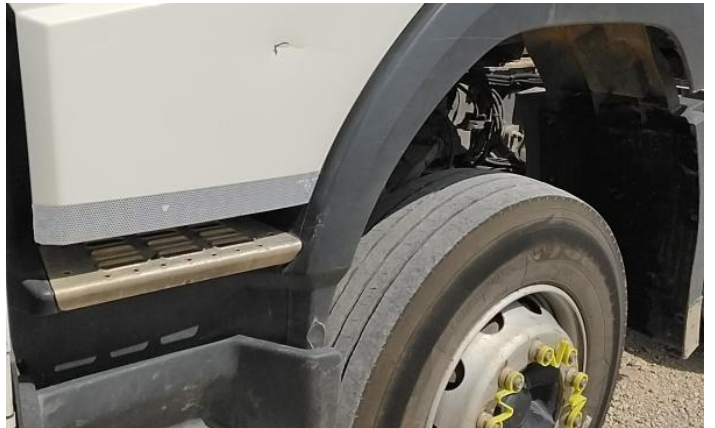
8: Wing Front Arch Extension ns  
Scuffed (Unpainted)  
Over 100mm

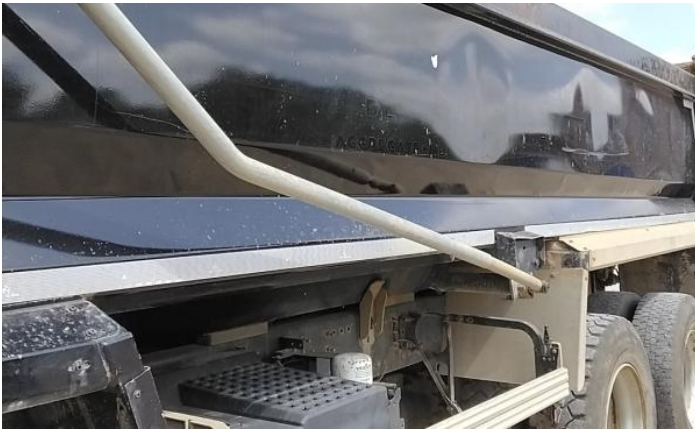
9: Qtr Panel nsr  
Scratched  
Over 25mm Thru Paint

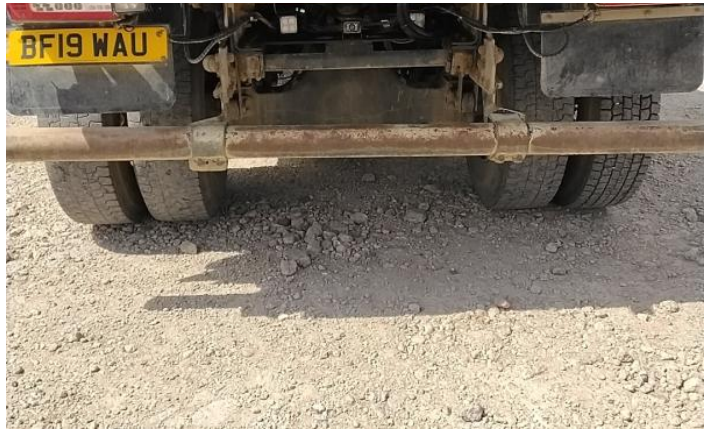
10: Bumper Rear  
Rusted  
Over 5mm

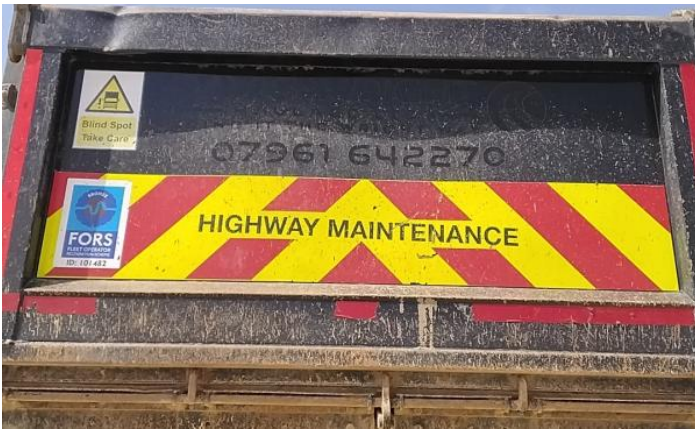
11: Door nsr  
Scratched  
Over 25mm Thru Paint

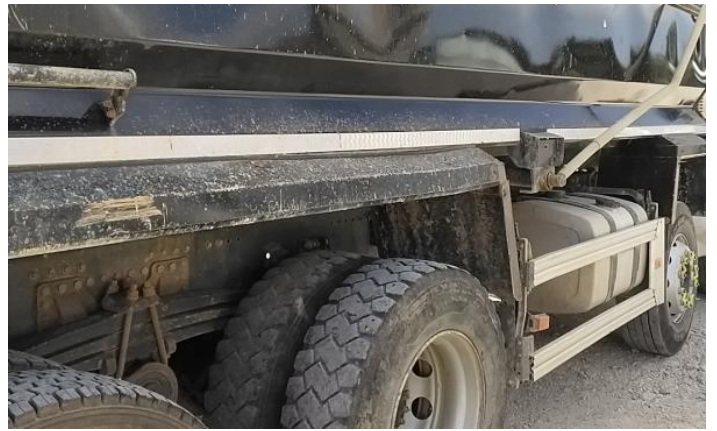
12: Qtr Panel osr  
Scratched  
Over 25mm Thru Paint

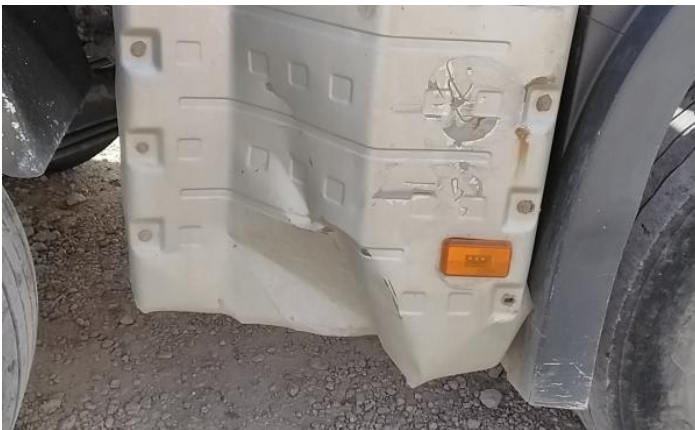
13: Qtr Panel osr  
Dented  
With Paint Damage

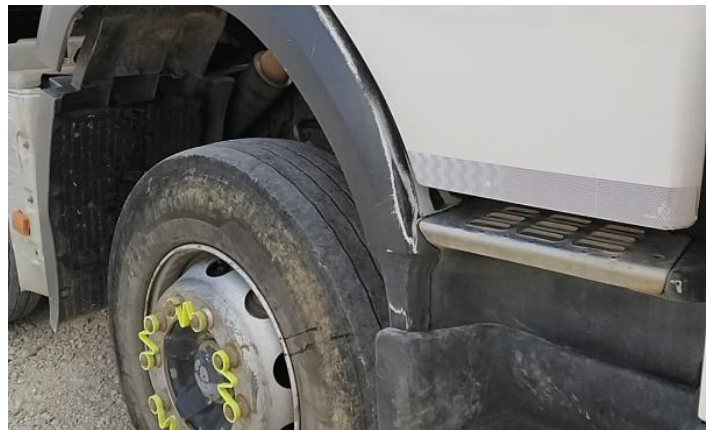
14: Wing Front Arch Extension os  
Scuffed (Unpainted)  
Over 100mm

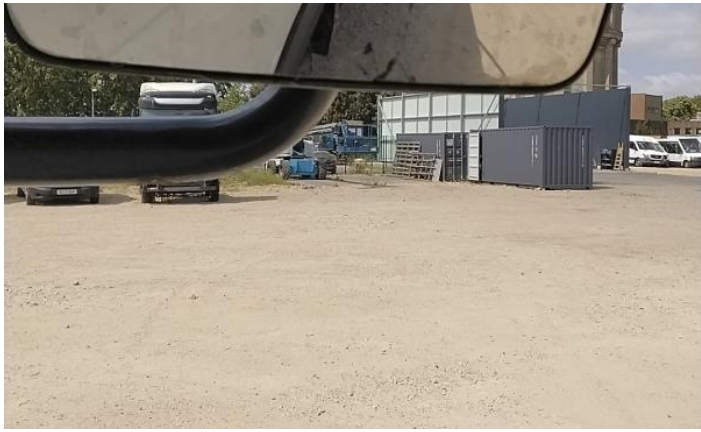
15: Door Mirror Glass os  
Broken  
Replace
