# VEHICLE INSPECTION REPORT

**NU18GKJ**

## Man TGX 18.420

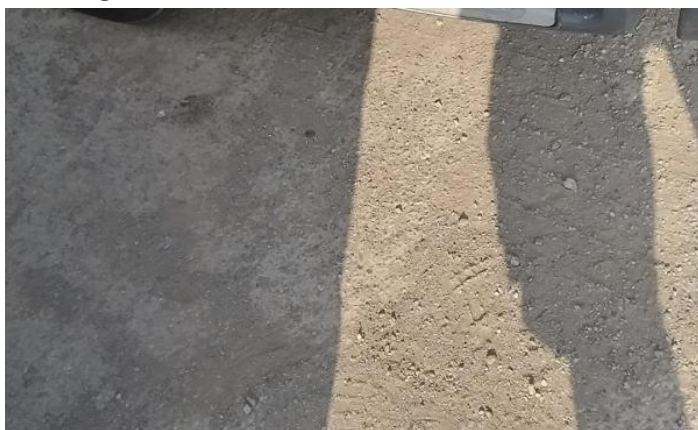
1: Bumper Front Moulding  
Scuffed (Unpainted)  
Over 100mm

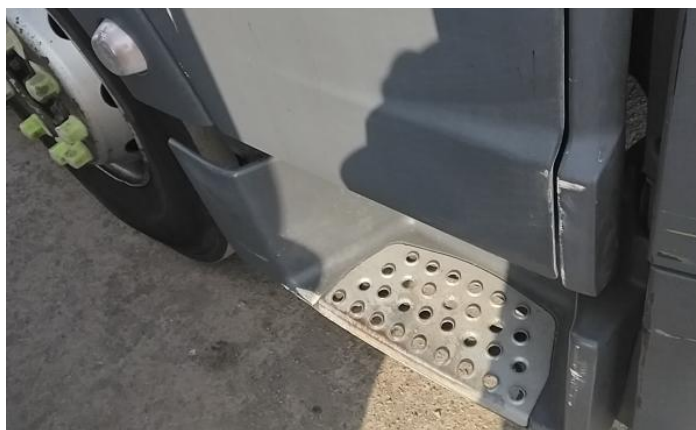
2: Door Moulding osf  
Scuffed (Unpainted)  
Over 100mm

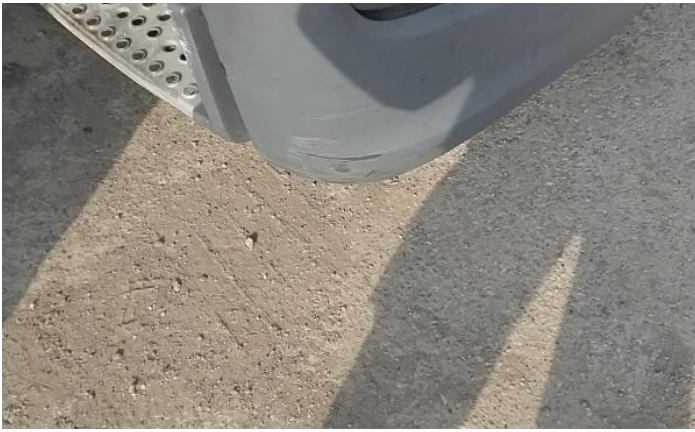
3: Bumper Front Moulding  
Scuffed (Unpainted)  
Over 100mm

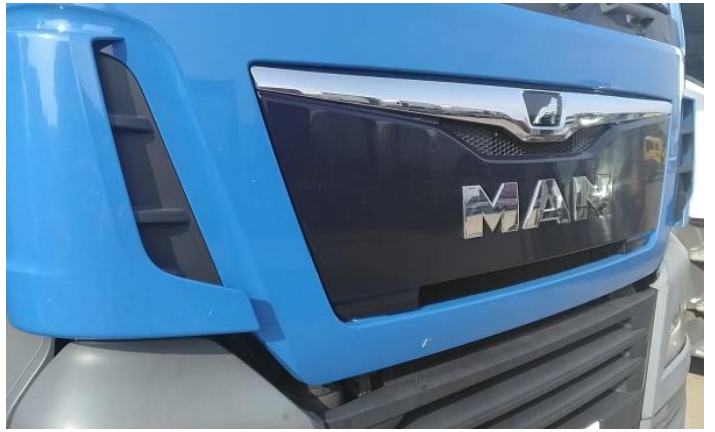
4: Bonnet  
Chipped  
Multiple Chips

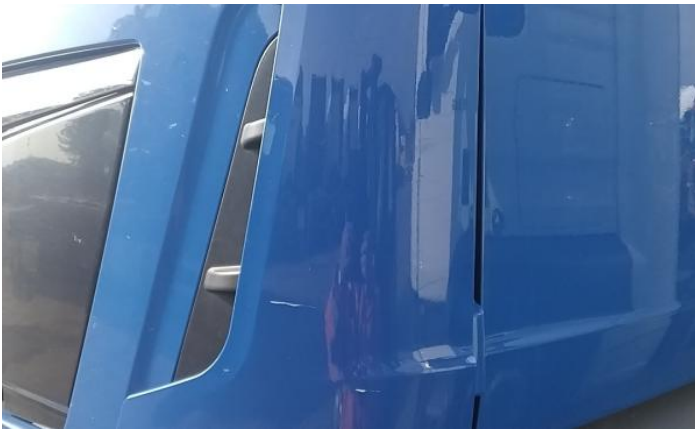
5: Panel Front  
Scratched  
Over 25mm Thru Paint

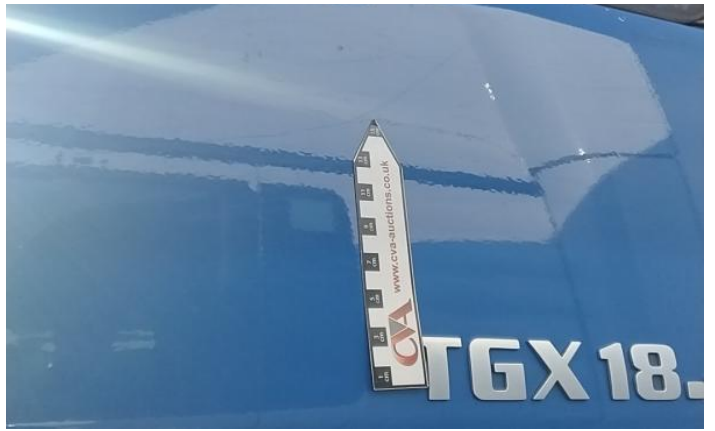
6: Door nsf  
Dented  
Over 30mm

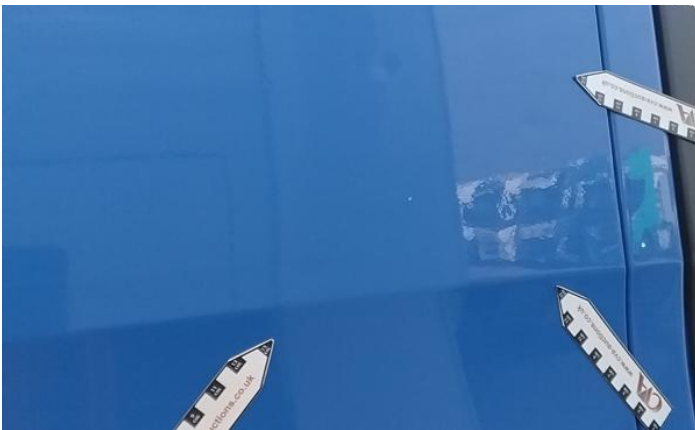
7: Qtr Panel nsr  
Dented  
Over 30mm

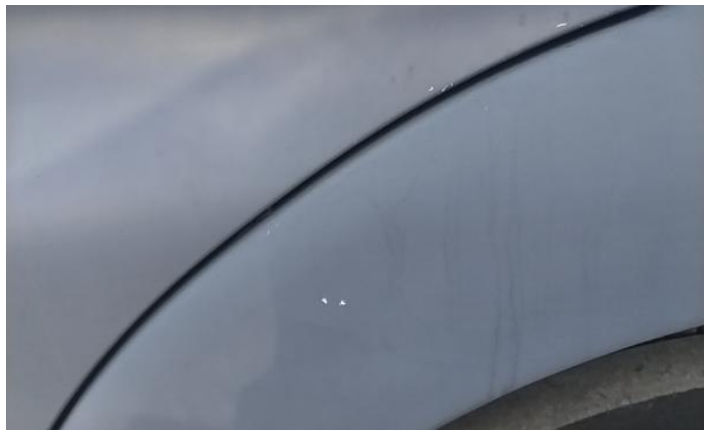
8: Door Moulding nsf  
Scuffed (Unpainted)  
UpTo 100mm

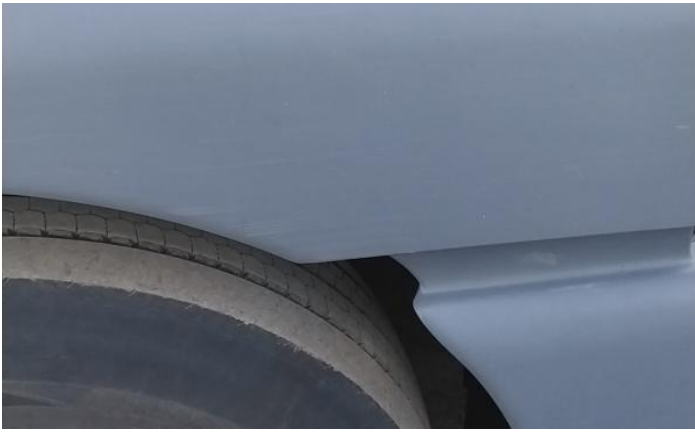
9: Qtr Panel Moulding ns  
Scuffed (Unpainted)  
Over 100mm

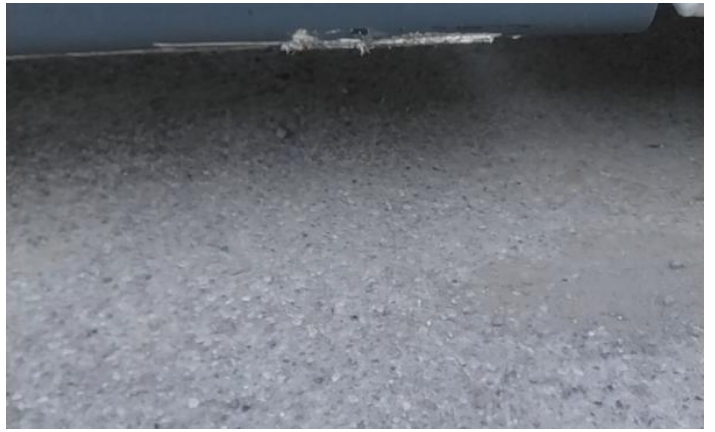
10: Qtr Panel Moulding os  
Broken  
Replace

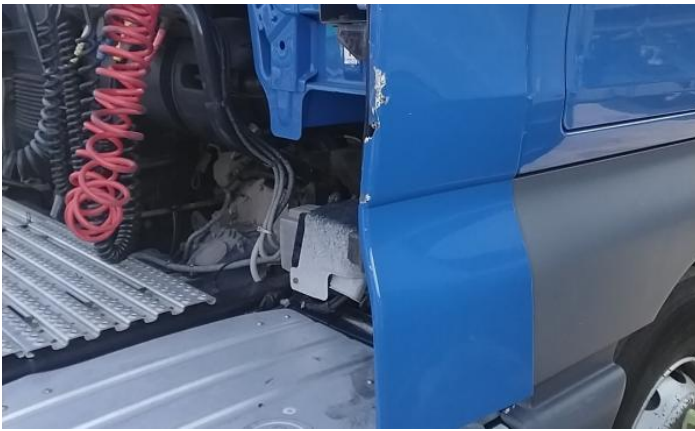
11: Qtr Panel Trim os  
Broken  
Replace

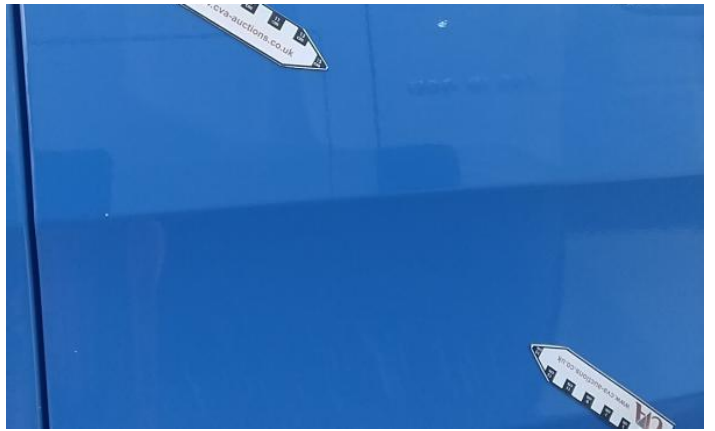
12: Qtr Panel osr  
Dented  
Over 30mm

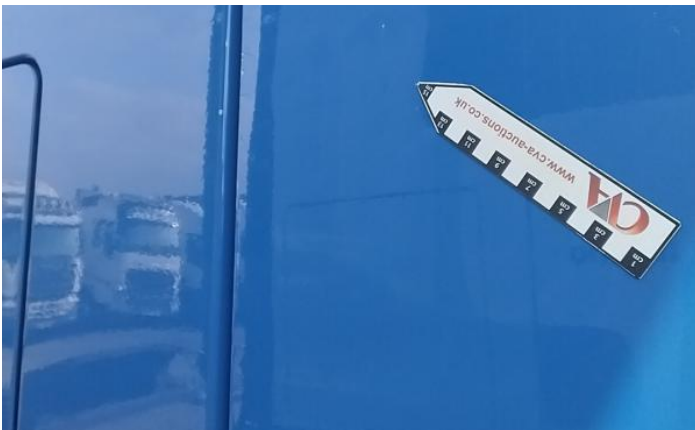
13: Door osf  
Dented  
With Paint Damage

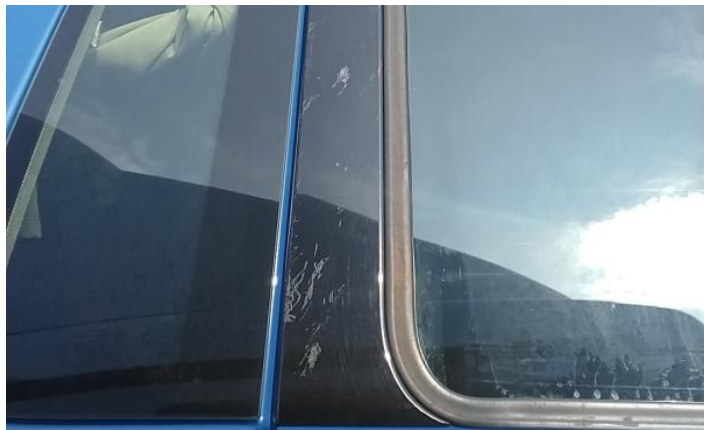
14: Door Moulding osf  
Scratched (Painted)  
Over 25mm Thru Paint

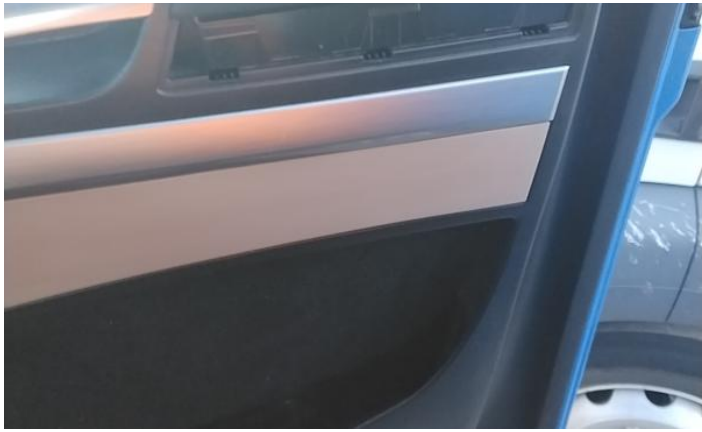
15: Door Pad osf  
Broken  
Replace
