# VEHICLE INSPECTION REPORT

**DX70TFK**

## Daf LF 180

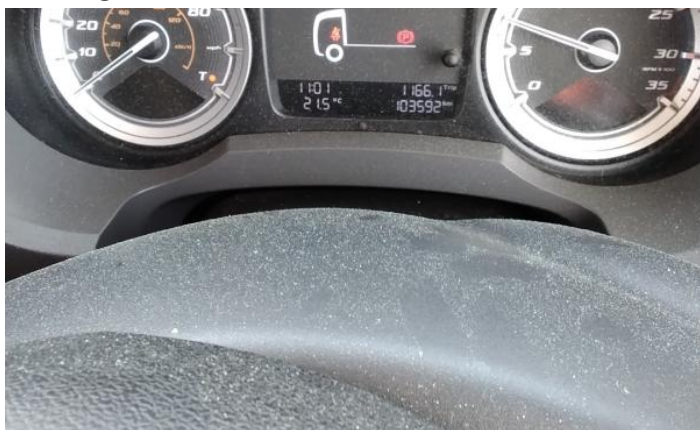
1: Dash Warning Lights  
Displayed  
No Action

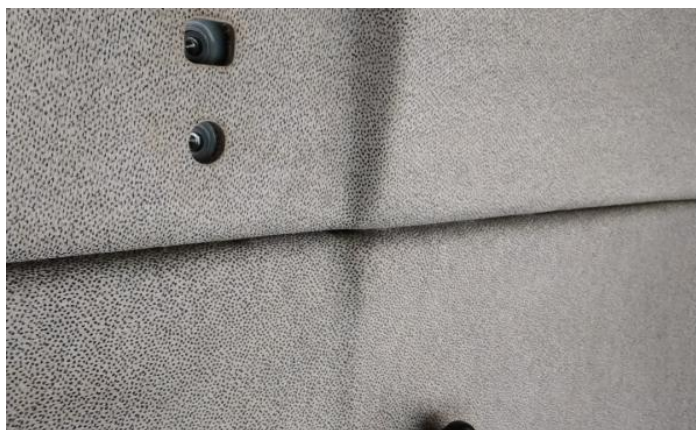
2: Fascia Trim  
Missing  
Replace

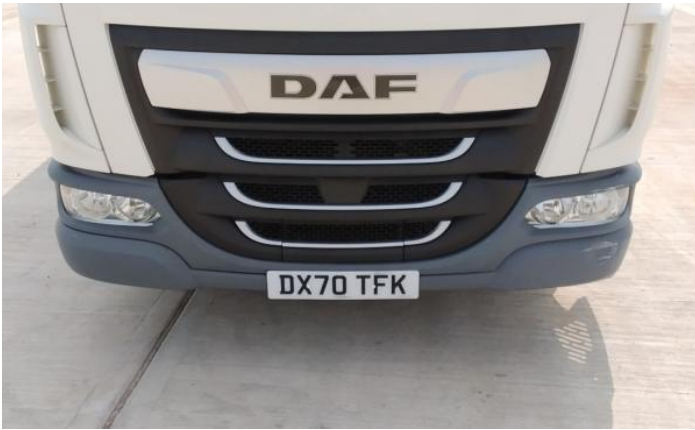
3: Bonnet  
Chipped  
Multiple Chips

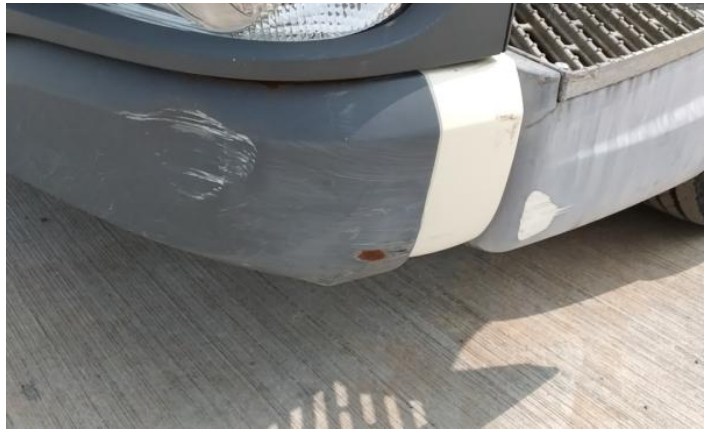
4: Bumper Front  
Dented  
With Paint Damage

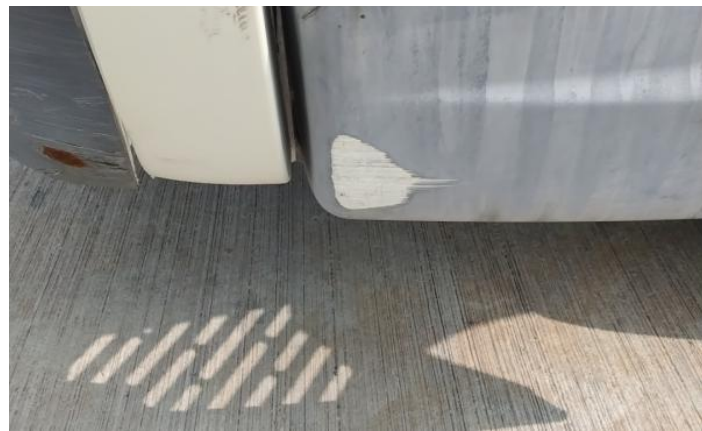
5: Wing nsf  
Cracked  
Replace

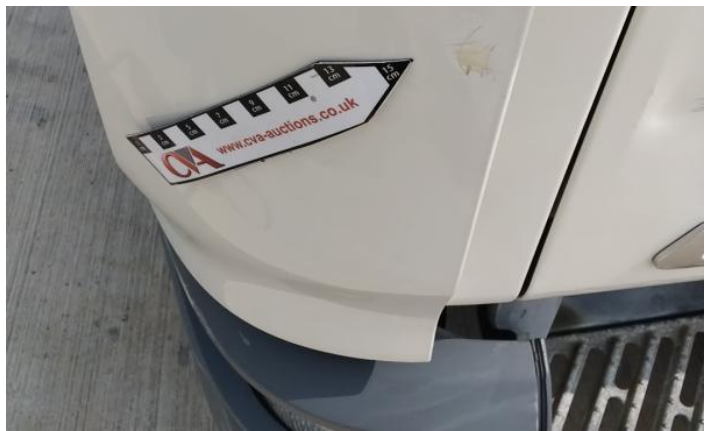
6: Moulding nsf Wing  
Scratched (Painted)  
Over 25mm Thru Paint

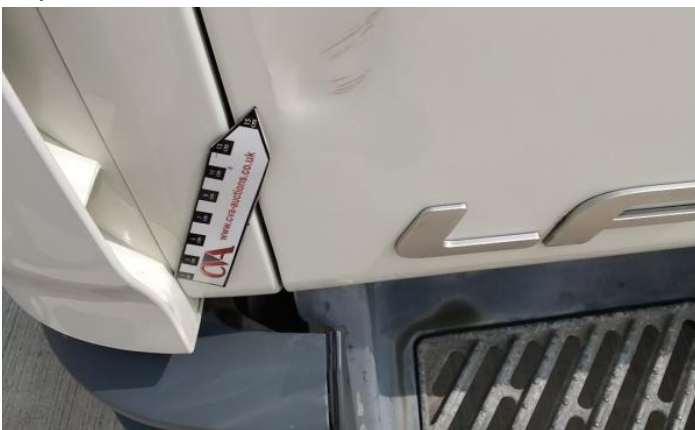
7: Door nsf  
Dented  
With Paint Damage

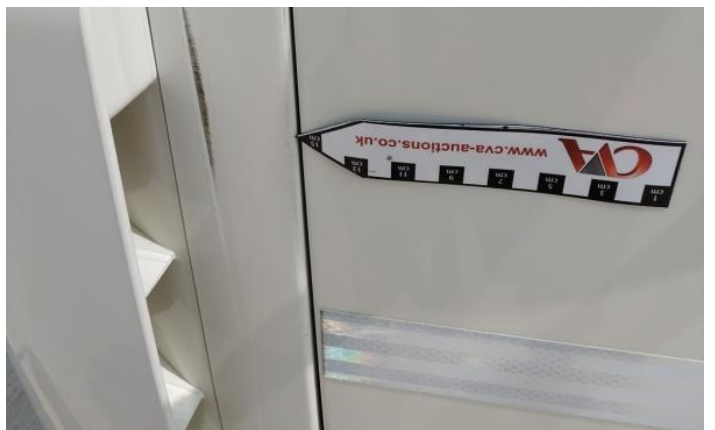
8: Wing nsf  
Scratched  
Over 25mm Thru Paint

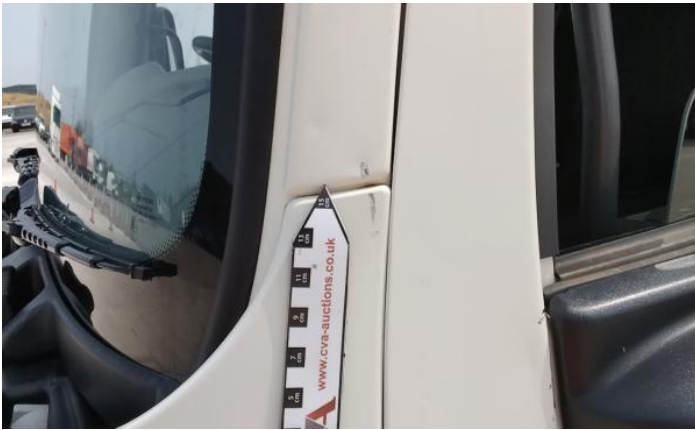
9: A Post ns  
Dented  
With Paint Damage

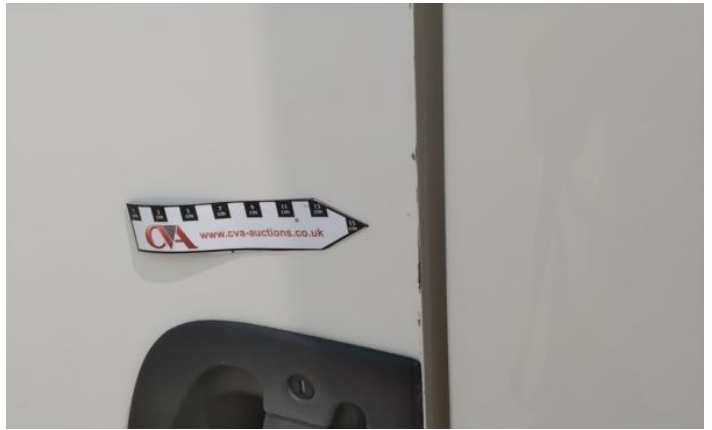
10: Door nsf  
Chipped  
Multiple Chips

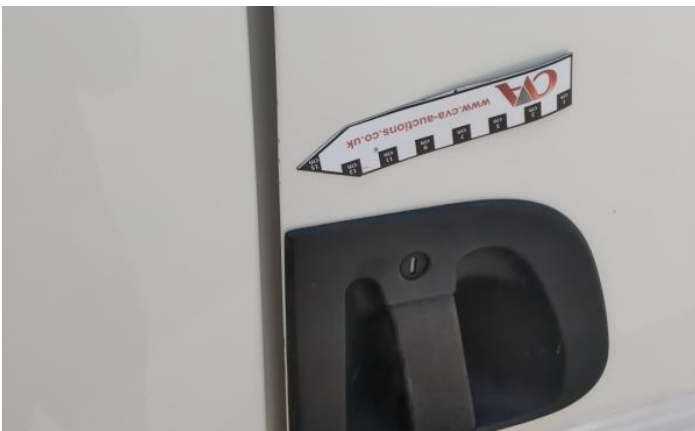
11: Door osf  
Chipped  
Multiple Chips

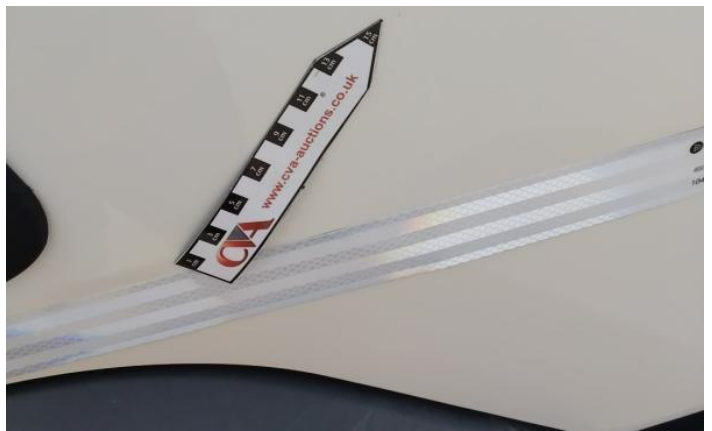
12: Door osf  
Dented  
With Paint Damage

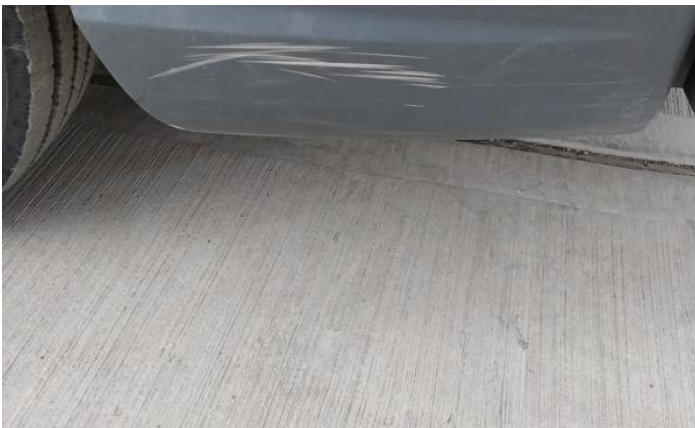
13: Wing osf  
Scratched  
Over 25mm Thru Paint

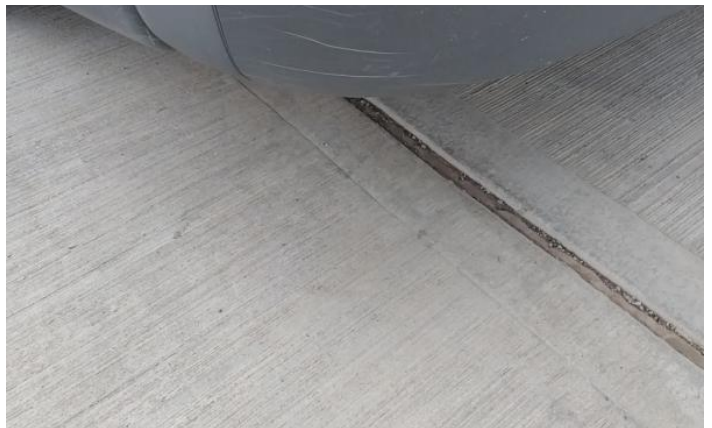
14: Bumper Front  
Scratched  
Over 100mm Thru Paint

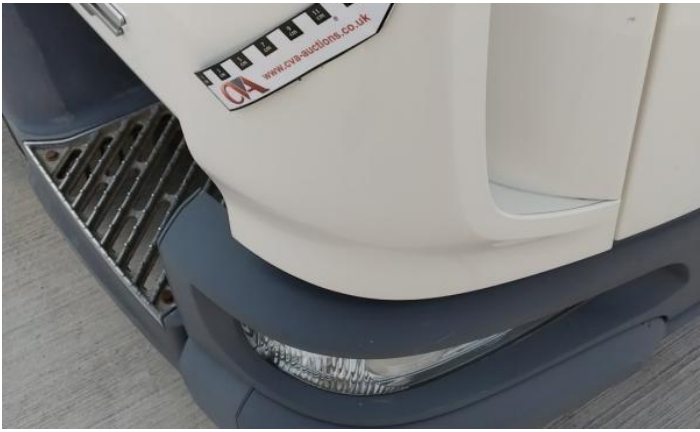
15: Moulding of Wing  
 Scratched (Painted)  
 Up To 25mm Thru Paint
