# VEHICLE INSPECTION REPORT

**KM68EJX**

## Mercedes-Benz Sprinter 314 CDI

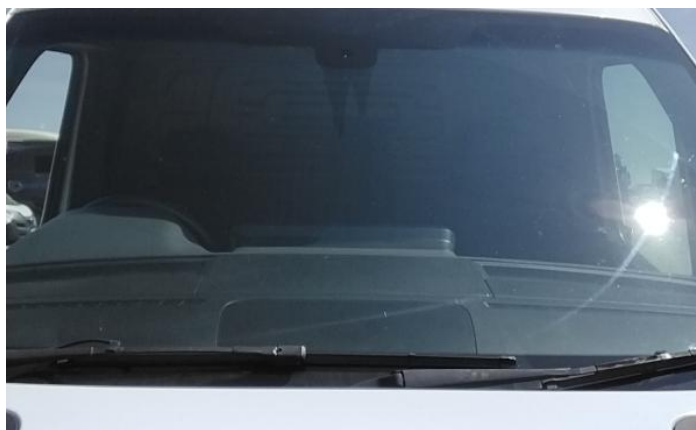
2: Screen Front  
Chipped  
UpTo 10mm

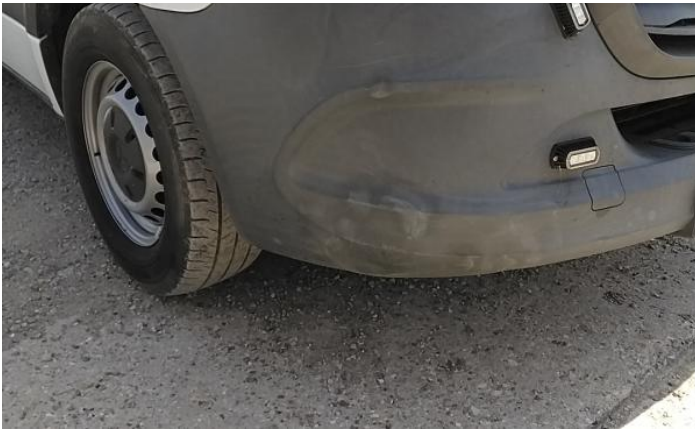
3: Bumper Front Moulding  
Scuffed (Unpainted)  
Over 100mm

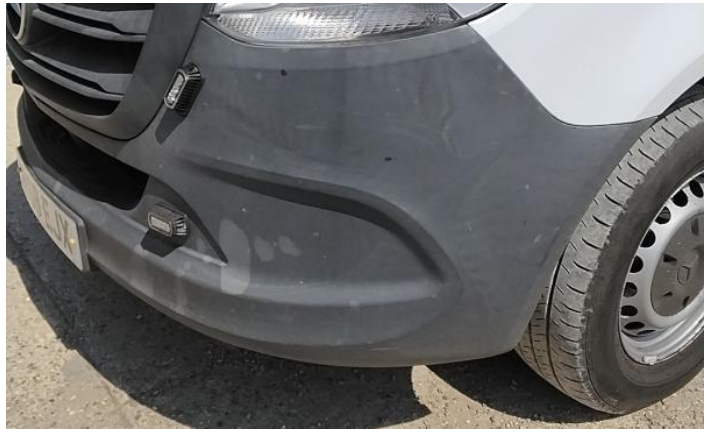
4: Bumper Front Moulding  
Scuffed (Unpainted)  
Over 100mm

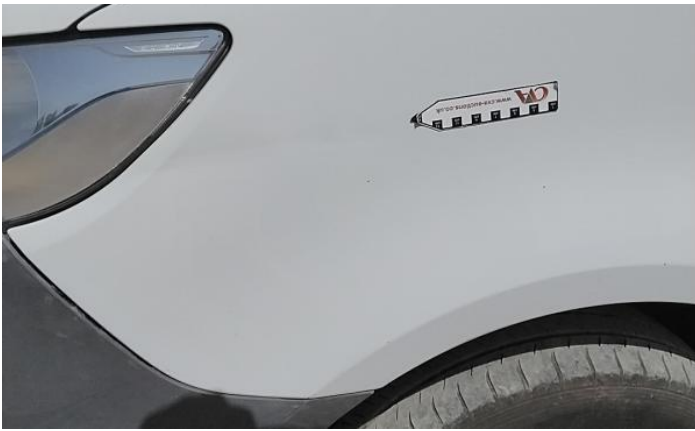
5: Wing nsf  
Dented  
Between 10mm + 30mm

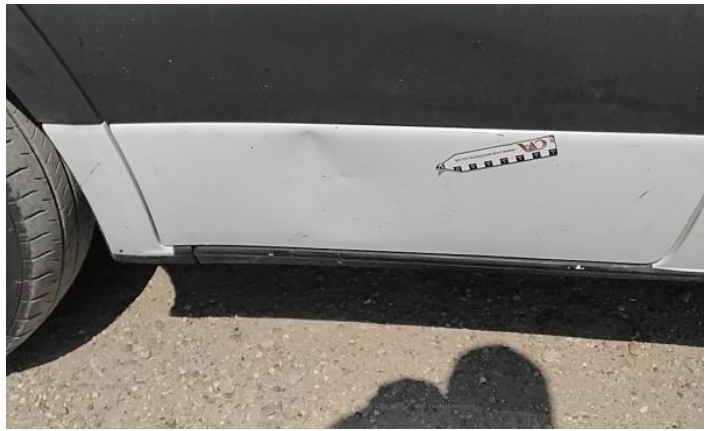
6: Door nsf  
Dented  
Over 30mm

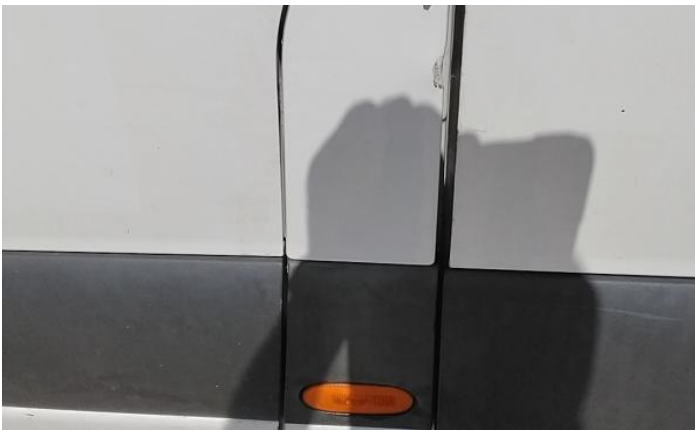
7: Fuel Flap  
Dented  
With Paint Damage

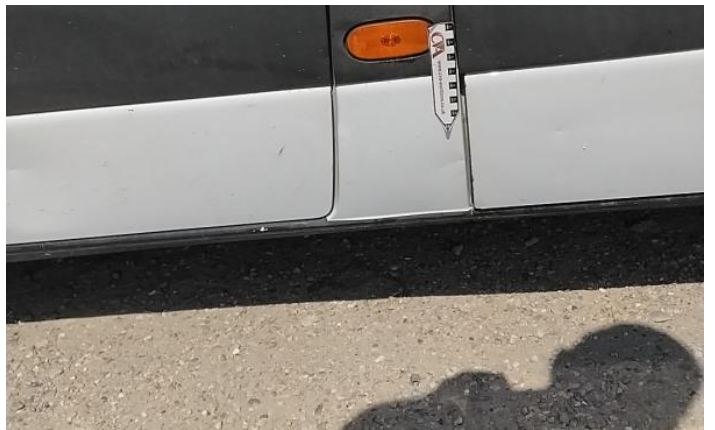
8: B Post ns  
Dented  
Between 10mm + 30mm

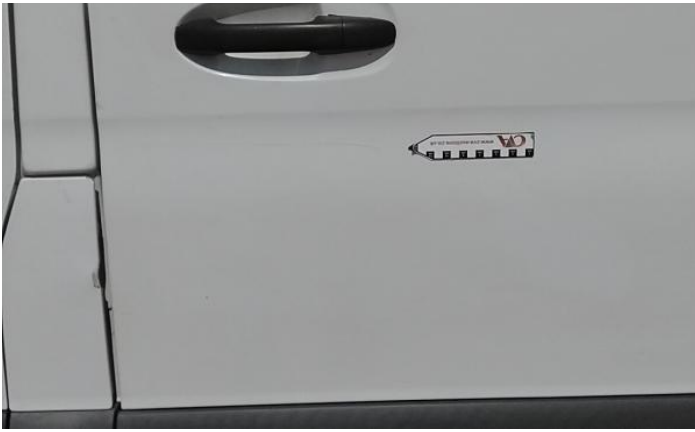
9: Door nsr  
Scratched  
Over 25mm Thru Paint

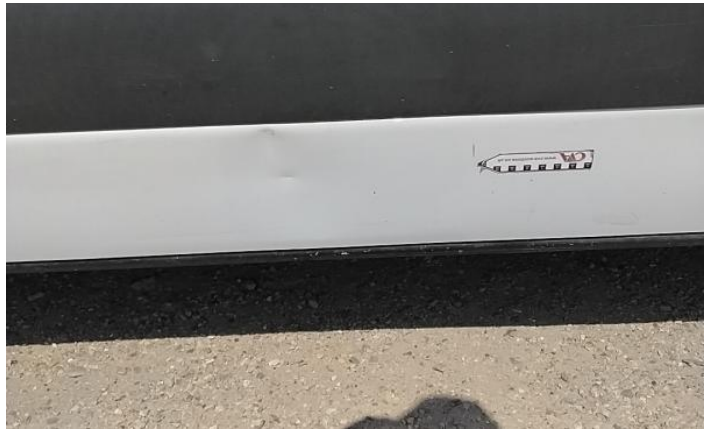
10: Door nsr  
Dented  
Between 10mm + 30mm

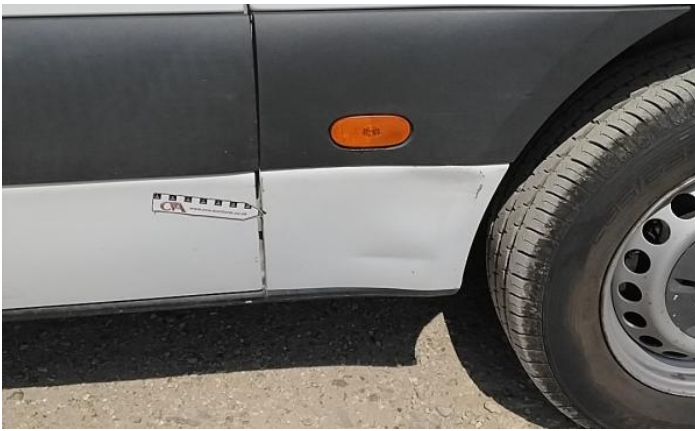
11: Qtr Panel nsr  
Dented  
Over 30mm

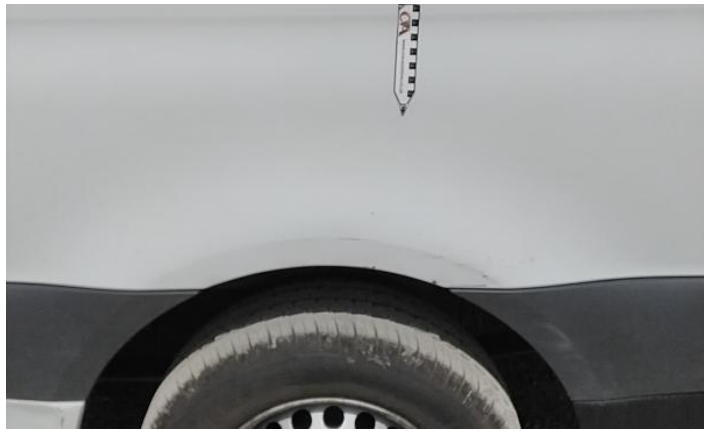
12: Qtr Panel nsr  
Scratched  
Over 25mm Thru Paint

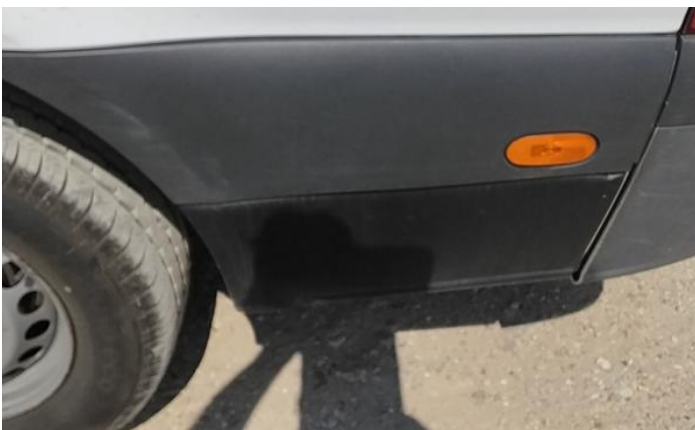
13: Qtr Panel Moulding os  
Scuffed (Unpainted)  
Over 100mm

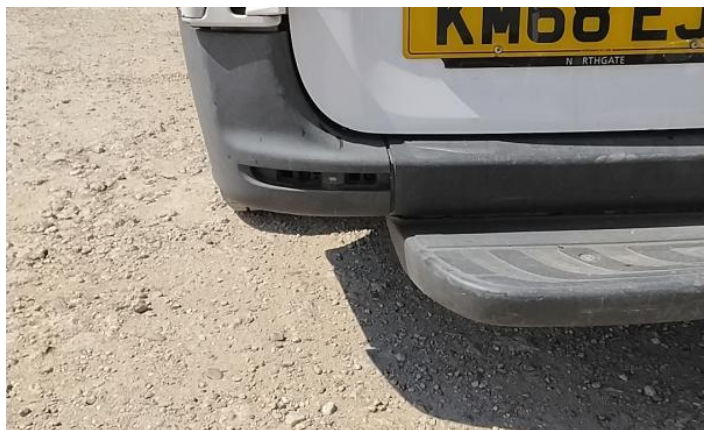
14: Reflector nsr  
Missing  
Replace

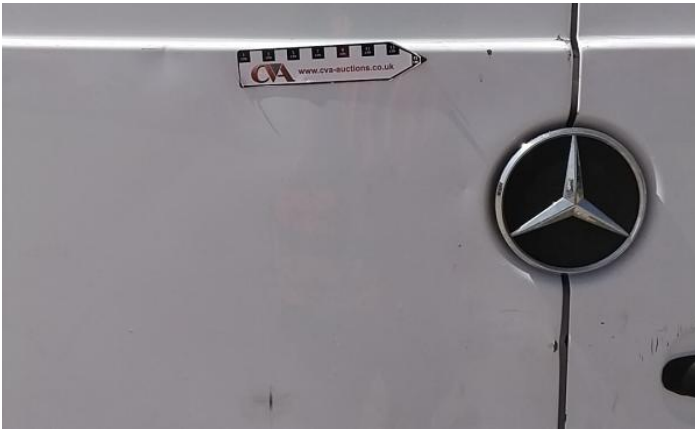
15: Door nsr  
Scratched  
UpTo 25mm Thru Paint

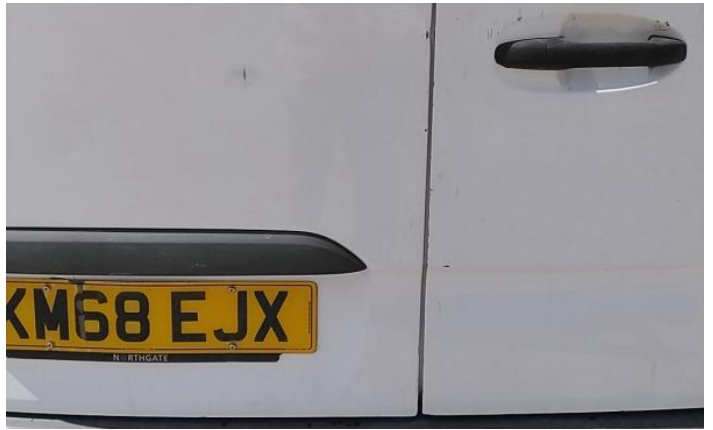
16: Door nsr  
Dented  
Between 10mm + 30mm

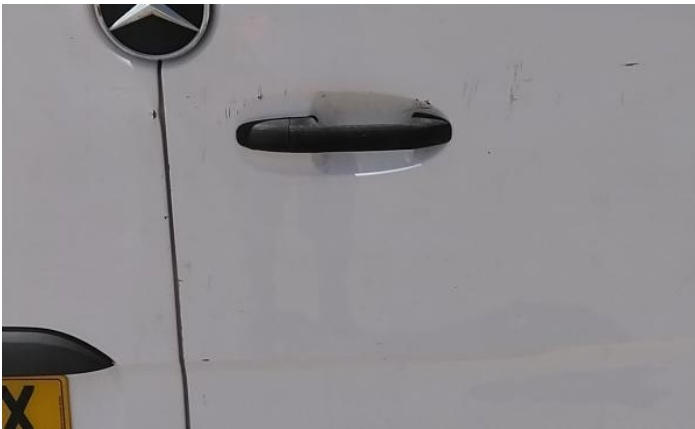
17: Door osr  
Scratched  
Over 25mm Thru Paint

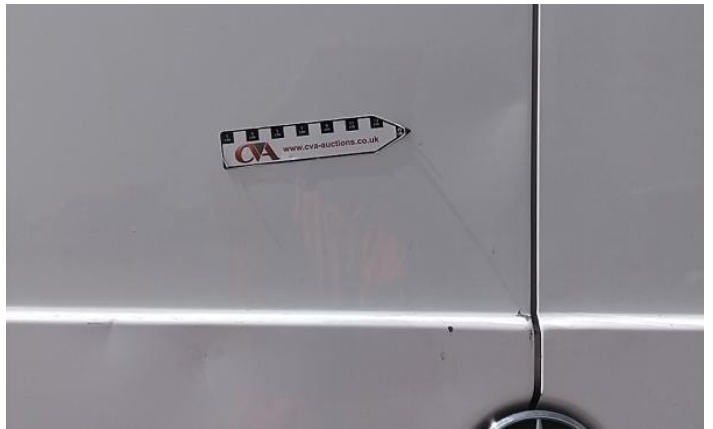
18: Door nsr  
Dented  
Between 10mm + 30mm

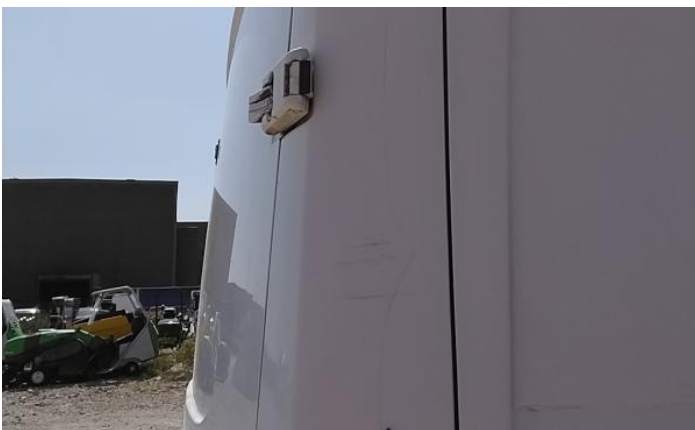
19: Qtr Panel osr  
Scratched  
Over 25mm Thru Paint

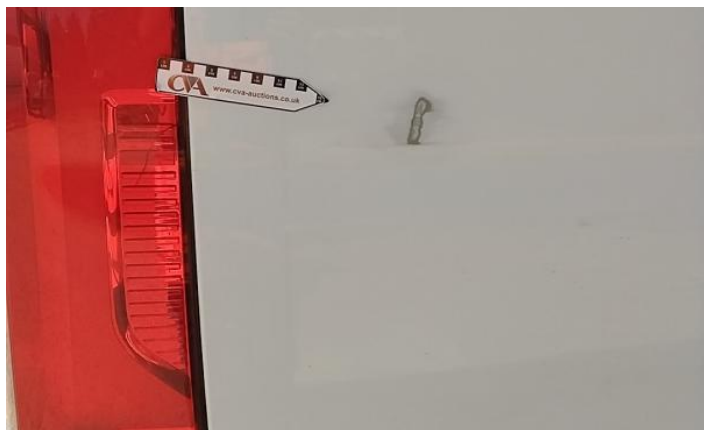
20: Qtr Panel osr  
Scratched  
Over 25mm Thru Paint

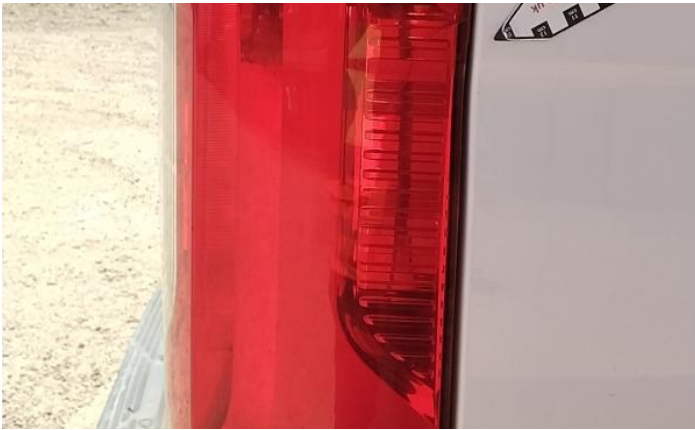
21: Lamp osr  
Broken  
Replace

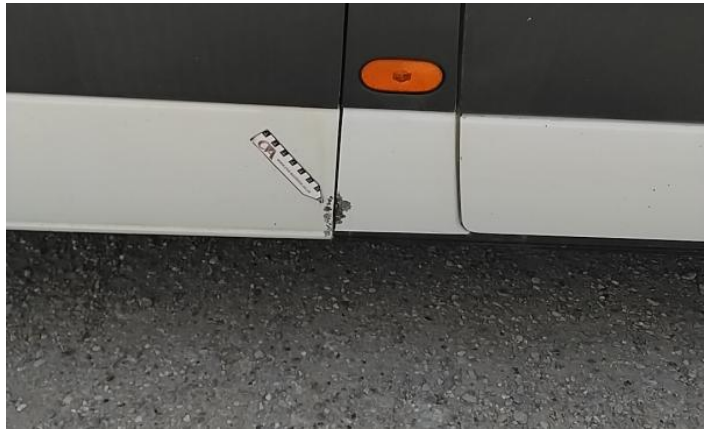
22: B Post os  
Scratched  
Over 25mm Thru Paint

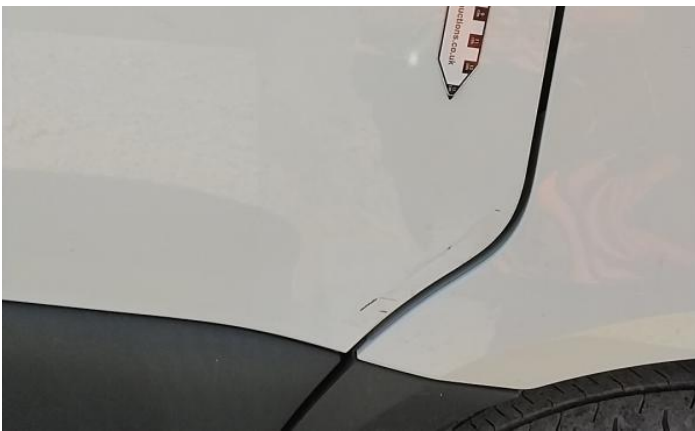
23: Door osf  
Dented  
With Paint Damage

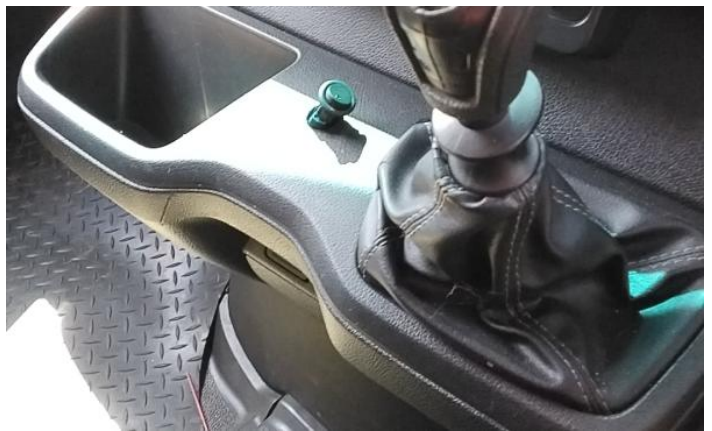
24: Switches And Controls  
Broken  
Replace
