# VEHICLE INSPECTION REPORT

**NU18HUA**

## Man TGX 18.420

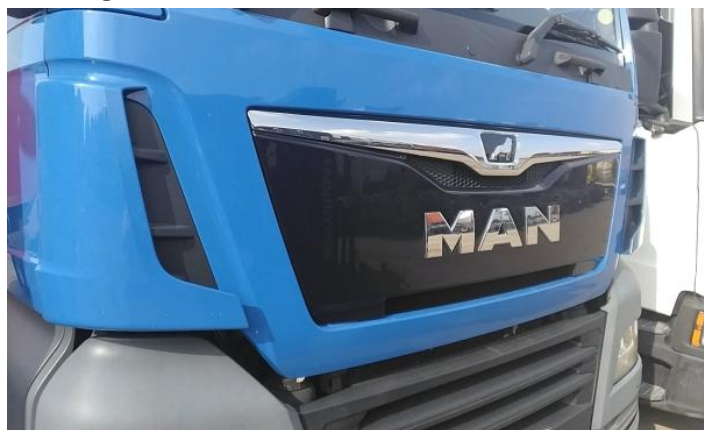
1: Bonnet  
Chipped  
Multiple Chips

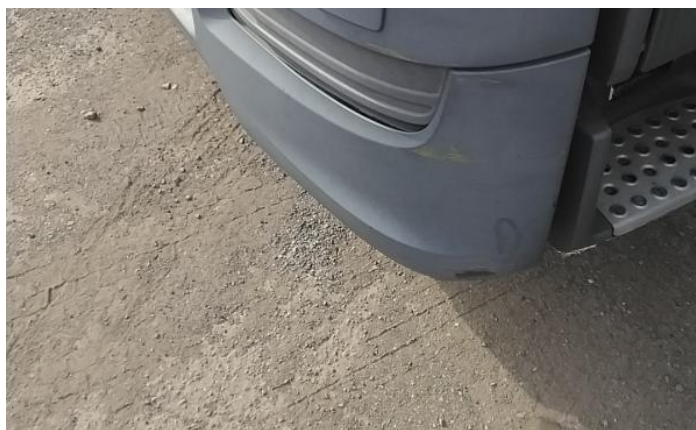
2: Bumper Front Moulding  
Scuffed (Unpainted)  
Over 100mm

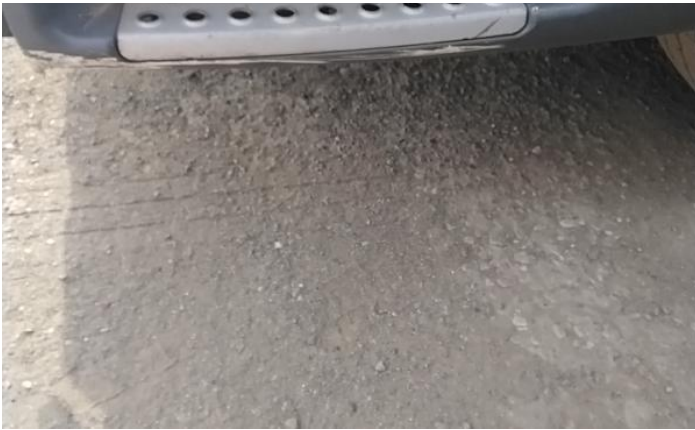
3: Bumper Front Moulding  
Scuffed (Unpainted)  
Over 100mm

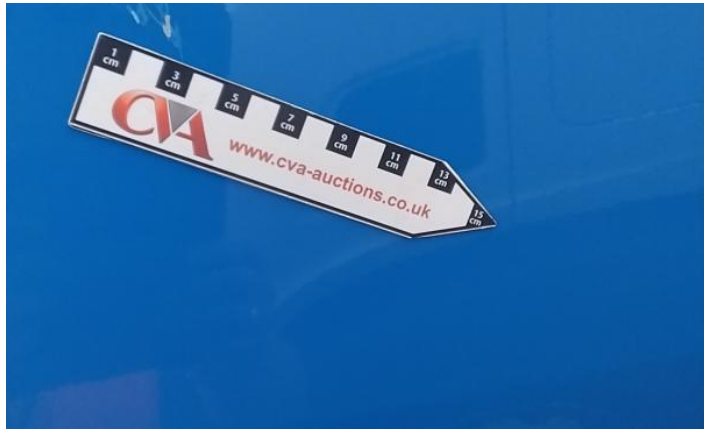
4: Door nsf  
Scratched  
Over 25mm Thru Paint

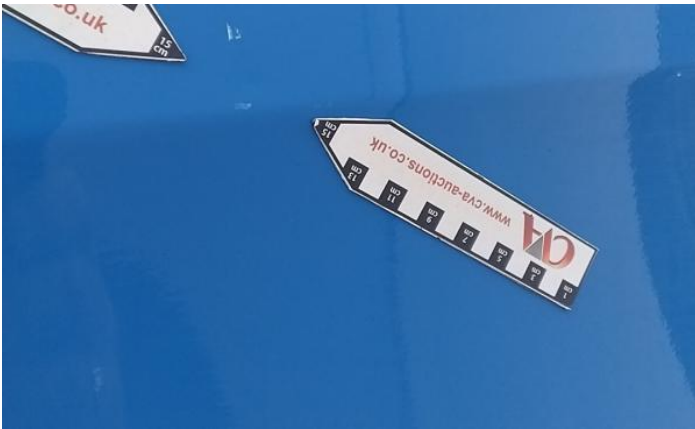
5: Qtr Panel nsr  
Dented  
With Paint Damage

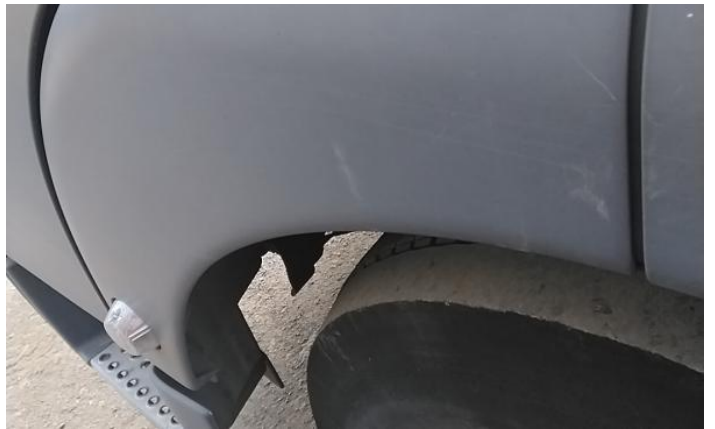
6: Wing nsf  
Scratched  
Over 25mm Thru Paint

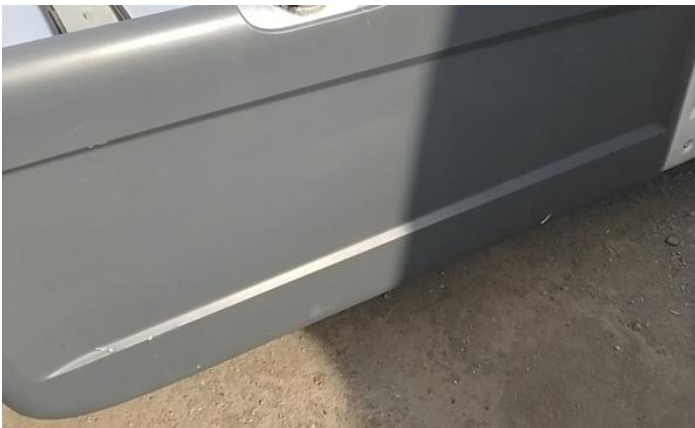
7: Qtr Panel Moulding os  
Scuffed (Unpainted)  
Over 100mm

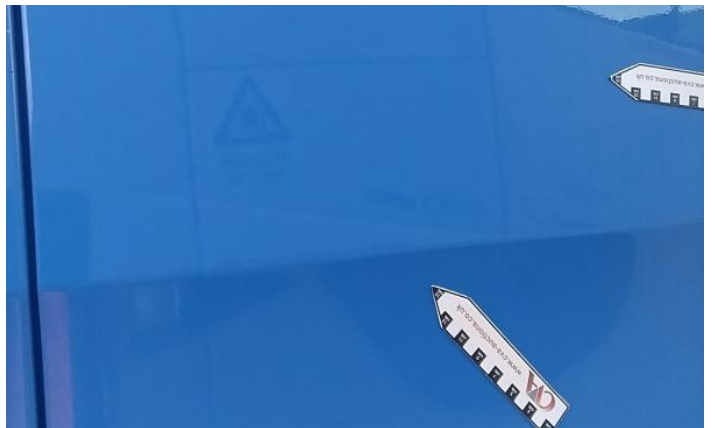
8: Qtr Panel osr  
Dented  
Over 30mm

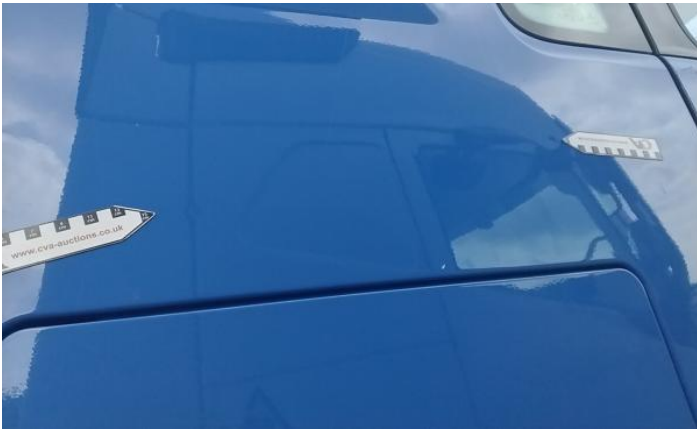
9: Qtr Panel osr  
Dented  
Over 30mm

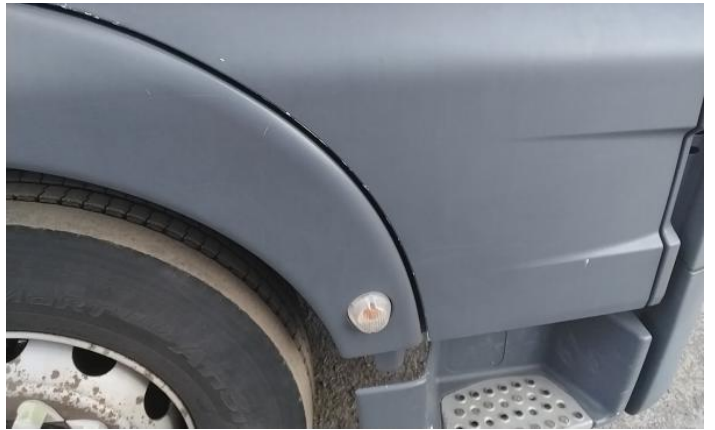
10: Door Moulding osf  
Scuffed (Unpainted)  
Over 100mm

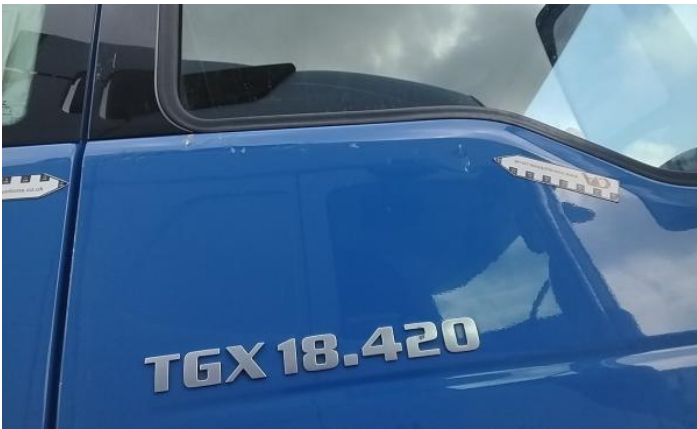
11: Door osf  
Dented  
With Paint Damage

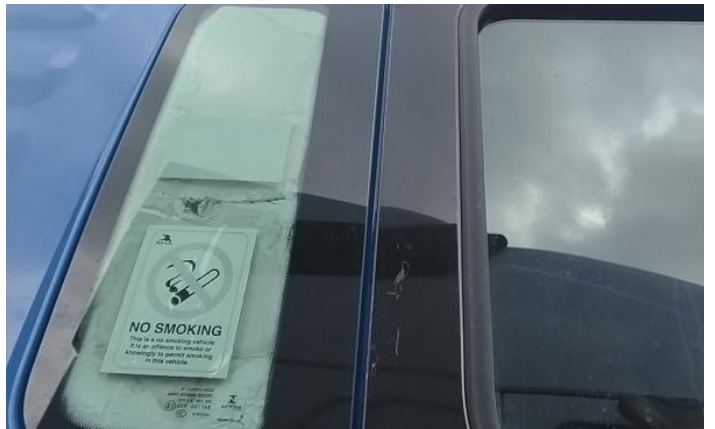
12: Door Moulding osf  
Broken  
Replace
