# VEHICLE INSPECTION REPORT

**DX20UKS**

## Daf LF 180

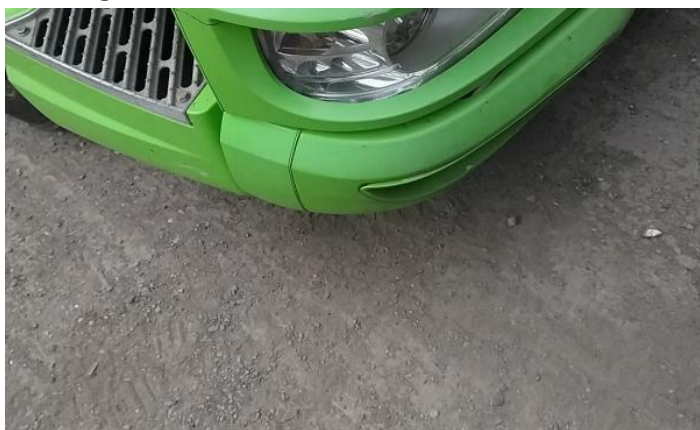
1: Panel Front  
Cracked  
Replace

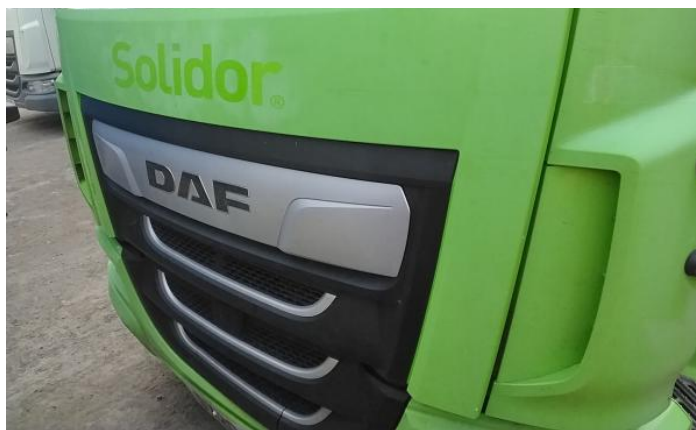
2: Bonnet  
Chipped  
Multiple Chips

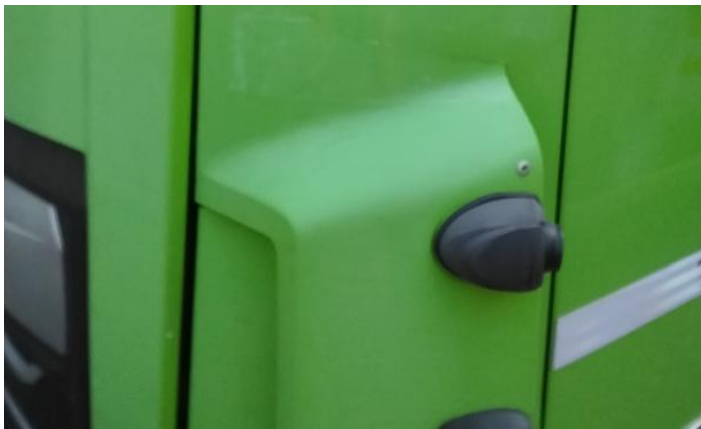
3: Panel Front  
Cracked  
Replace

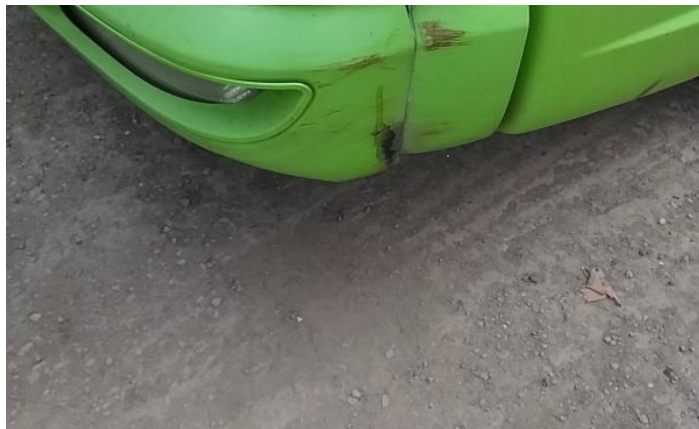
4: Bumper Front  
Dented  
With Paint Damage

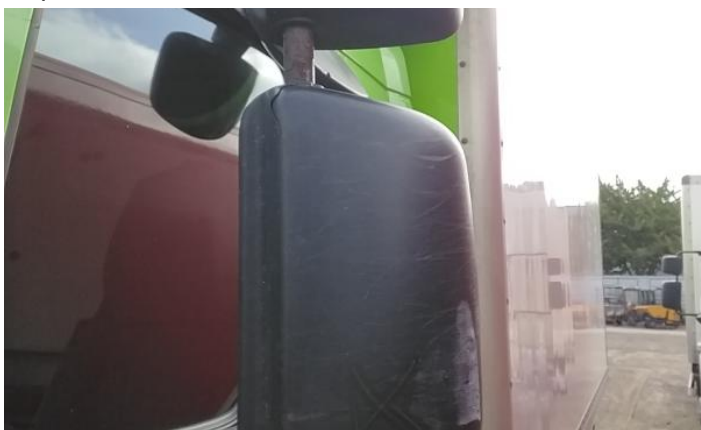
5: Door Mirror Assy nsf  
Broken  
Replace

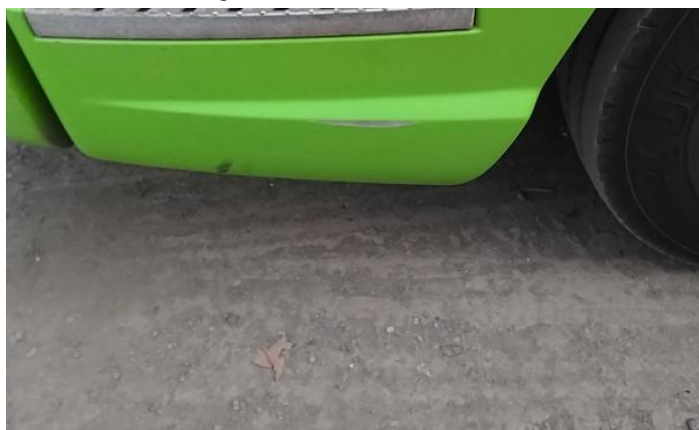
6: Bumper Front Moulding  
Scratched (Painted)  
Over 25mm Thru Paint

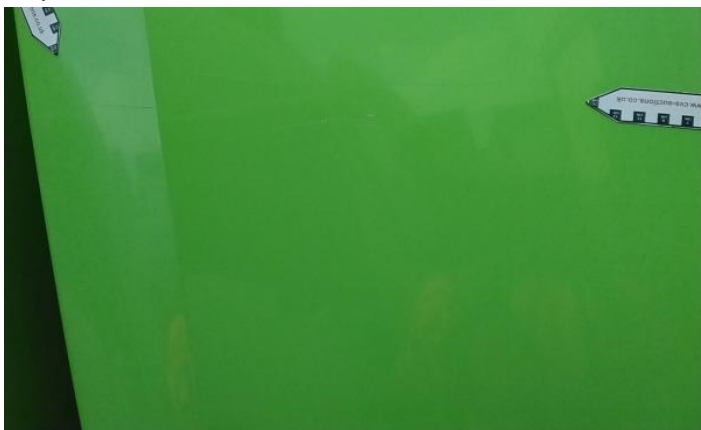
7: Qtr Panel osr  
Scratched  
Over 25mm Thru Paint

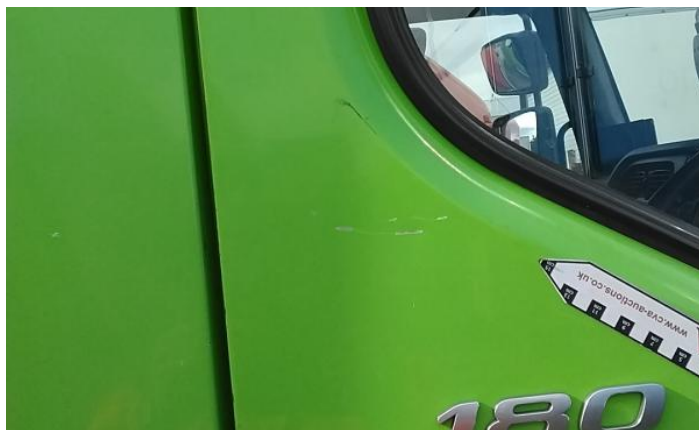
8: Door osf  
Scratched  
Over 25mm Thru Paint

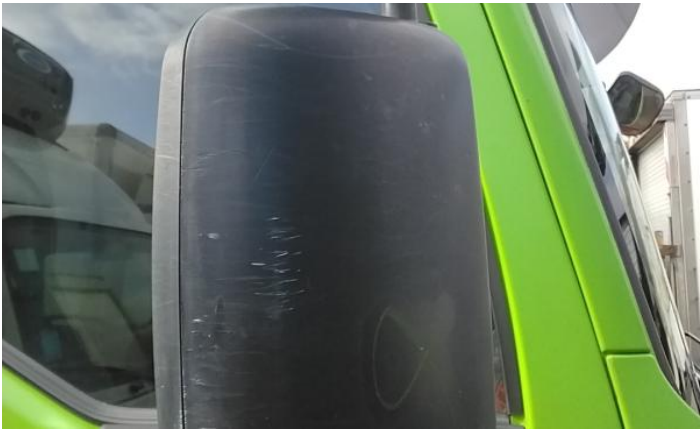
9: Door Mirror Assy osf  
Scuffed (Unpainted)  
Over 100mm

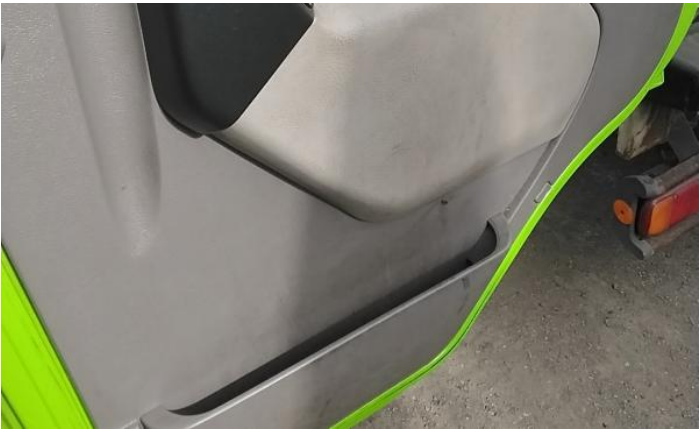
10: Door Pad osf  
Soiled  
Heavy
