# VEHICLE INSPECTION REPORT

**FL70VBJ**

## DAF CF 320

HILLEND PK21 BODY, TERBERG SINGLE BIN LIFT

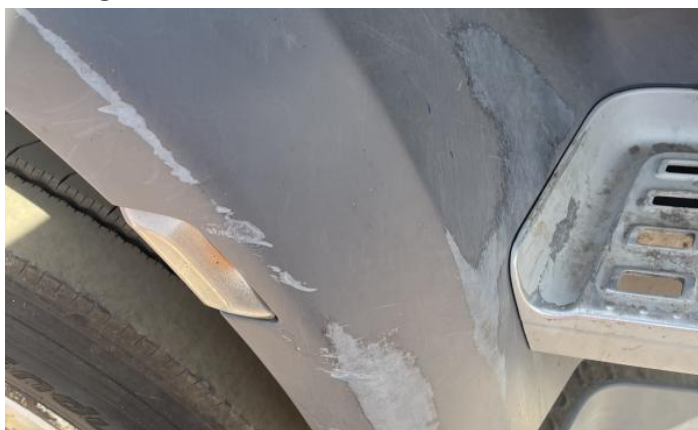
1: Door Moulding of  
Scuffed (Unpainted)  
Over 100mm

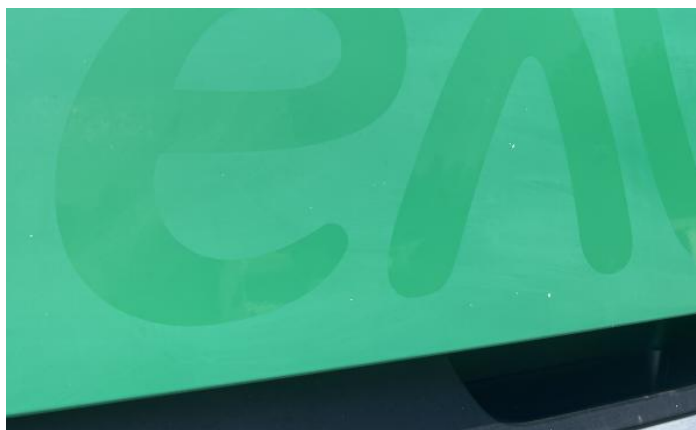
2: Bonnet  
Chipped  
1 To 5

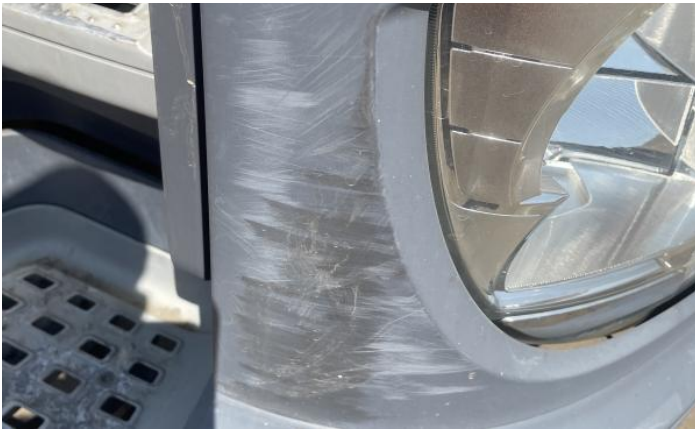
3: Bumper Front Moulding  
Scuffed (Unpainted)  
Over 100mm

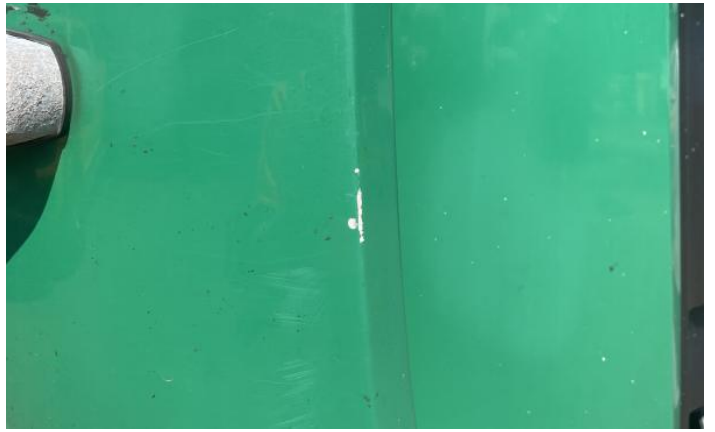
4: Wing osf  
Scratched  
Over 25mm Thru Paint

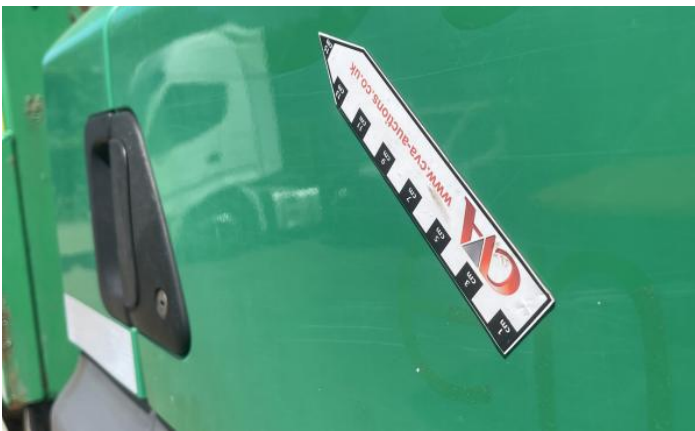
5: Door osf  
Dented  
Over 30mm

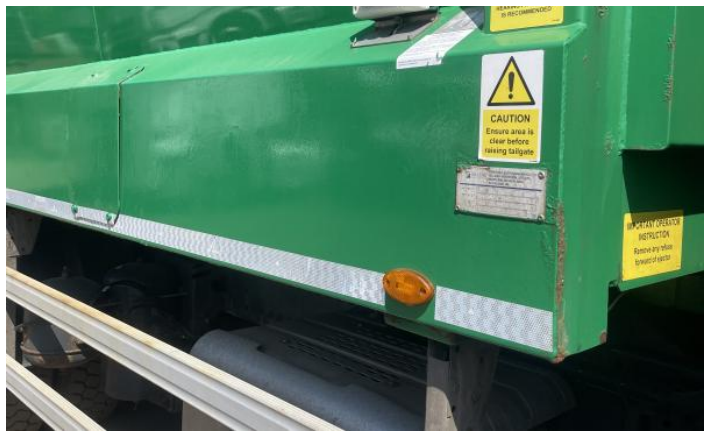
6: Qtr Panel osr  
Rusted  
Over 5mm

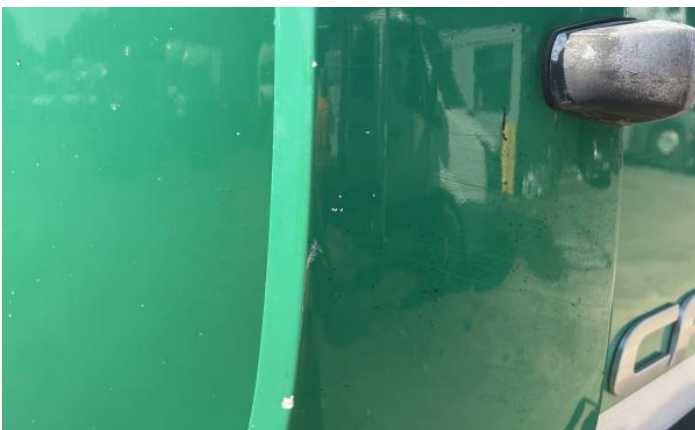
7: Wing nsf  
Scratched  
Over 25mm Thru Paint

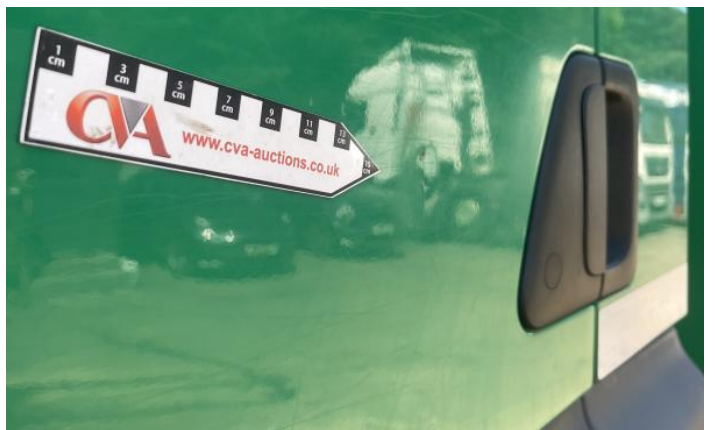
8: Door nsf  
Dented  
Over 30mm

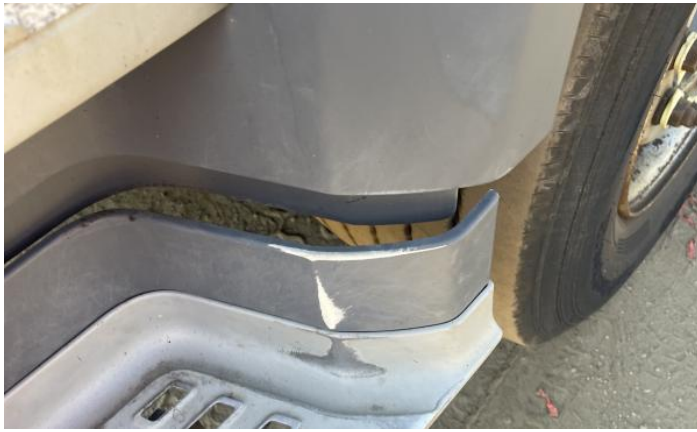
9: Door Moulding osf  
Scuffed (Unpainted)  
Over 100mm

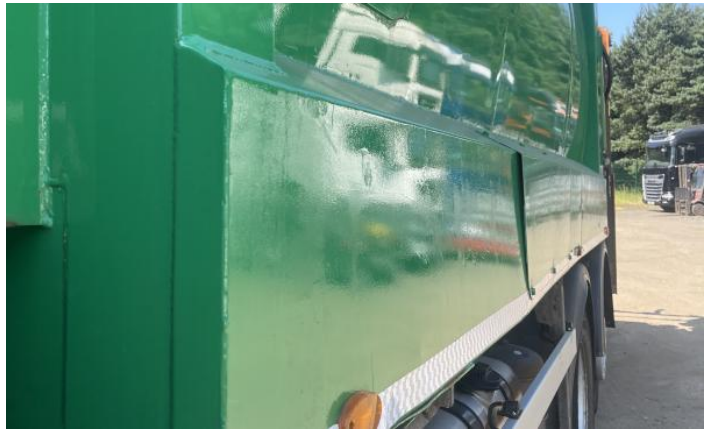
10: Qtr Panel nsr  
Rusted  
Over 5mm
