# VEHICLE INSPECTION REPORT

**VU15RMY**

## Scania R 520 V8

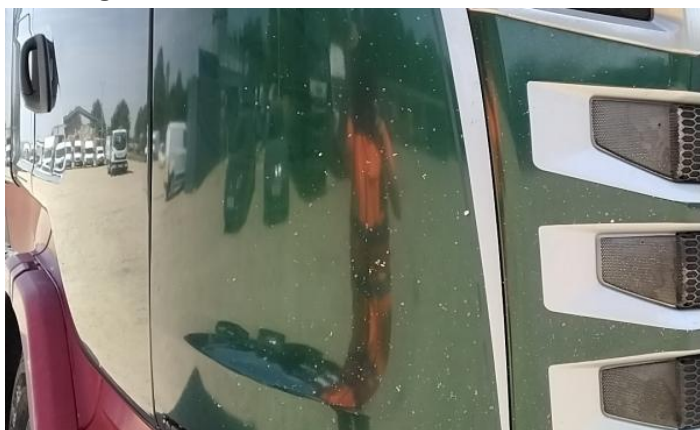
1: Wing of  
Chipped  
Multiple Chips

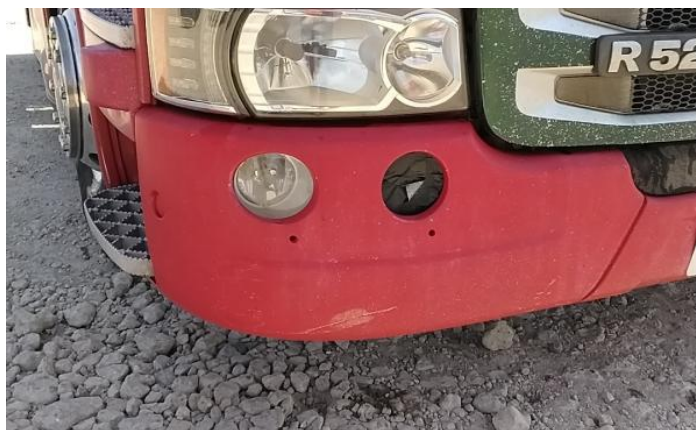
2: Bumper Front  
Scratched  
25 to 100mm Thru Paint

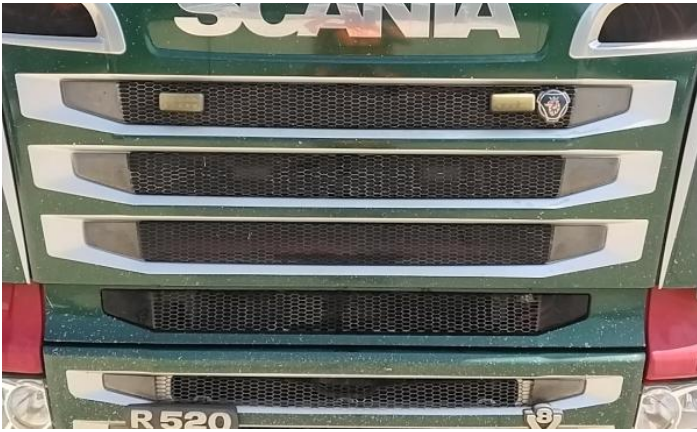
3: Bonnet  
Chipped  
Multiple Chips

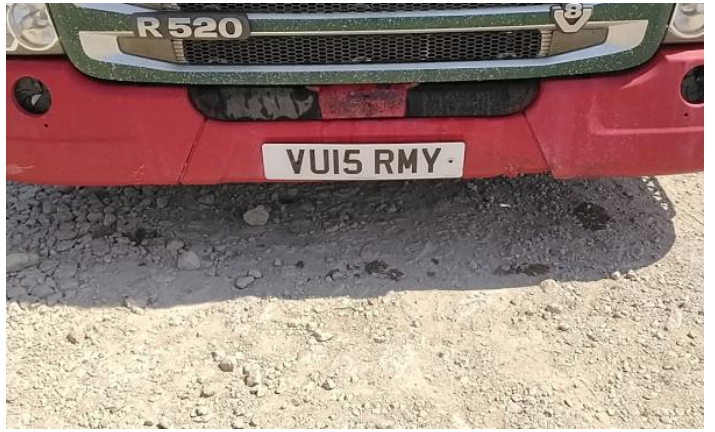
4: Bumper Front  
Chipped  
Multiple Chips

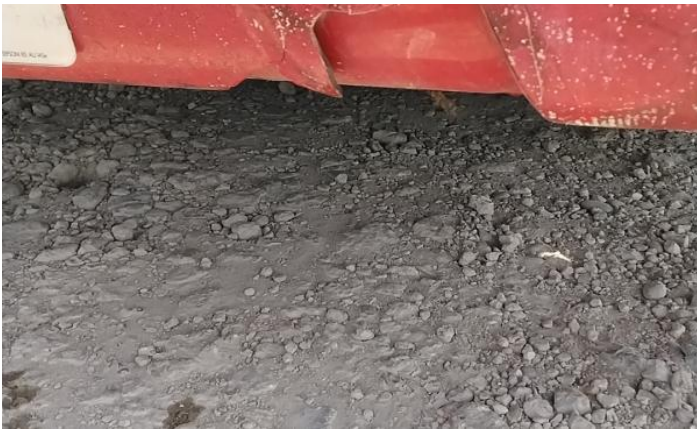
5: Bumper Front Moulding  
Broken  
Replace

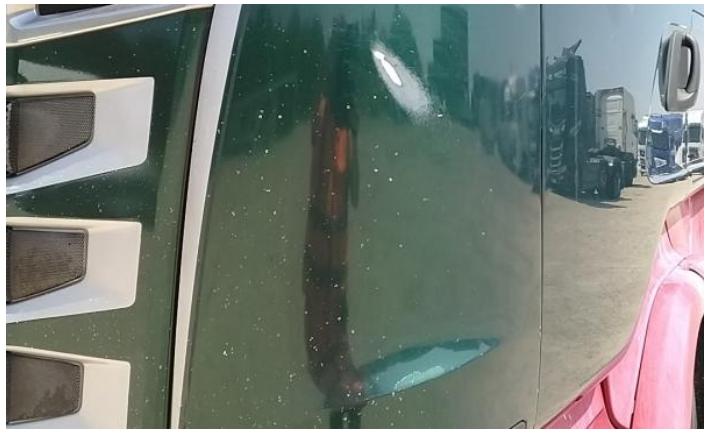
6: Wing nsf  
Scratched  
Over 25mm Thru Paint

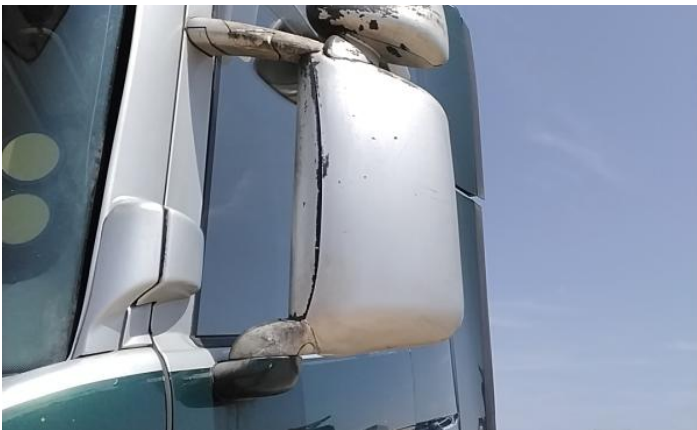
7: Door Mirror Assy nsf  
Scratched (Painted)  
Over 25mm Thru Paint

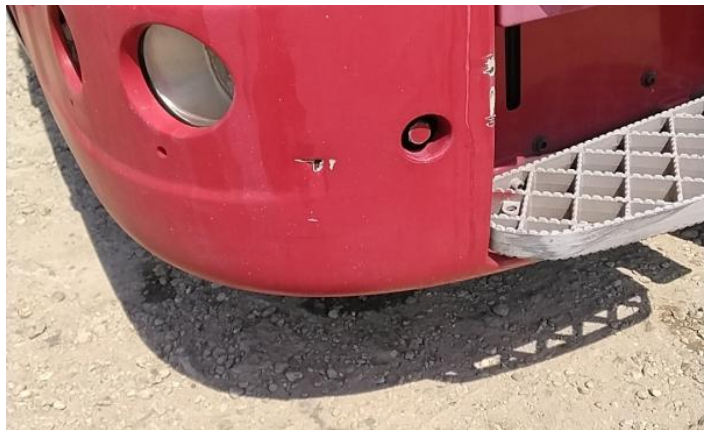
8: Bumper Front  
Scratched  
25 to 100mm Thru Paint

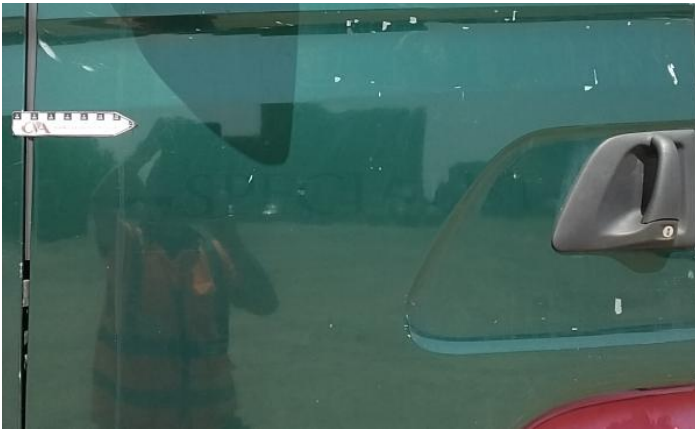
9: Door nsf  
Scratched  
Over 25mm Thru Paint

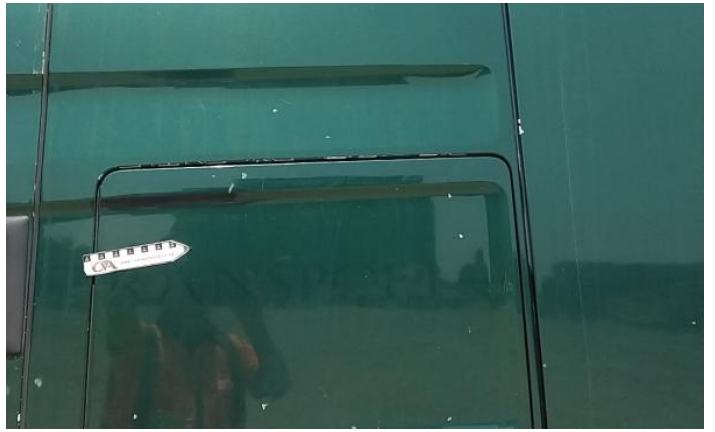
10: Qtr Panel nsr  
Scratched  
Over 25mm Thru Paint

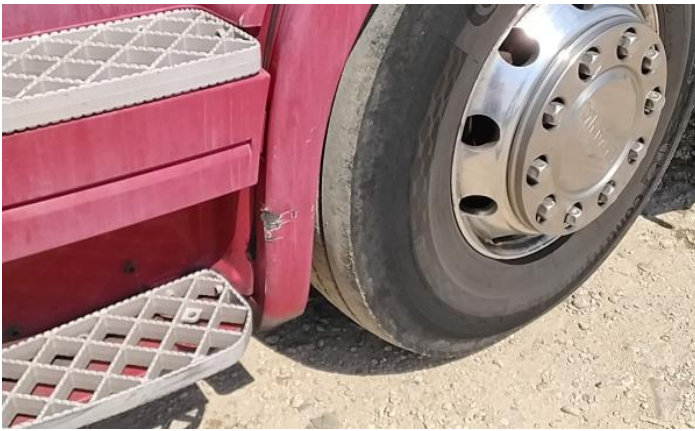
11: Wing Front Arch Extension ns  
Scratched (Painted)  
Over 25mm Thru Paint

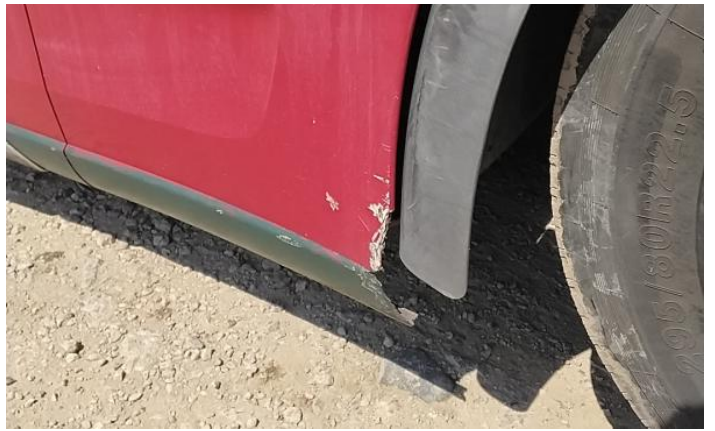
12: Qtr Panel nsr  
Cracked  
Replace

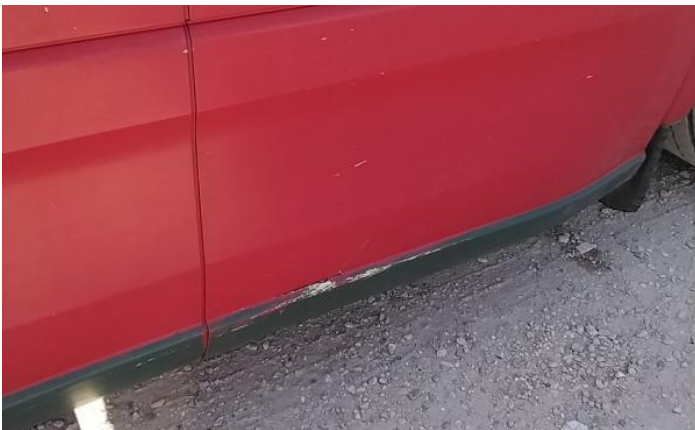
13: Qtr Panel osr  
Cracked  
Replace

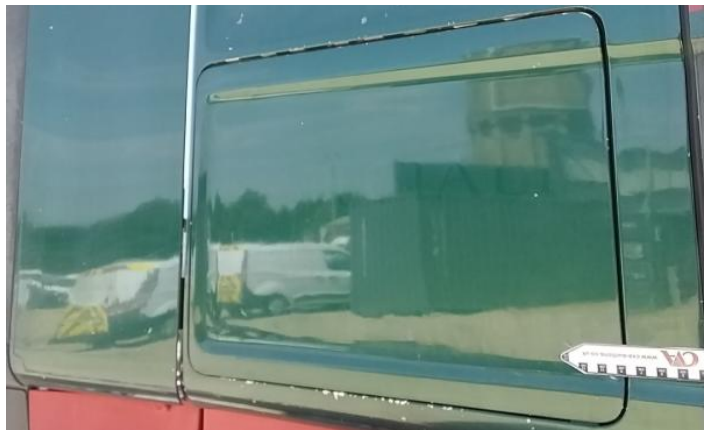
14: Qtr Panel osr  
Scratched  
Rusted

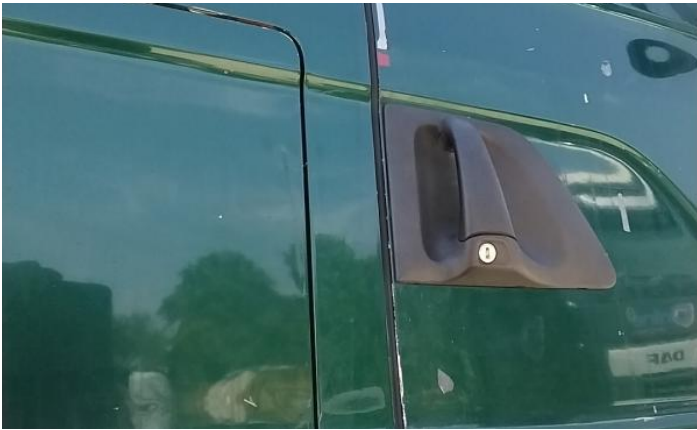
15: Door osf  
Chipped  
Edge Chip

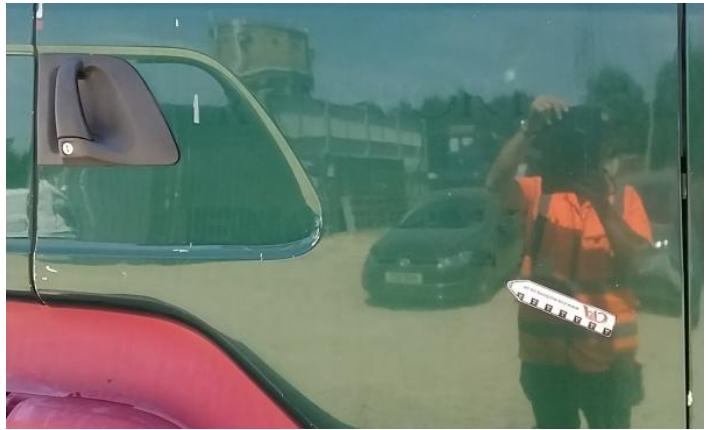
16: Door osf  
Scratched  
Over 25mm Thru Paint

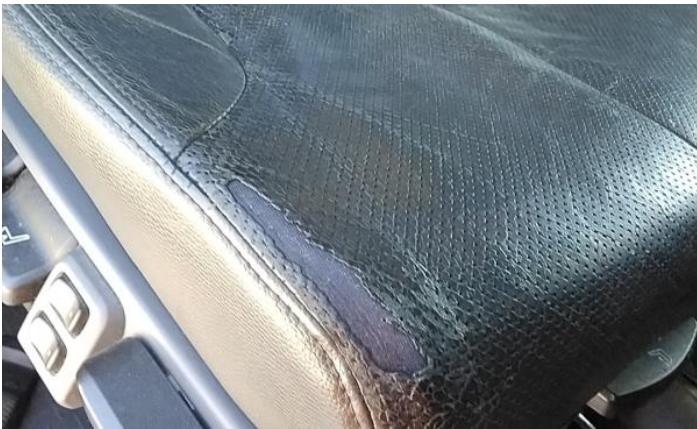
17: Seat Base Cover osf  
Holed  
Over 3mm

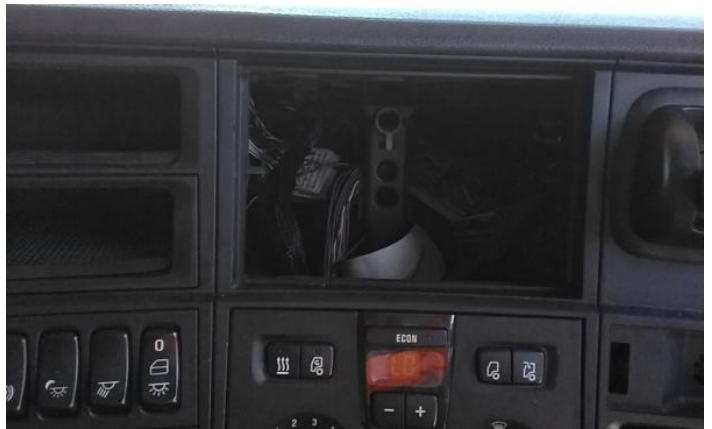
18: In Car Entertainment  
Missing  
Replace
