# VEHICLE INSPECTION REPORT

**PE63NSU**

## Daf LF 45.140

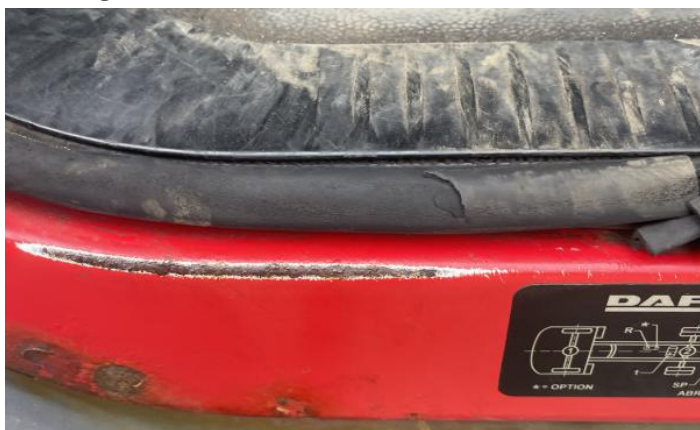
1: Sill os  
Rusted  
Over 5mm

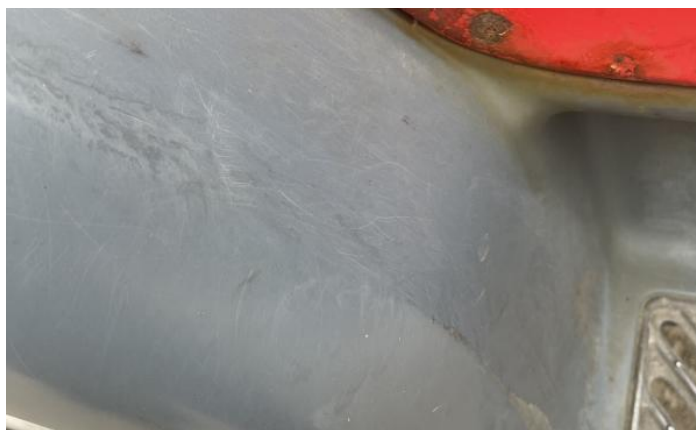
2: Door Moulding osf  
Scuffed (Unpainted)  
Over 100mm

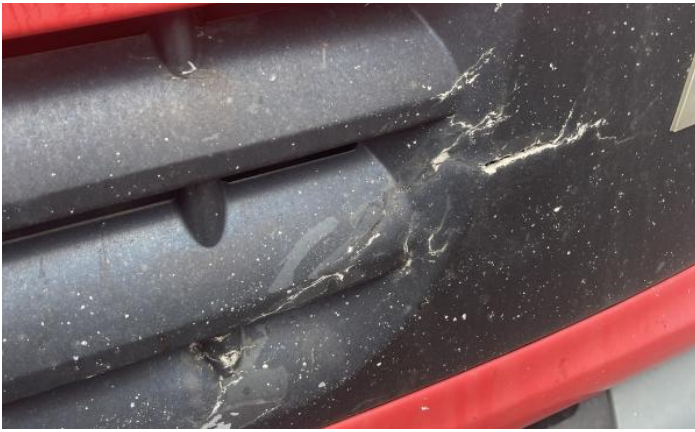
3: Bonnet  
Cracked  
Replace

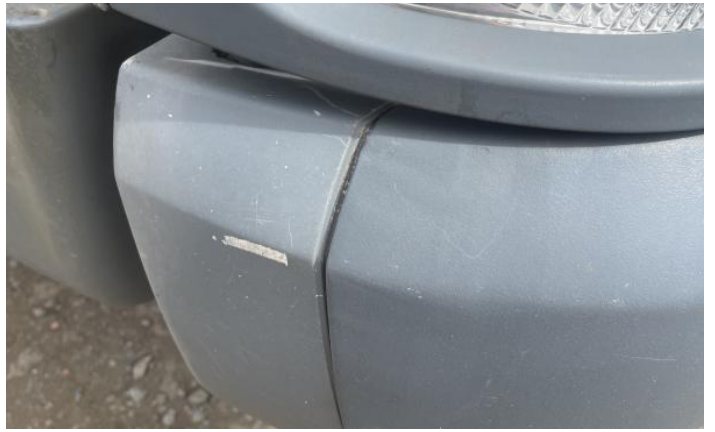
4: Bumper Front Moulding  
Scuffed (Unpainted)  
Over 100mm

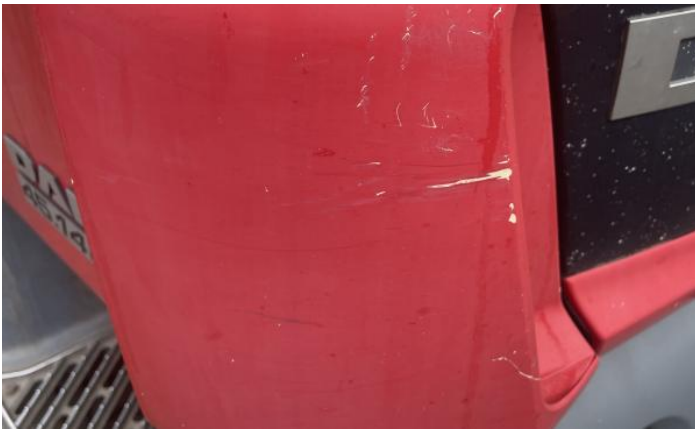
5: Wing osf  
Scratched  
Over 25mm Thru Paint

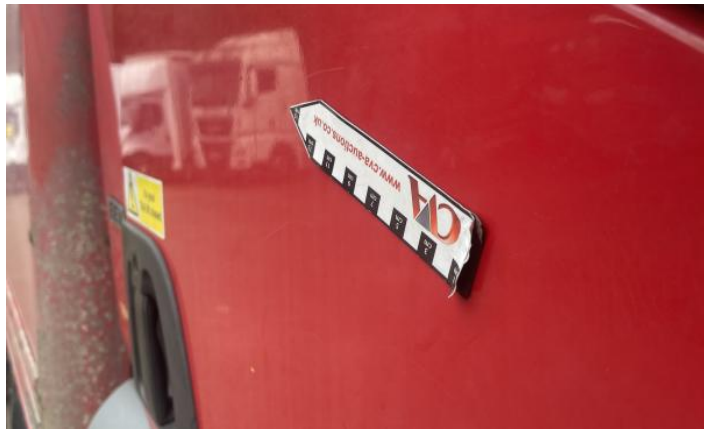
6: Door osf  
Dented  
With Paint Damage

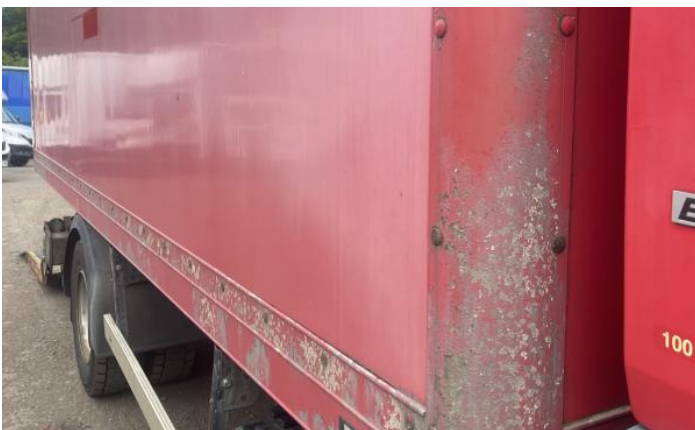
7: Qtr Panel osr  
Rusted  
Over 5mm

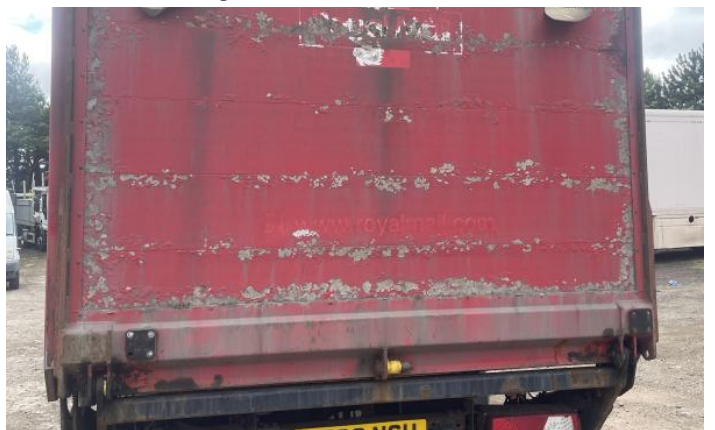
8: Tailgate  
Rusted  
Over 5mm

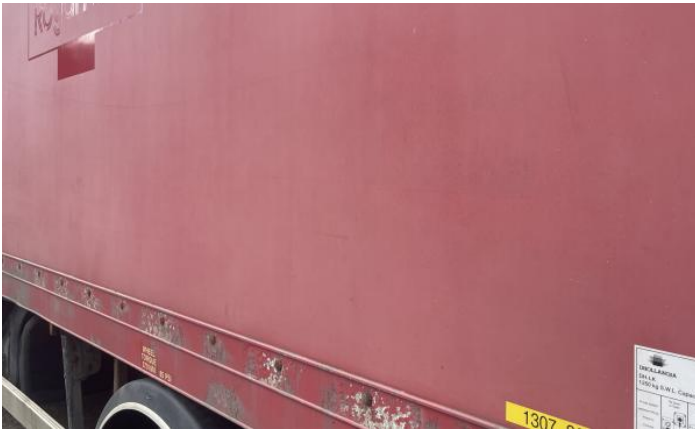
9: Qtr Panel nsr  
Rusted  
Over 5mm

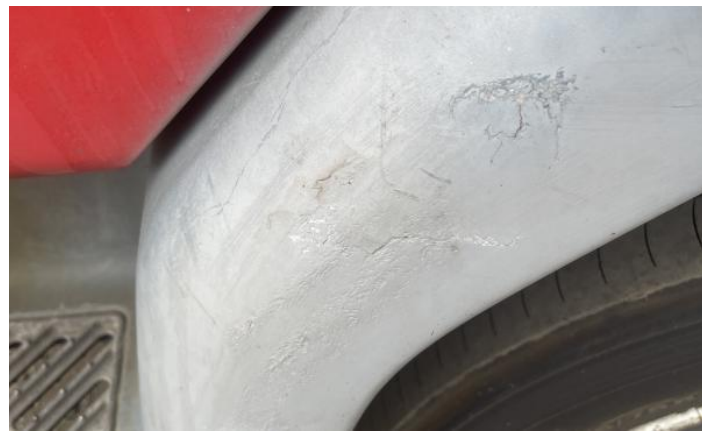
10: Door nsf  
Dented  
With Paint Damage

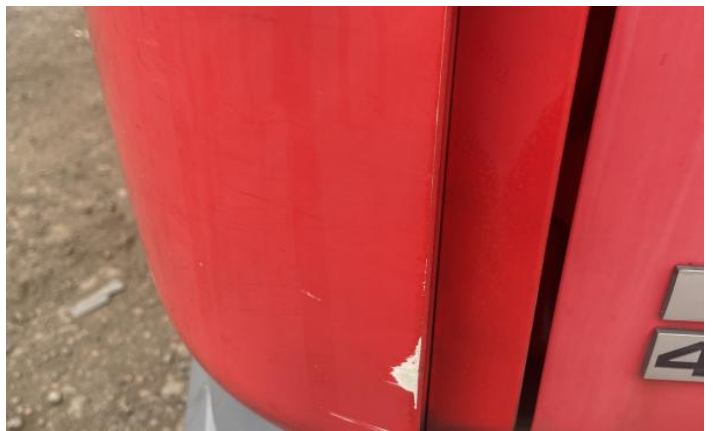
11: Door Moulding nsf  
Scuffed (Unpainted)  
Over 100mm
