# VEHICLE INSPECTION REPORT

**PO13ECW**

## Daf LF 45.140

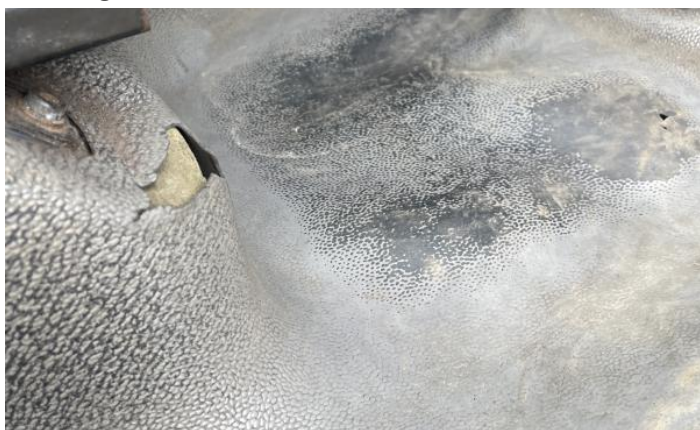
1: Carpets Front  
Torn  
Over 10mm

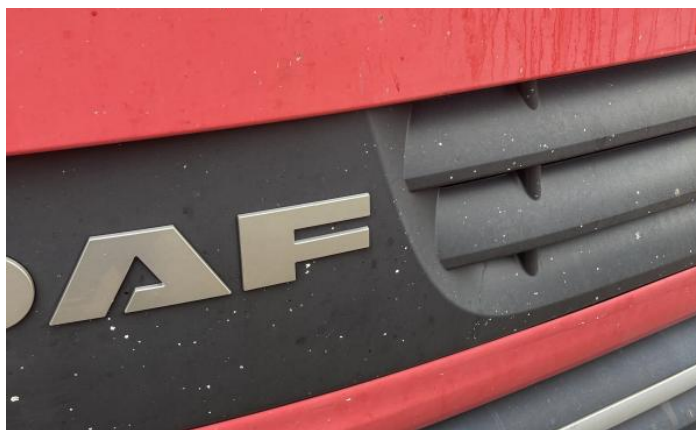
2: Bonnet  
Chipped  
Multiple Chips

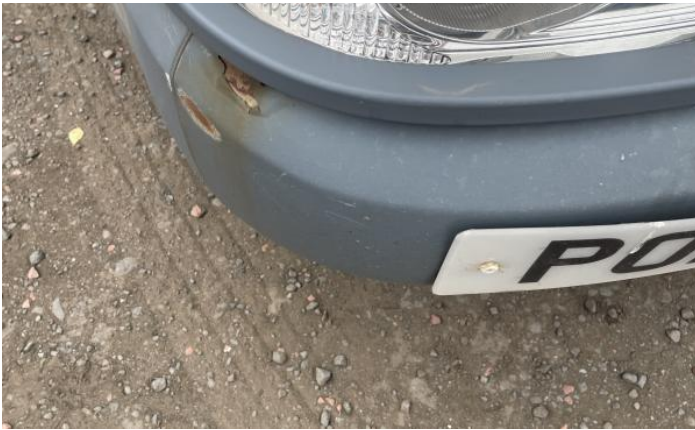
3: Bumper Front  
Rusted  
Over 5mm

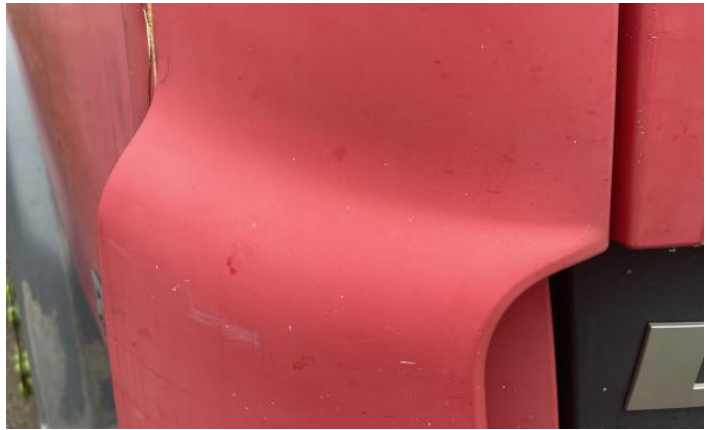
4: Wing osf  
Cracked  
Replace

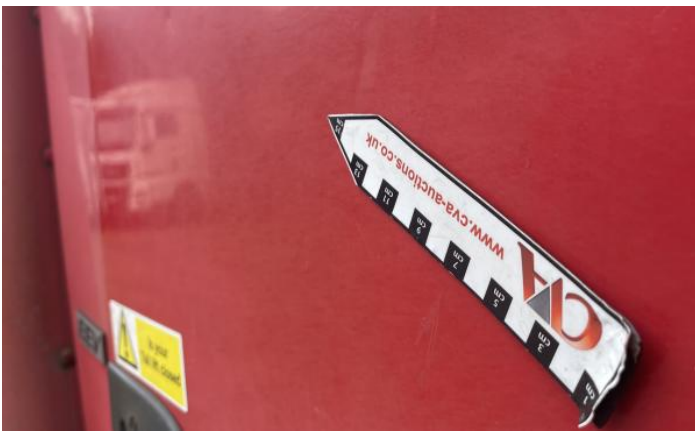
5: Door osf  
Dented  
Over 30mm

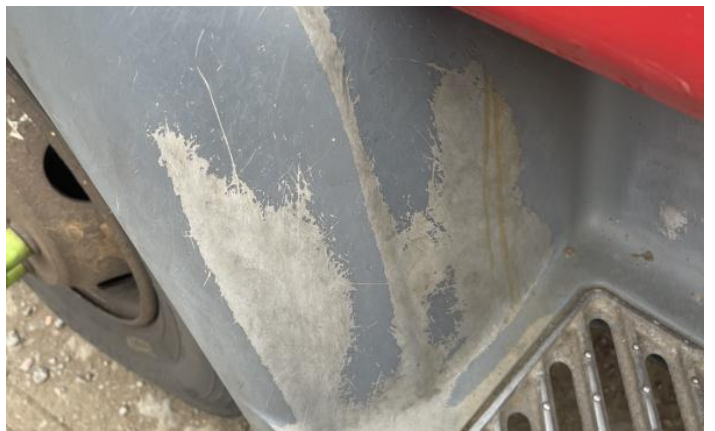
6: Door Moulding osf  
Scuffed (Unpainted)  
Over 100mm

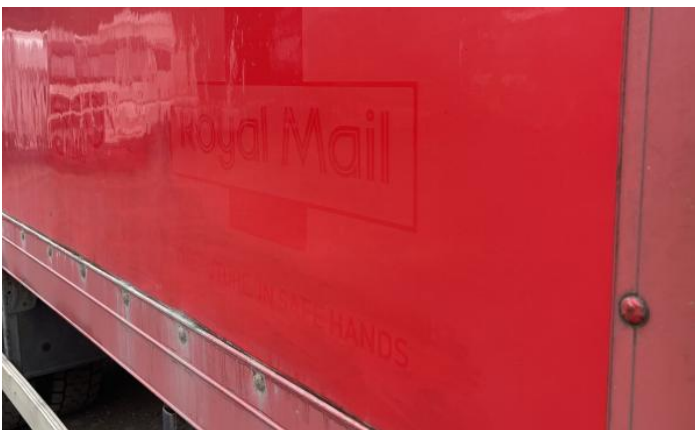
7: Qtr Panel osr  
Rusted  
Over 5mm

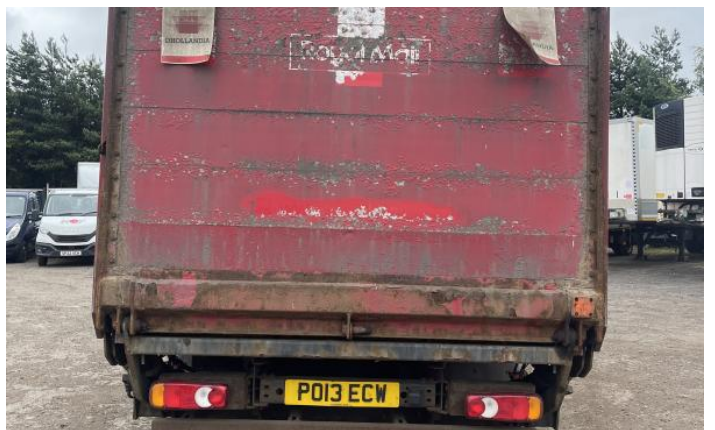
8: Tailgate  
Rusted  
Over 5mm

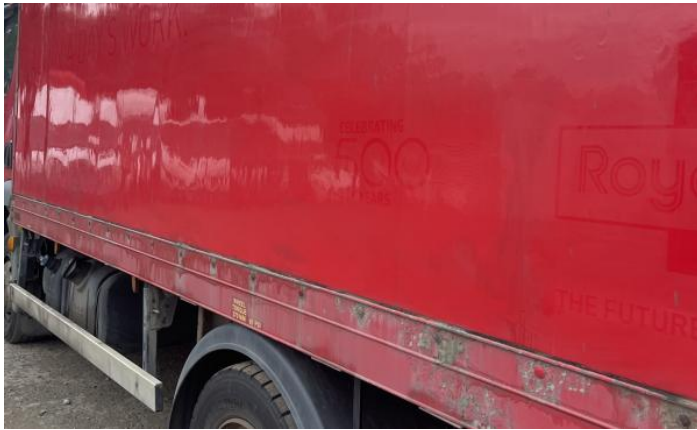
9: Qtr Panel nsf  
Rusted  
Over 5mm

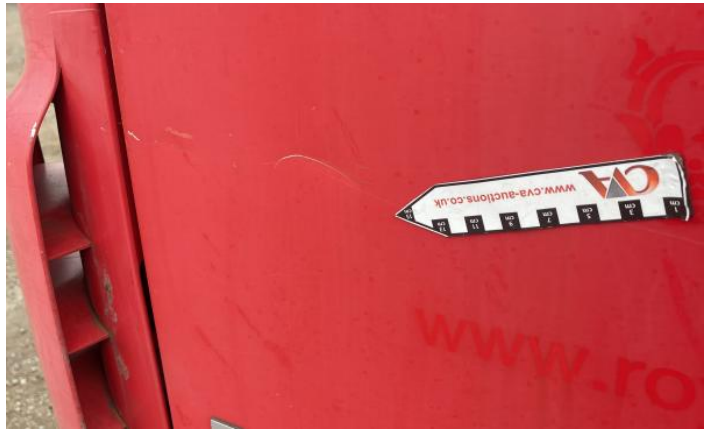
10: Door nsf  
Dented  
With Paint Damage

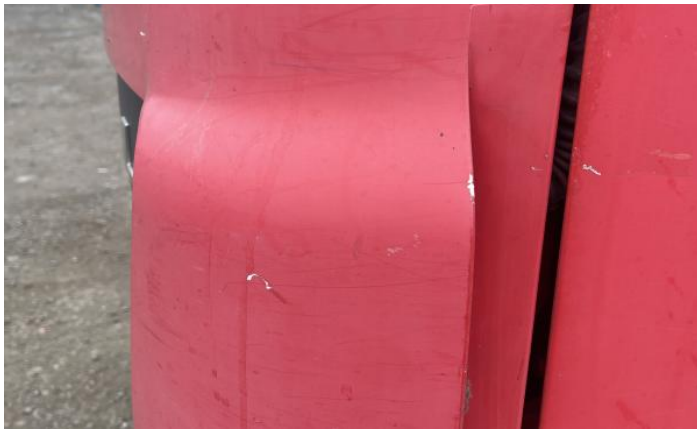
11: Wing nsf  
Scratched  
UpTo 25mm Thru Paint
