# VEHICLE INSPECTION REPORT

**LN16NXV**

## Daf LF 220

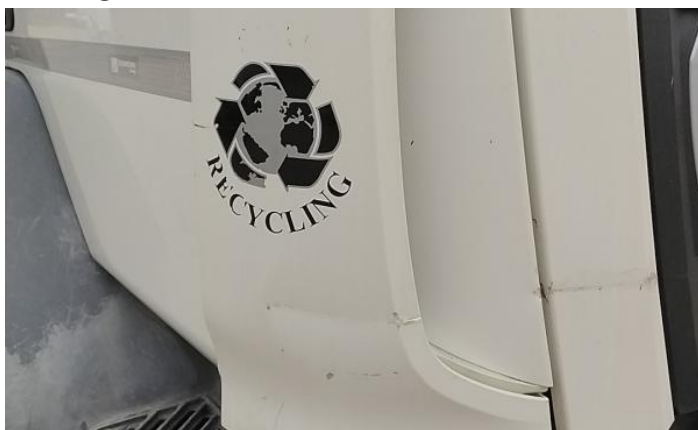
1: Wing of  
Cracked  
Replace

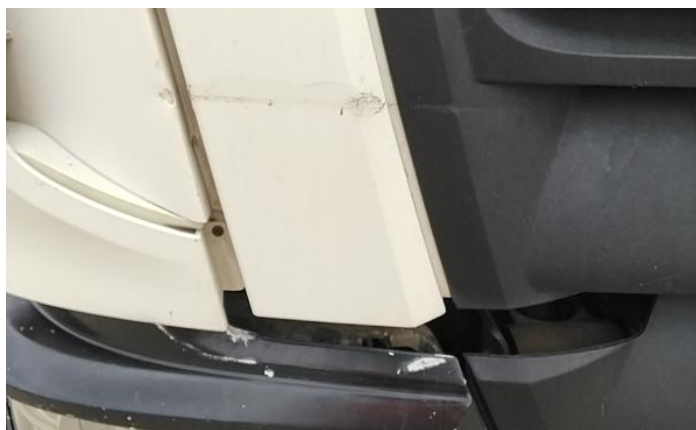
2: Bonnet  
Scratched  
Up To 25mm Thru Paint

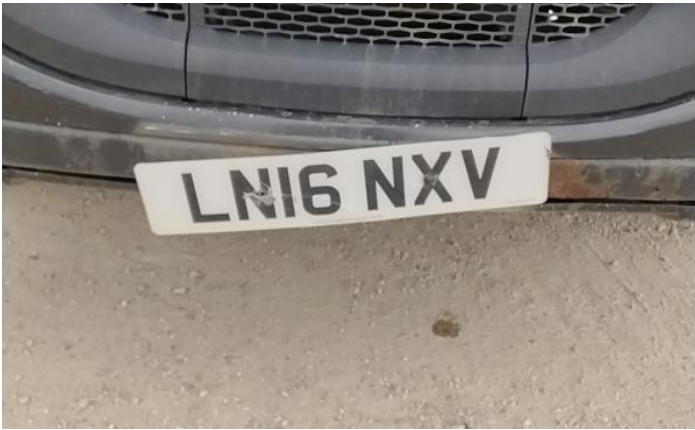
3: Number Plate Front  
Broken  
Replace

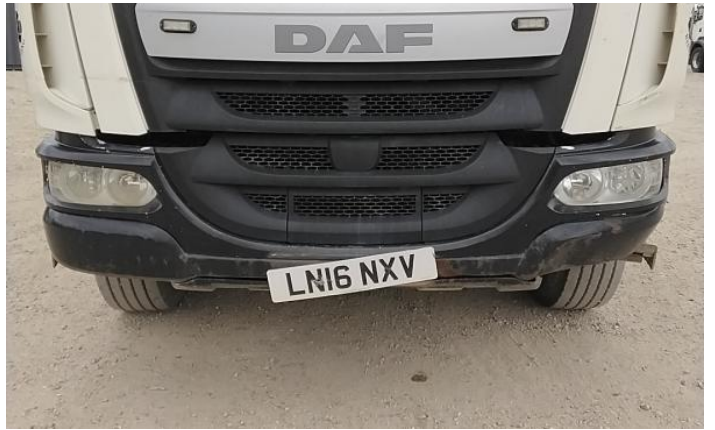
4: Bumper Front  
Rusted  
Over 5mm

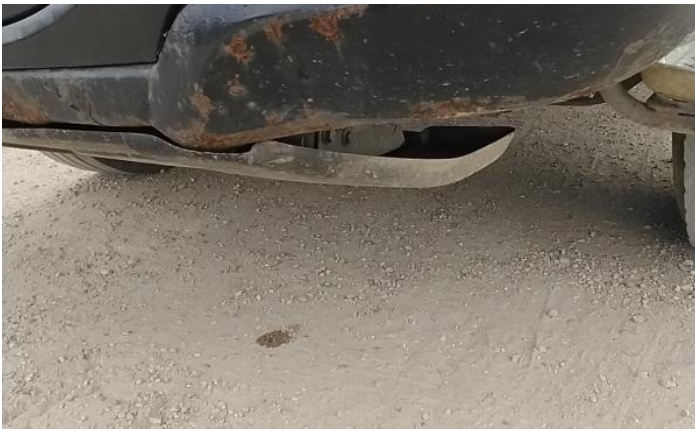
5: Bumper Front  
Dented  
Between 10mm + 30mm

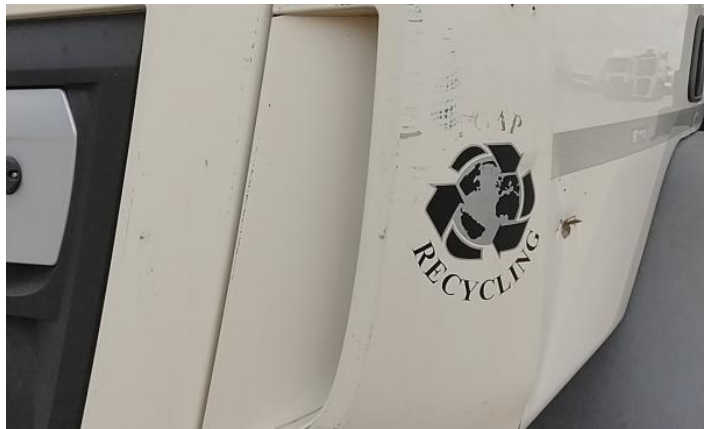
6: Wing nsf  
Scratched  
Over 25mm Not Thru Paint

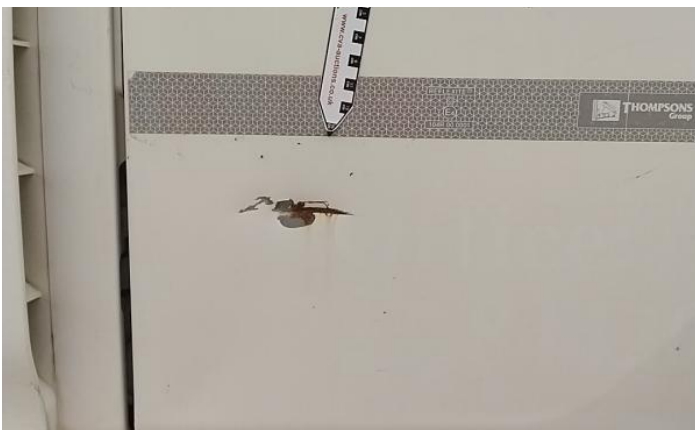
7: Door nsf  
Dented  
With Paint Damage

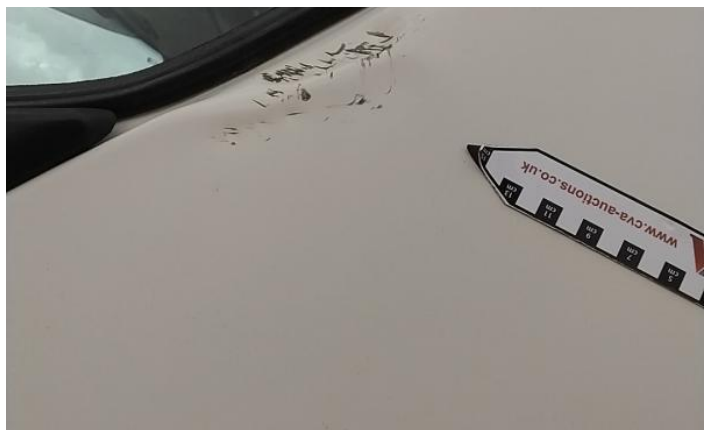
8: Door nsf  
Dented  
With Paint Damage

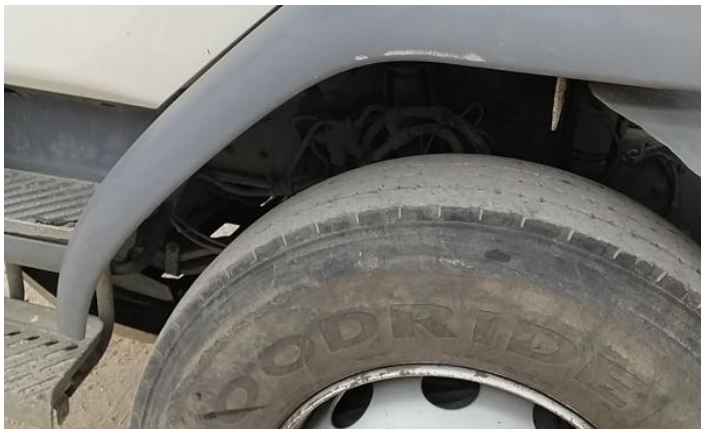
9: Wing Front Arch Extension ns  
Scuffed (Unpainted)  
Over 100mm

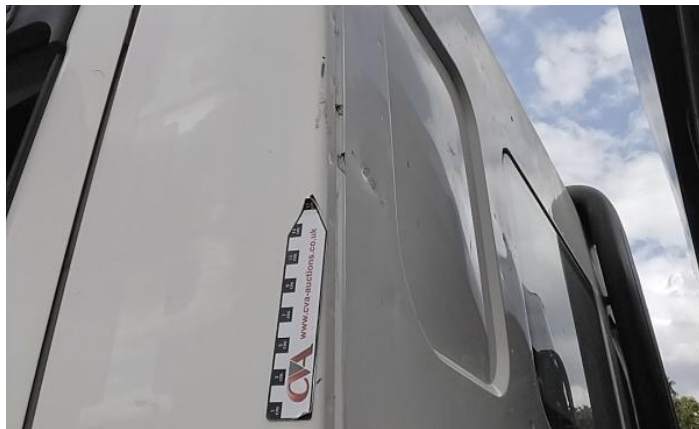
10: Qtr Panel nsr  
Scratched  
Over 25mm Thru Paint

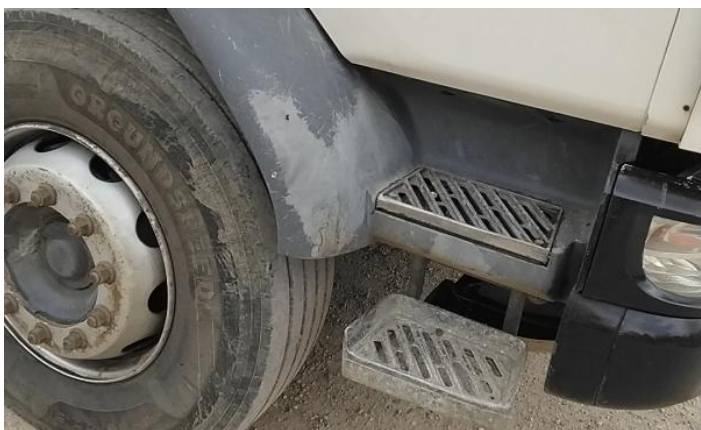
11: Wing Front Arch Extension os  
Scuffed (Unpainted)  
Over 100mm

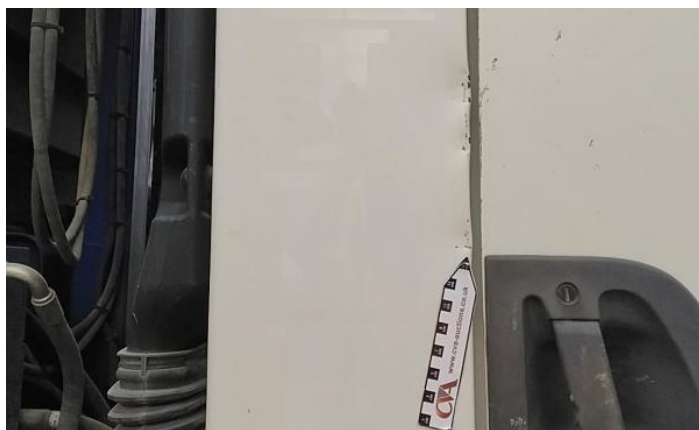
12: Qtr Panel osr  
Dented  
With Paint Damage

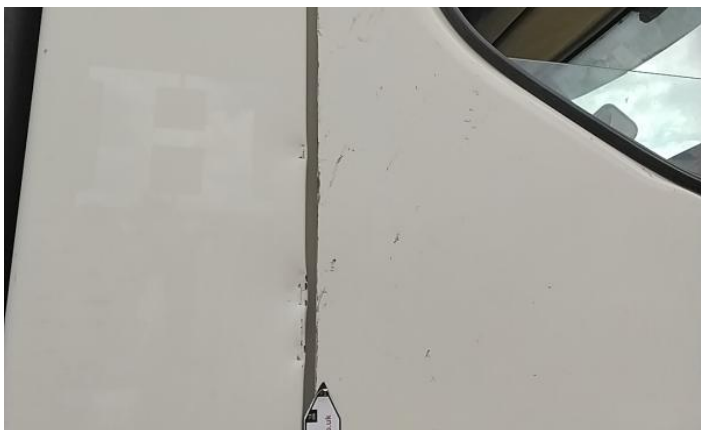
13: Door osf  
Chipped  
Edge Chip

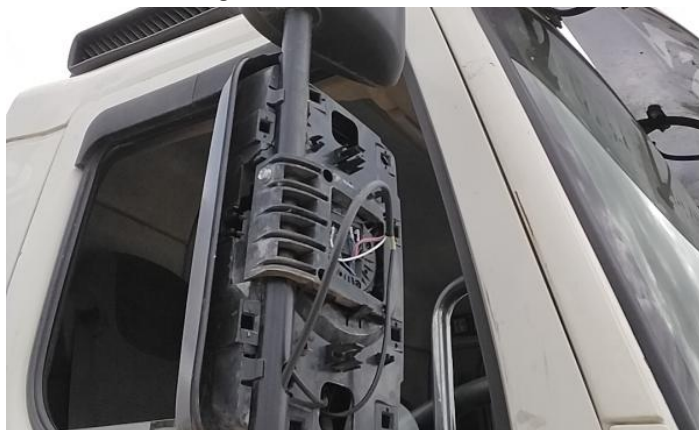
14: Door Mirror Assy osf  
Broken  
Replace

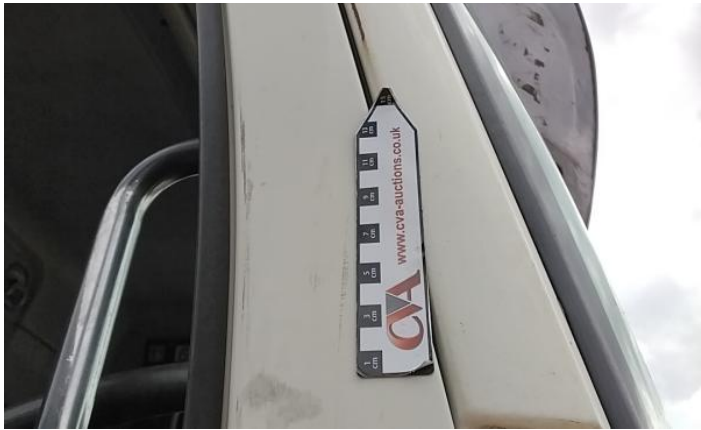
15: A Post os  
Scratched  
UpTo 25mm Thru Paint

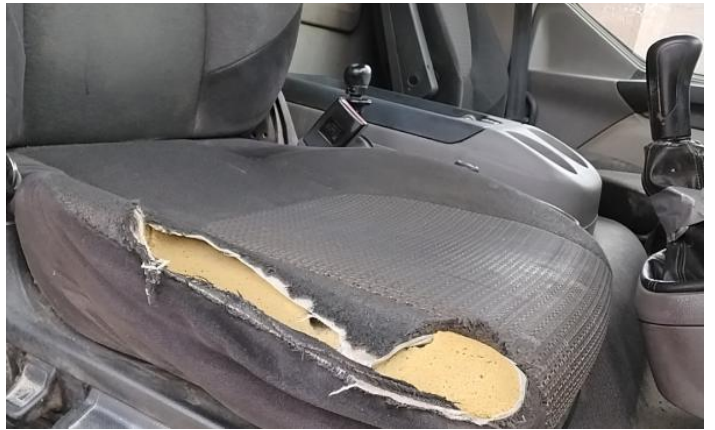
16: Seat Base Cover osf  
Holed  
Over 3mm

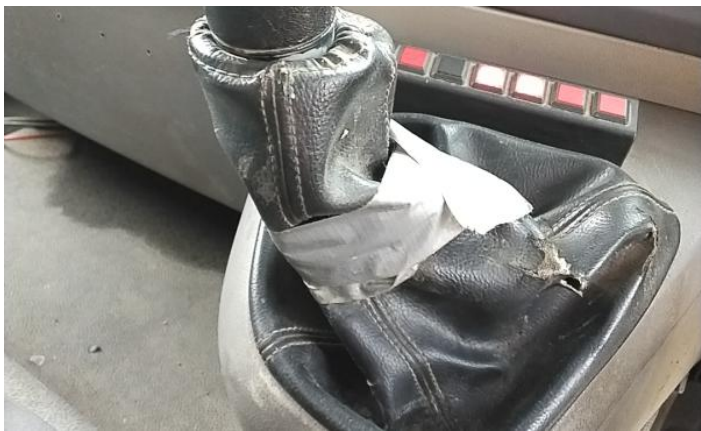
17: Switches And Controls  
Broken  
Replace
