# VEHICLE INSPECTION REPORT

**FN70AZO**

## Daf Trucks CF CF 320

Body Style Refuse Collector

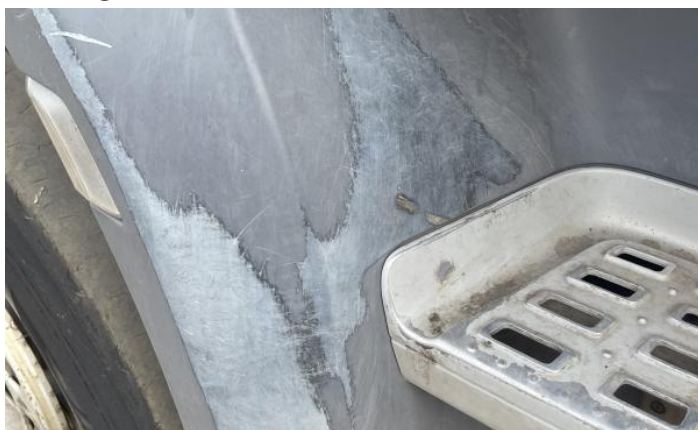
1: Door Moulding of  
Scuffed (Unpainted)  
Over 100mm

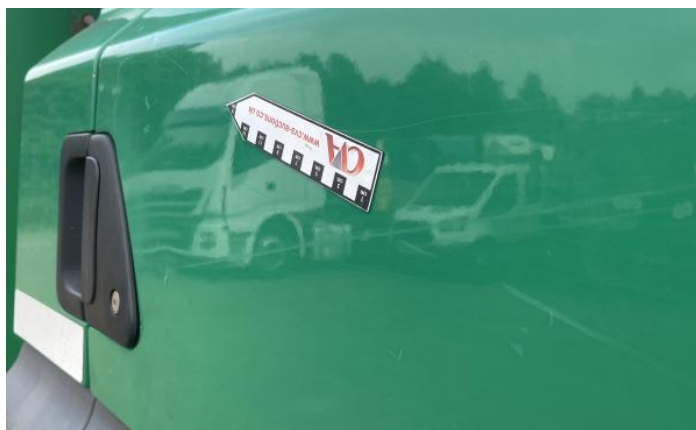
2: Door of  
Dented  
With Paint Damage

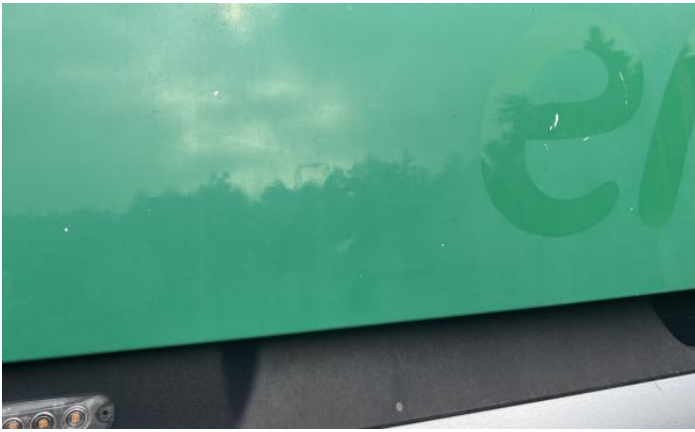
3: Bonnet  
Chipped  
1 To 5

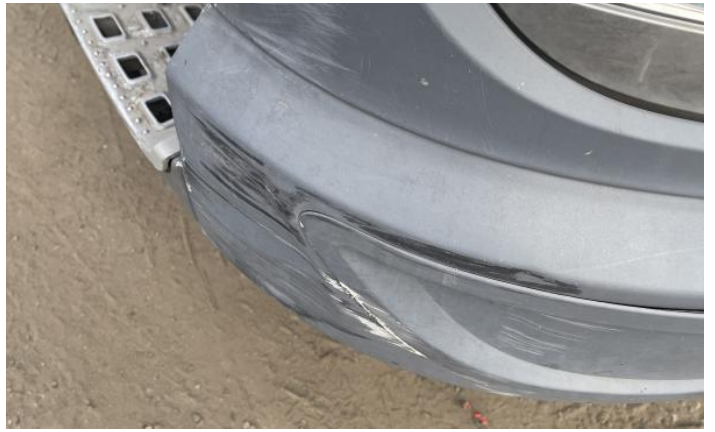
4: Bumper Front Moulding  
Scuffed (Unpainted)  
Over 100mm

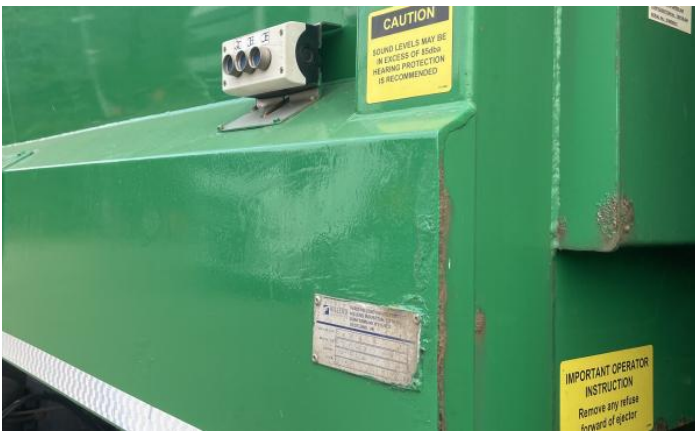
5: Qtr Panel osr  
Rusted  
Over 5mm

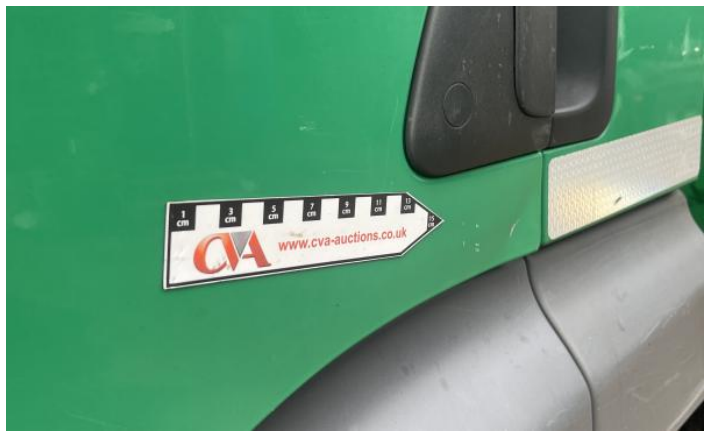
6: Door nsf  
Dented  
With Paint Damage

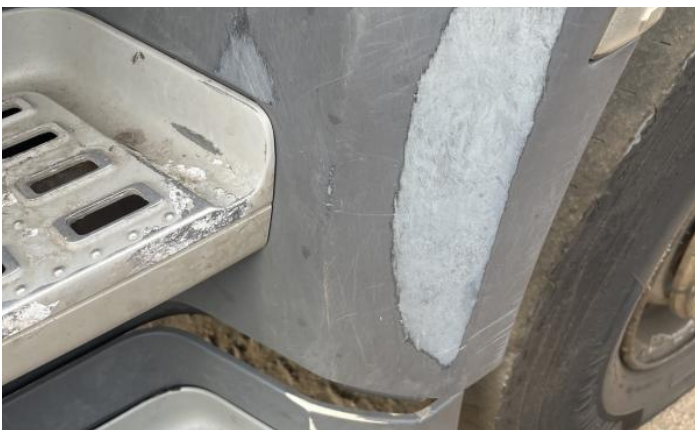
7: Door Moulding nsf  
Scuffed (Unpainted)  
Over 100mm

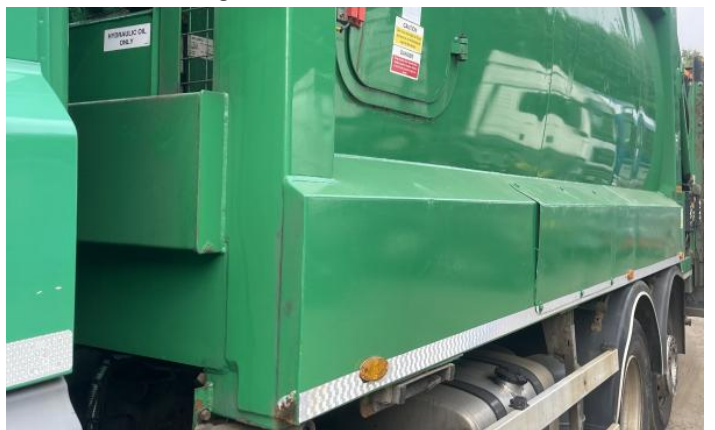
8: Qtr Panel nsr  
Rusted  
Over 5mm
