VEHICLE INSPECTION REPORT

BX09FZO

Daf LF 45.180

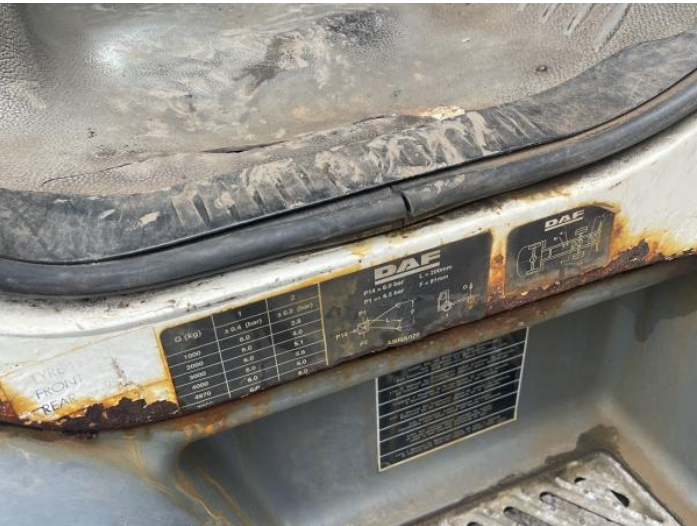
1: Sill os
Rusted
Over 5mm

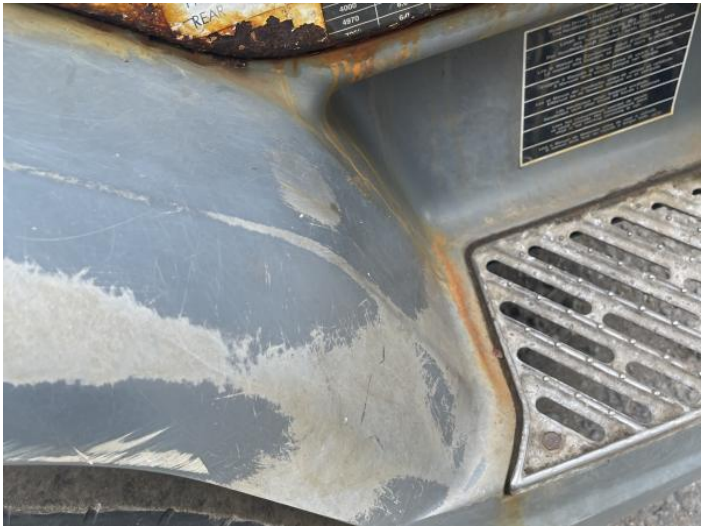
2: Door Moulding osf
Scuffed (Unpainted)
Over 100mm

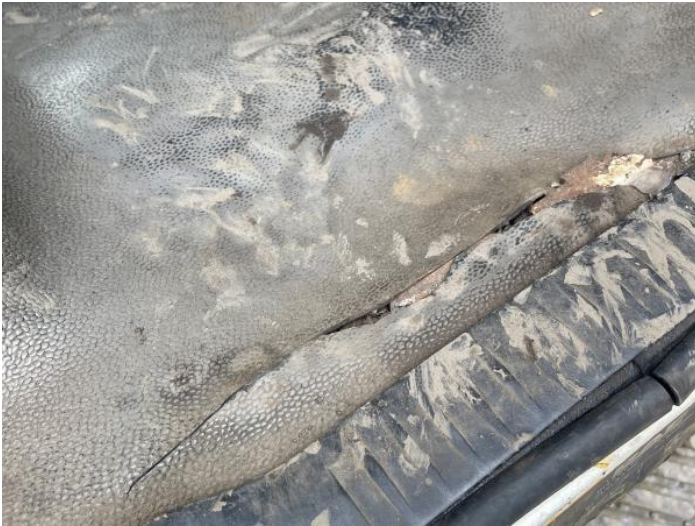
3: Carpets Front
Torn
Over 10mm

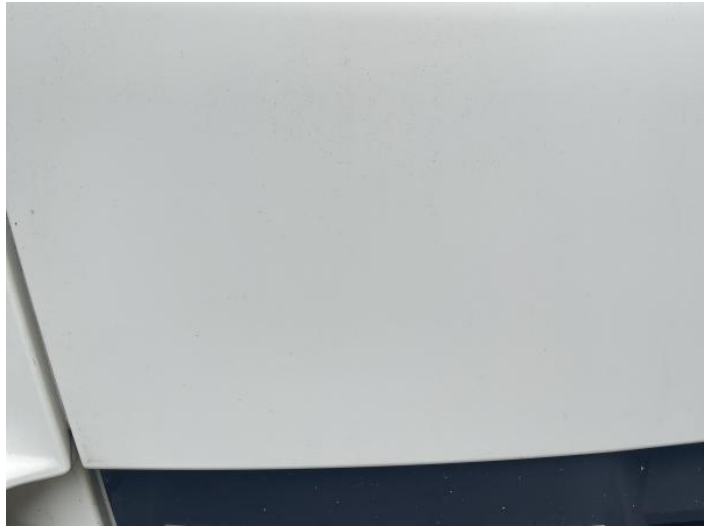
4: Bonnet
Chipped
1 To 5

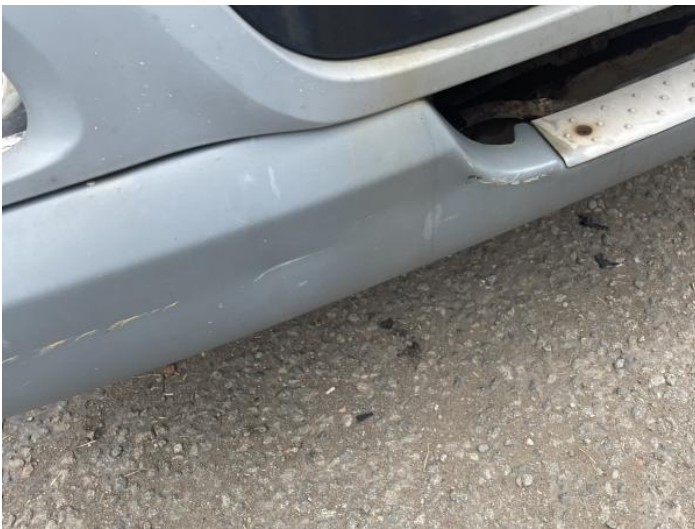
5: Bumper Front
Dented
With Paint Damage

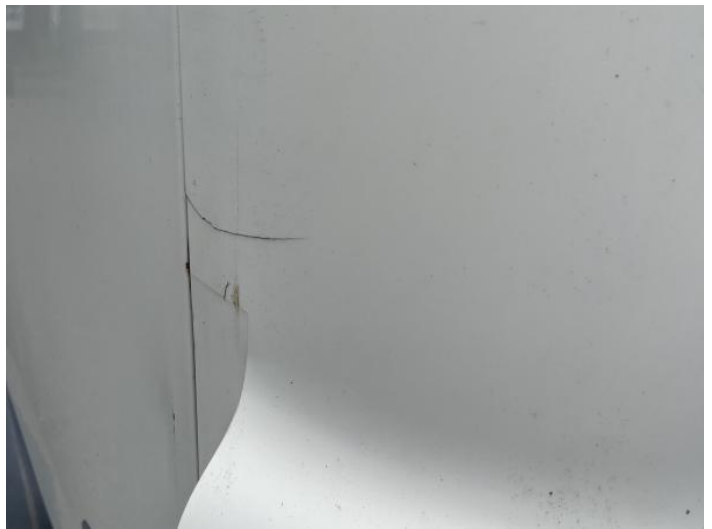
6: Wing osf
Cracked
Replace

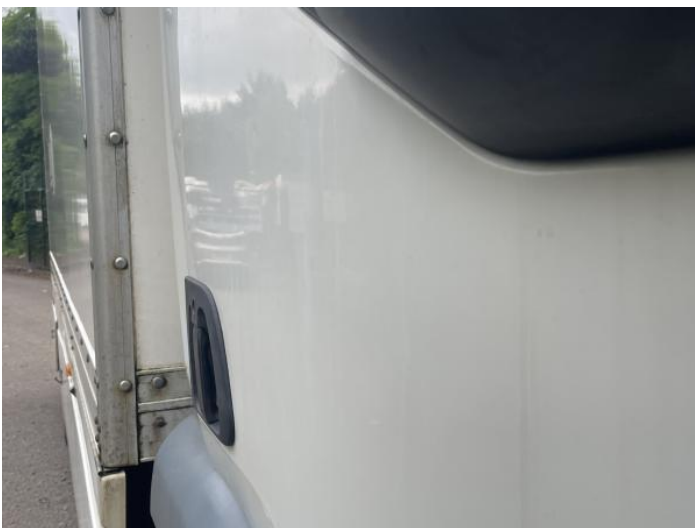
7: Door osf
Dented
Over 30mm

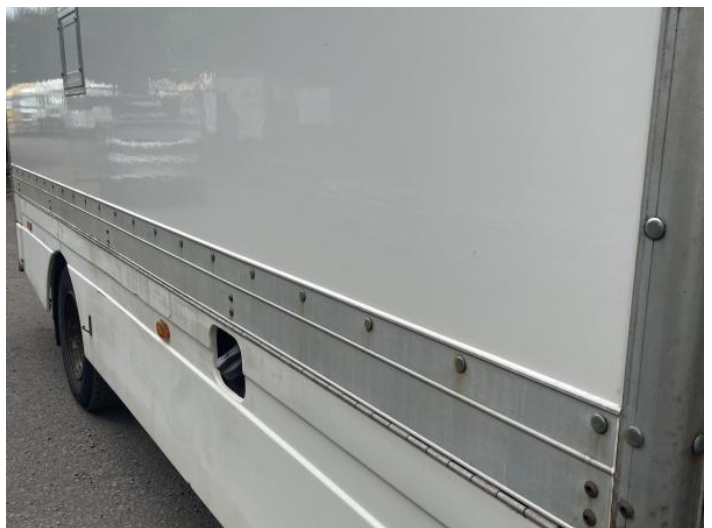
8: Qtr Panel osr
Rusted
Over 5mm

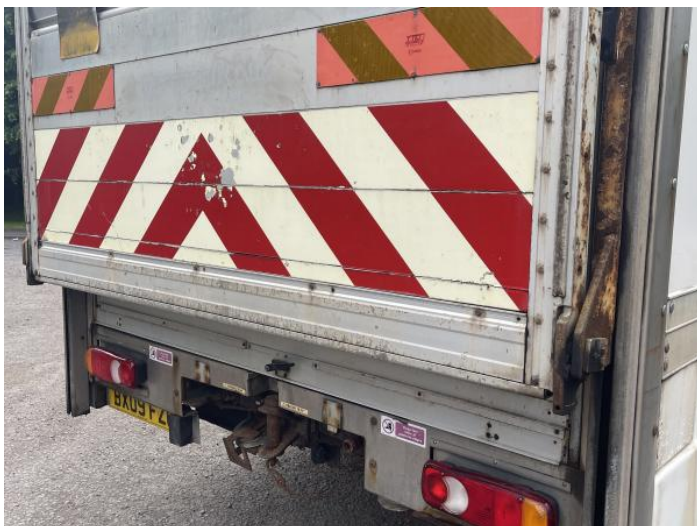
9: Tailgate
Rusted
Over 5mm

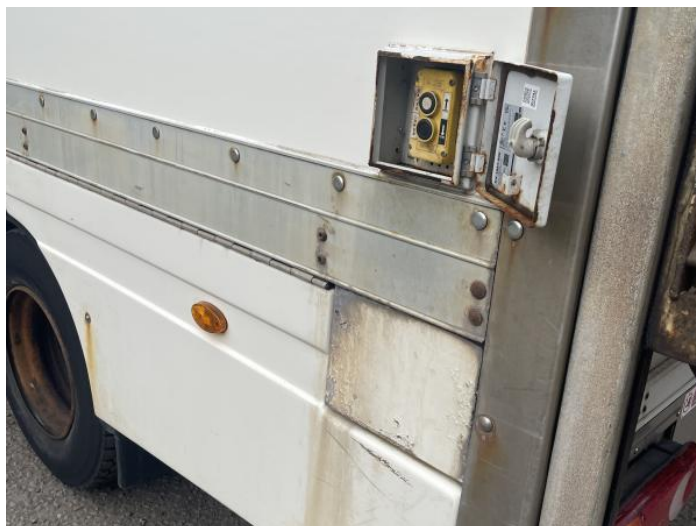
10: Qtr Panel nsr
Rusted
Over 5mm

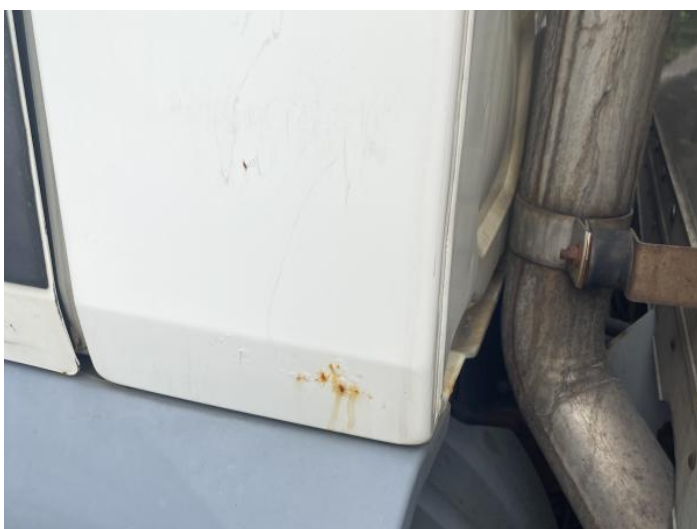
11: B Post ns
Rusted
Over 5mm

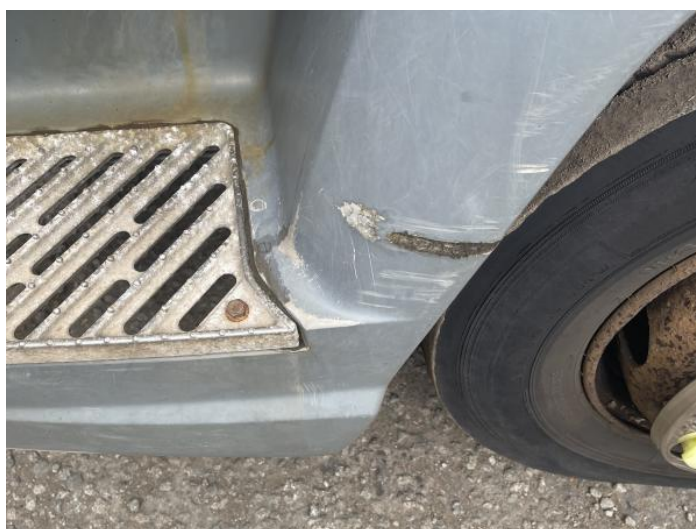
12: Door Moulding nsf
Scuffed (Unpainted)
Over 100mm
