# VEHICLE INSPECTION REPORT

**NU18GKF**

## Man TGX 18.420

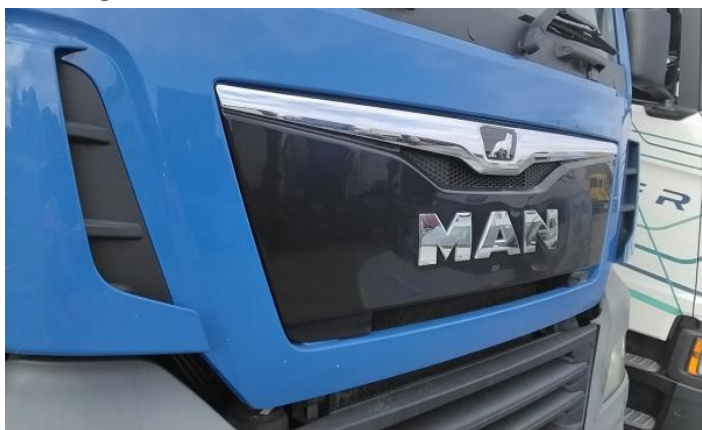
1: Bonnet  
Chipped  
Multiple Chips

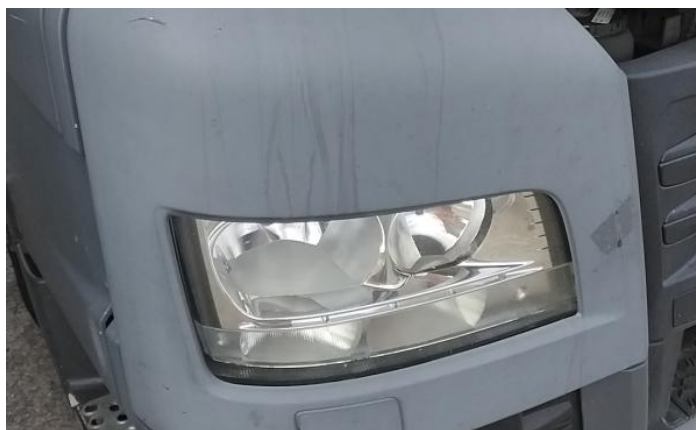
2: Panel Front  
Scratched  
Over 25mm Thru Paint

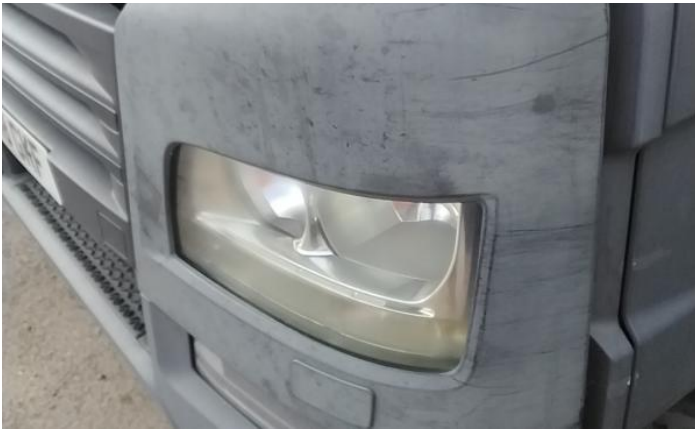
3: Panel Front  
Scratched  
Over 25mm Thru Paint

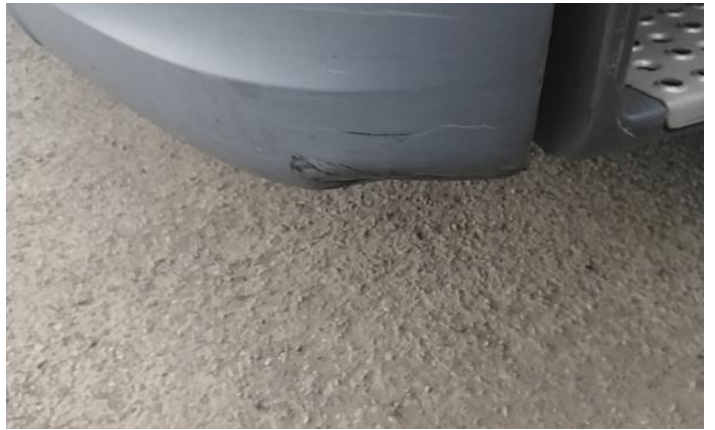
4: Bumper Front  
Dented  
Over 30mm

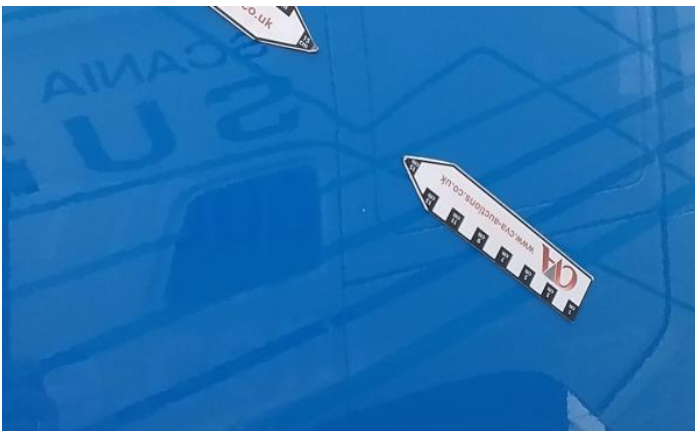
5: Door nsf  
Dented  
Over 30mm

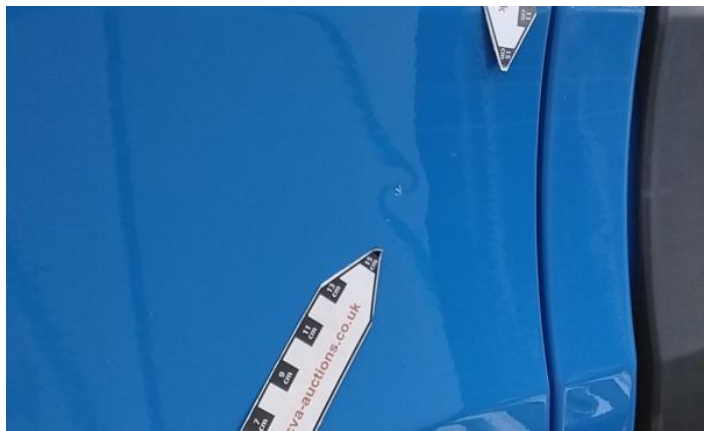
6: Qtr Panel nsr  
Dented  
With Paint Damage

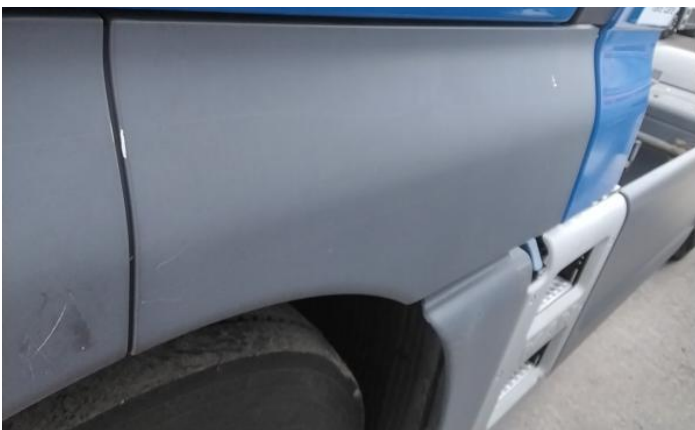
7: Qtr Panel Moulding ns  
Scuffed (Unpainted)  
UpTo 100mm

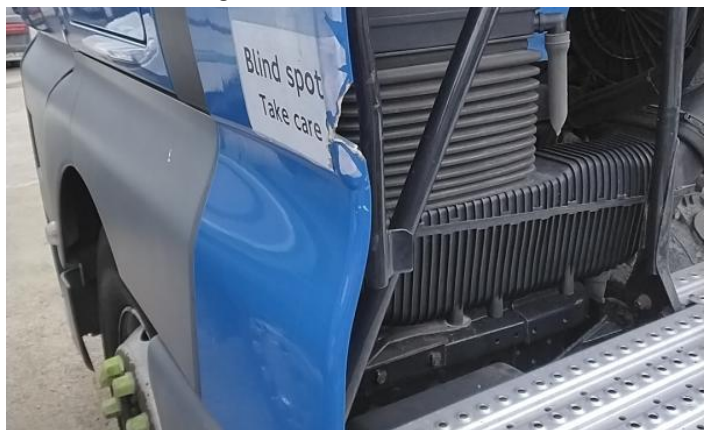
8: Qtr Panel Trim ns  
Broken  
Replace

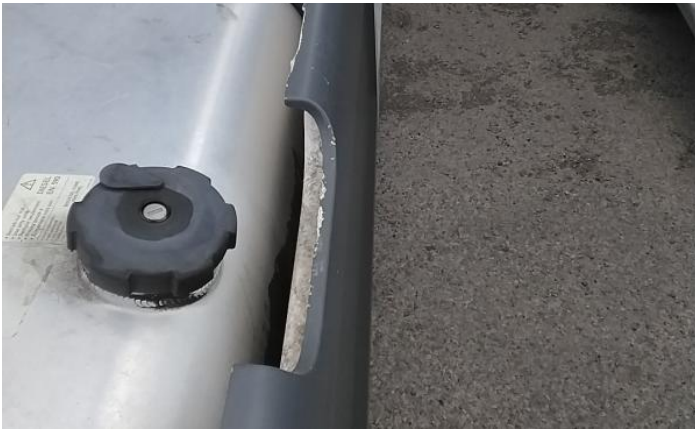
9: Qtr Panel Moulding os  
Broken  
Replace

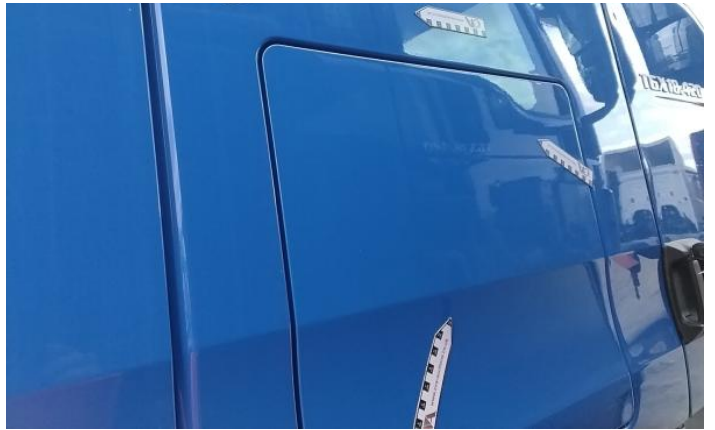
10: Qtr Panel osr  
Dented  
Over 30mm

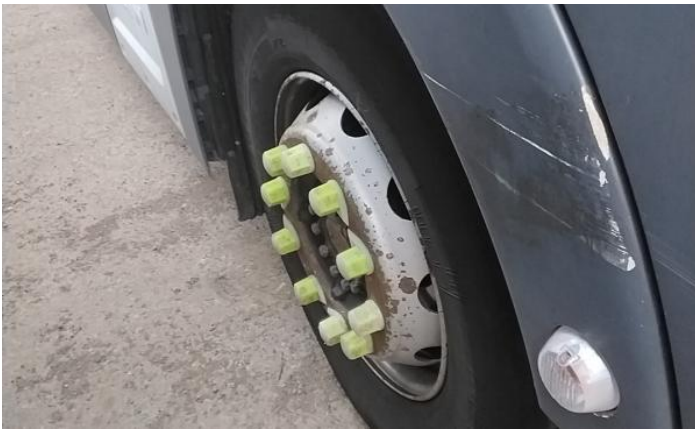
11: Wing osf  
Scratched  
Over 25mm Thru Paint

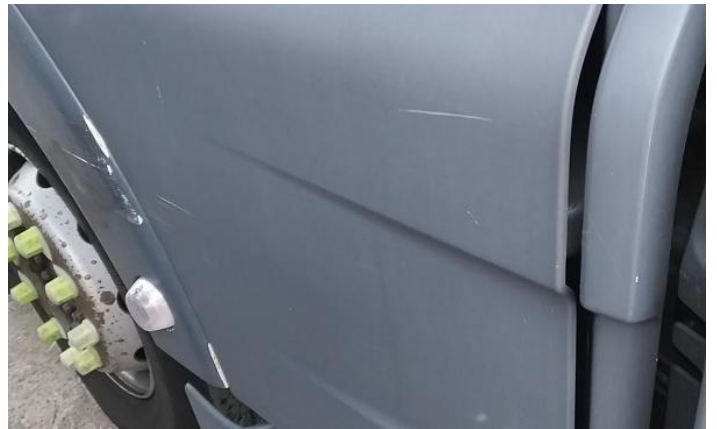
12: Door Moulding osf  
Scuffed (Unpainted)  
Over 100mm

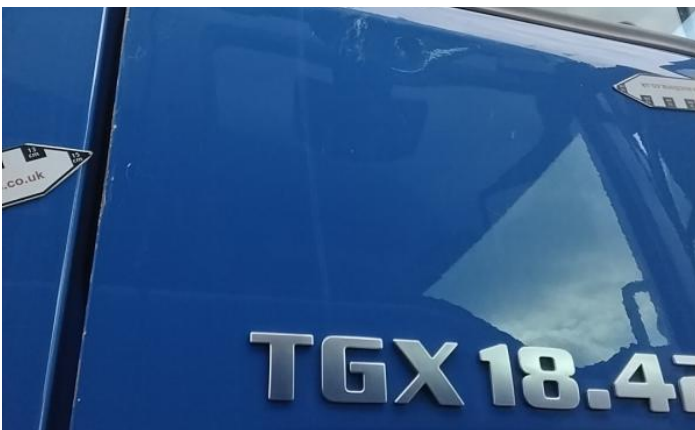
13: Door osf  
Dented  
With Paint Damage

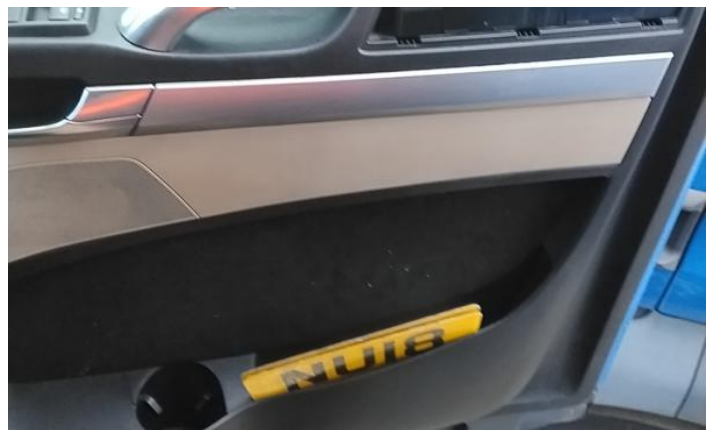
14: Door Pad osf  
Broken  
Replace
