# VEHICLE INSPECTION REPORT

**PE63NBL**

## Daf LF 45.140

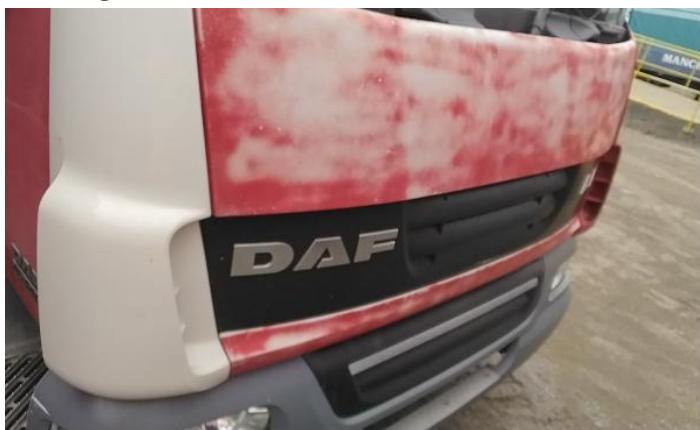
1: Bonnet  
Poor Previous Repair  
Poor Paint

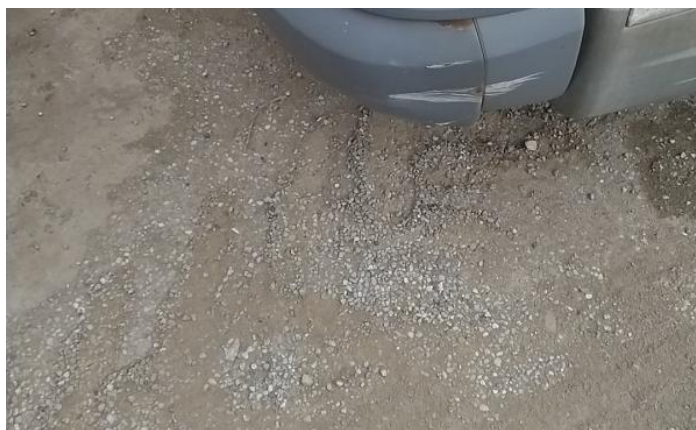
2: Bumper Front  
Dented  
With Paint Damage

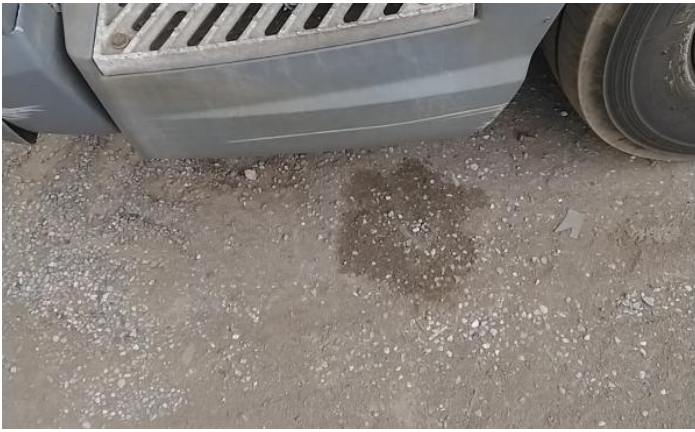
3: Wing nsf  
Scratched  
Over 25mm Thru Paint

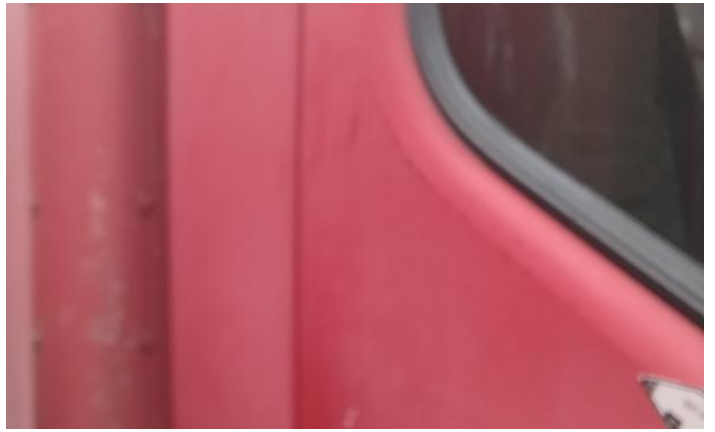
4: Door osf  
Scratched  
Over 25mm Thru Paint

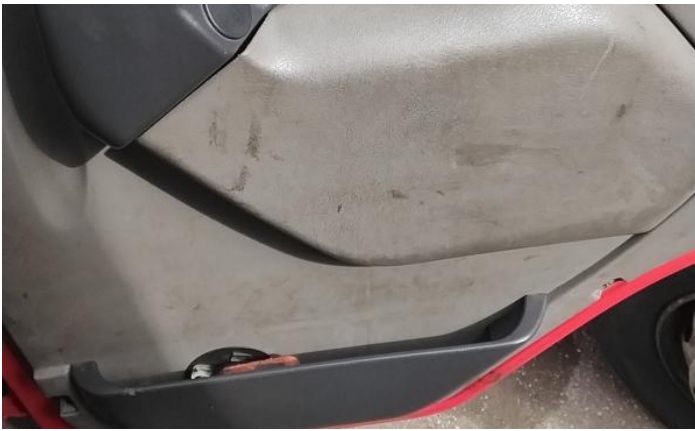
5: Door Pad osf  
Soiled  
Heavy

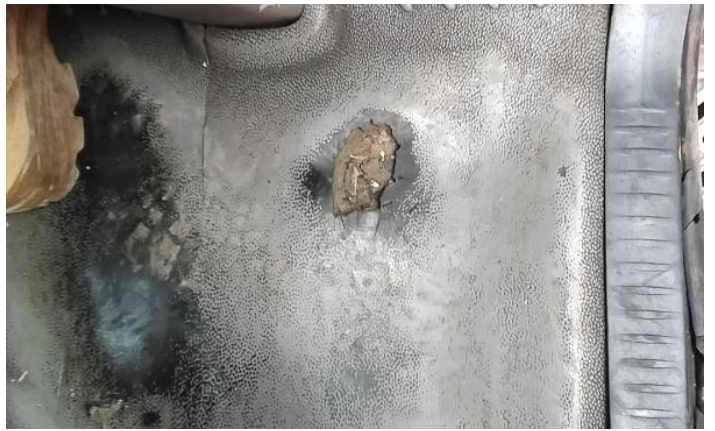
6: Carpets Front  
Holed  
Over 3mm

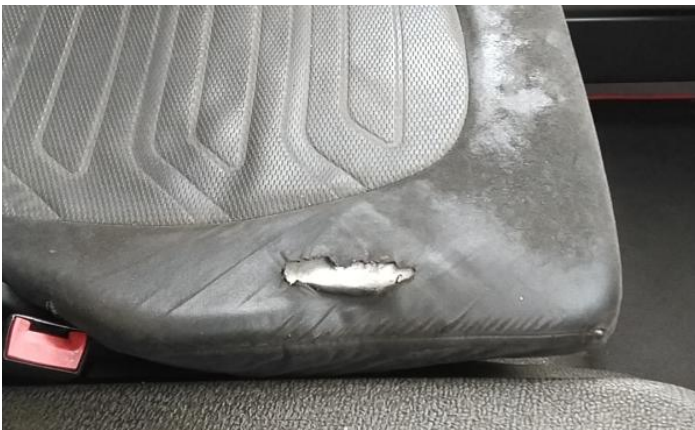
7: Seat Base Cover nsf  
Holed  
Over 3mm
