# VEHICLE INSPECTION REPORT

**PE63NDK**

## Daf LF 45.140

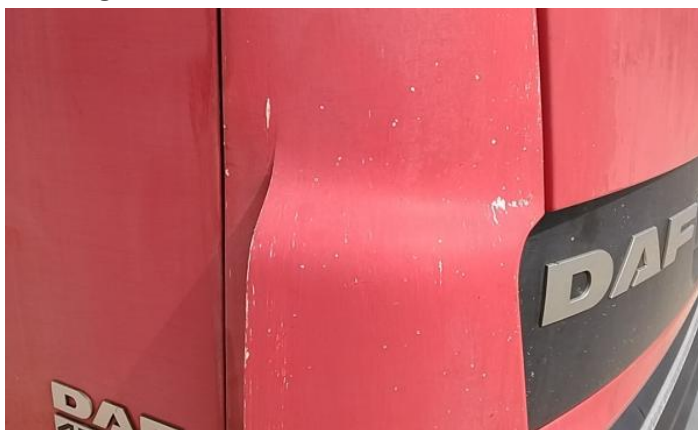
1: Wing of  
Scratched  
Over 25mm Thru Paint

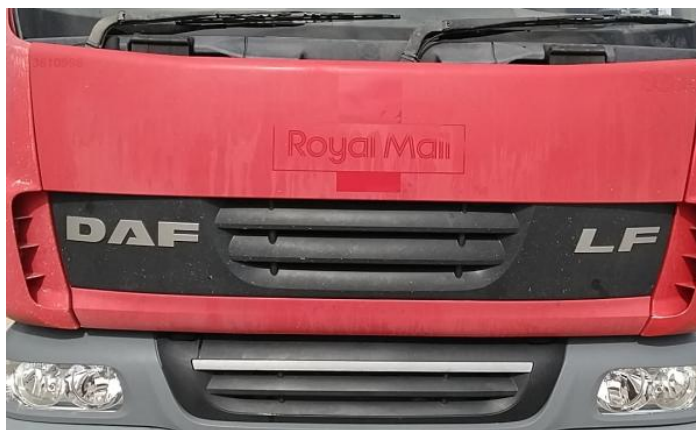
2: Bonnet  
Chipped  
Multiple Chips

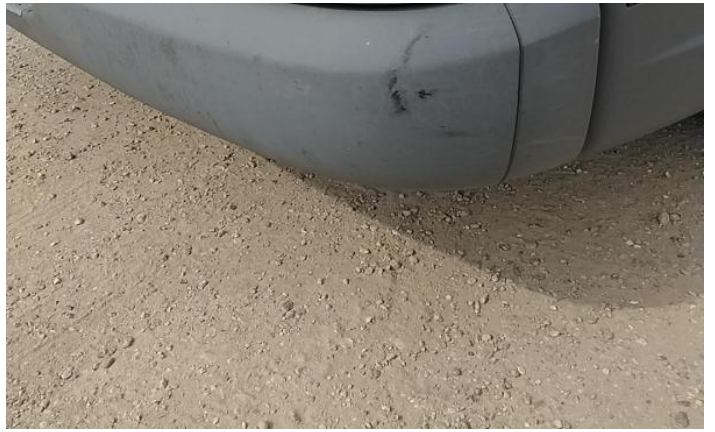
4: Bumper Front  
Scratched  
Over 25mm Not Thru Paint

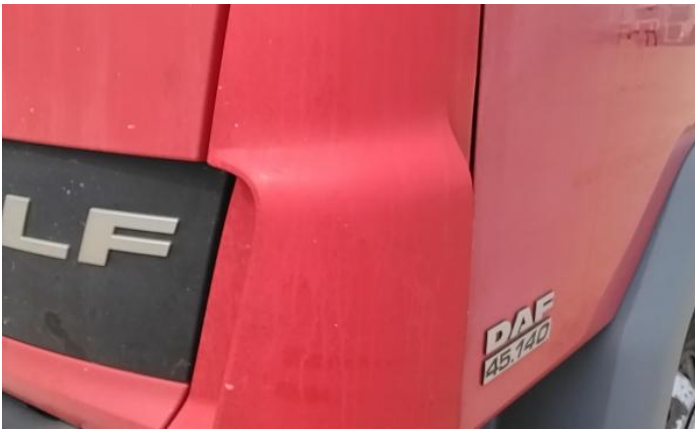
5: Wing nsf  
Chipped  
Multiple Chips

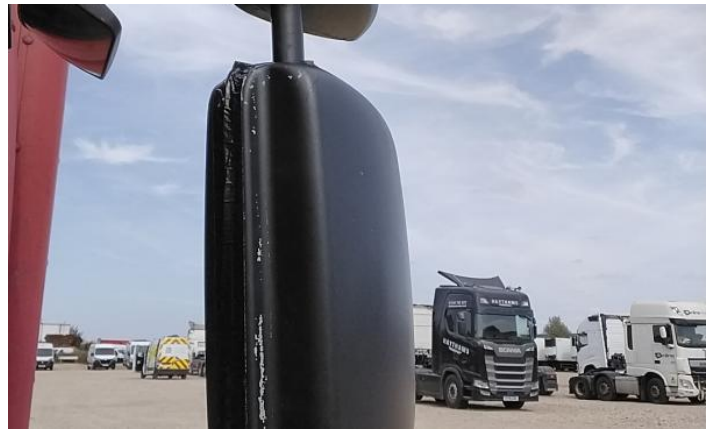
6: Door Mirror Assy nsf  
Broken  
Replace

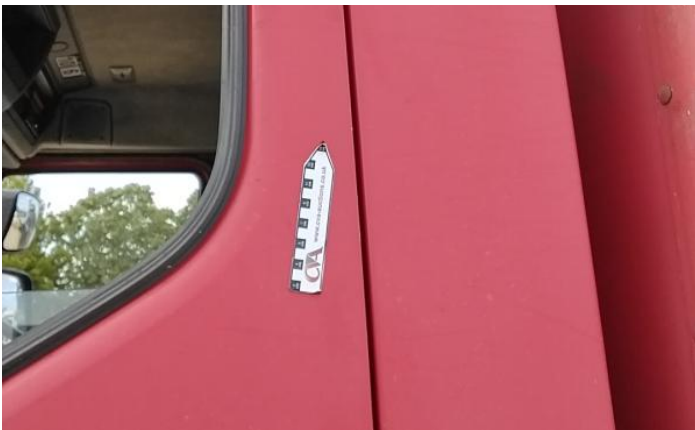
7: Door nsf  
Scratched  
Over 25mm Not Thru Paint

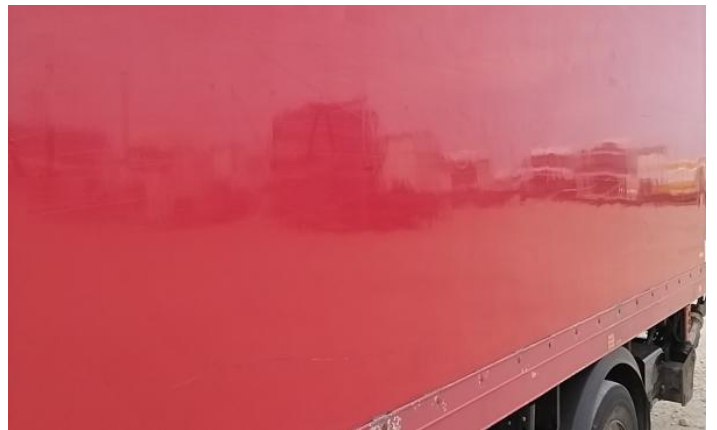
8: Qtr Panel nsr  
Scratched  
Over 25mm Not Thru Paint

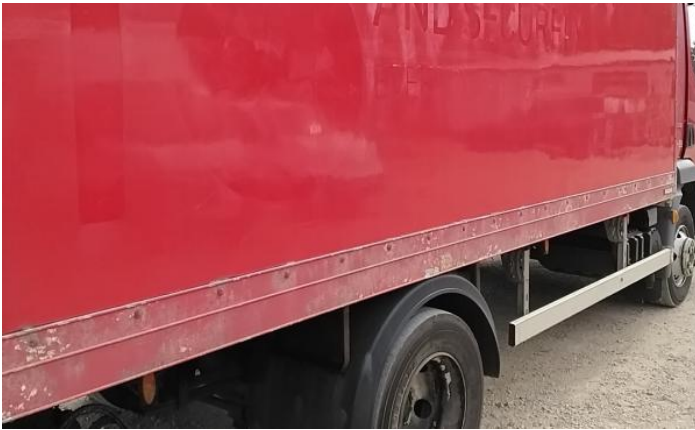
9: Qtr Panel osr  
 Scratched  
 Over 25mm Not Thru Paint

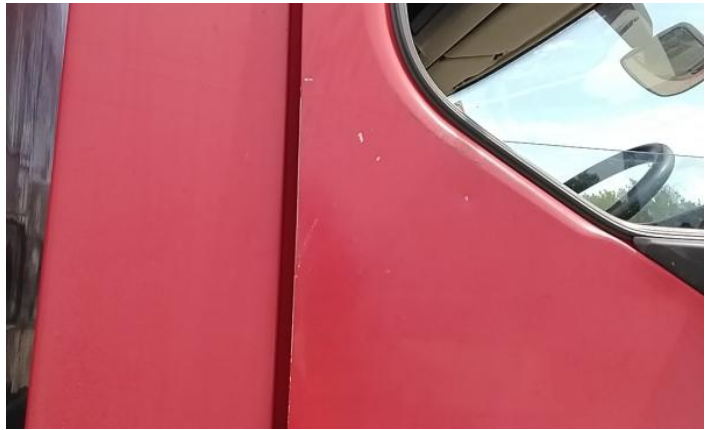
10: Door osf  
 Chipped  
 Edge Chip

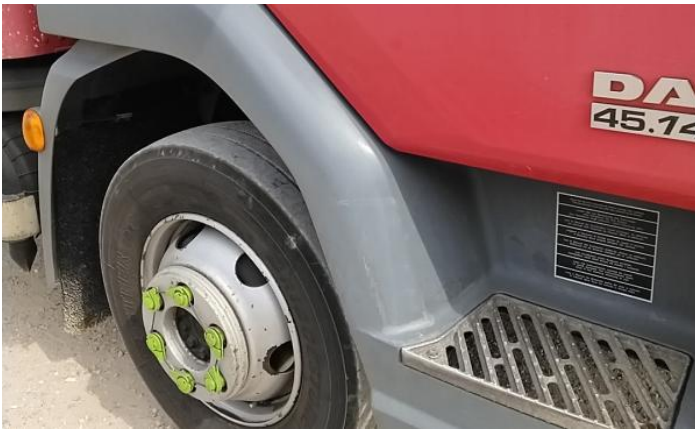
11: Wing Front Arch Extension os  
 Scuffed (Unpainted)  
 Over 100mm

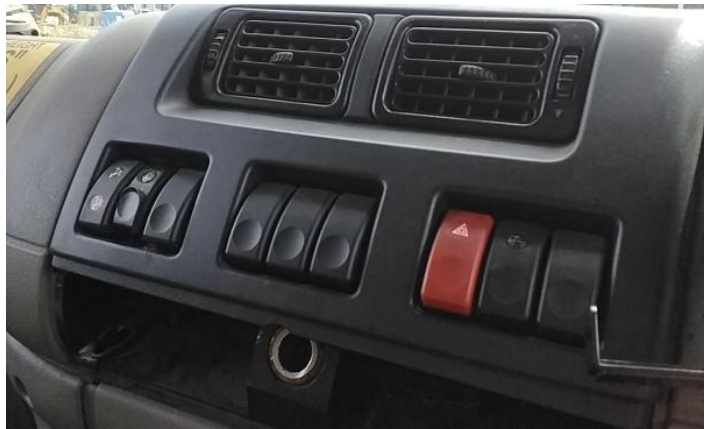
12: Centre Console Front  
 Broken  
 Replace
