# VEHICLE INSPECTION REPORT

**PE65VDF**

## Daf LF 150

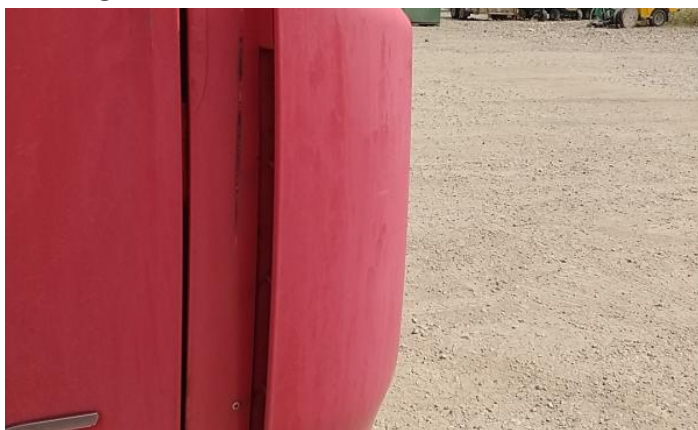
1: Wing osf  
Poor Previous Repair  
Poor Paint

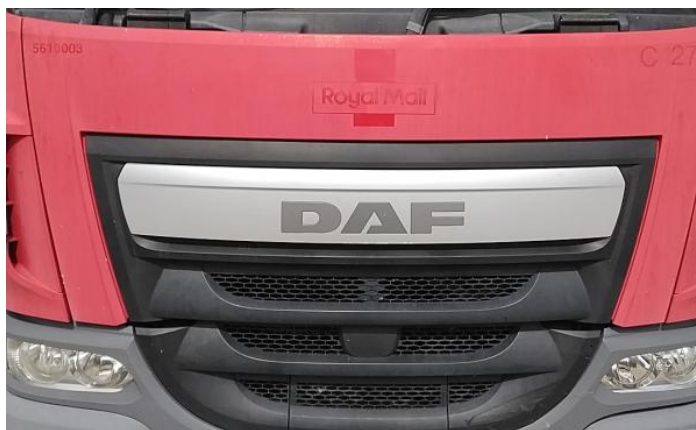
2: Bonnet  
Chipped  
Multiple Chips

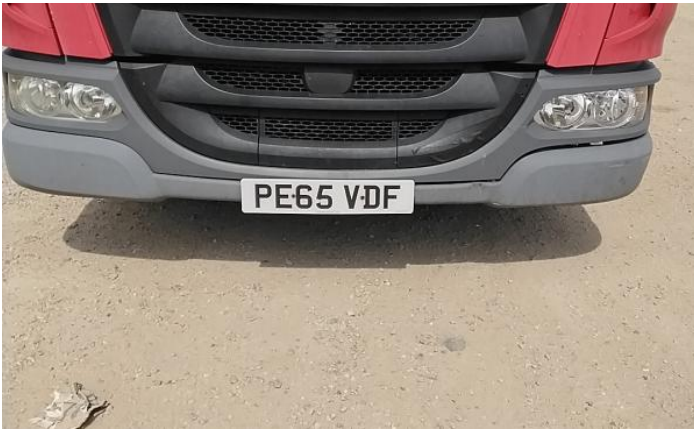
3: Bumper Front  
Chipped  
Multiple Chips

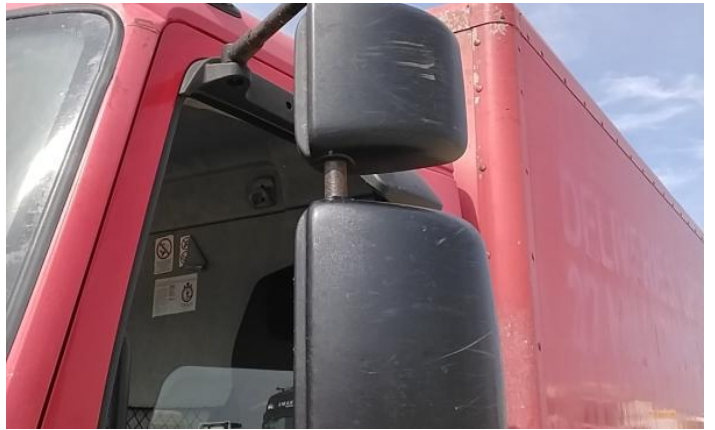
4: Door Mirror Assy nsf  
Scuffed (Unpainted)  
Over 100mm

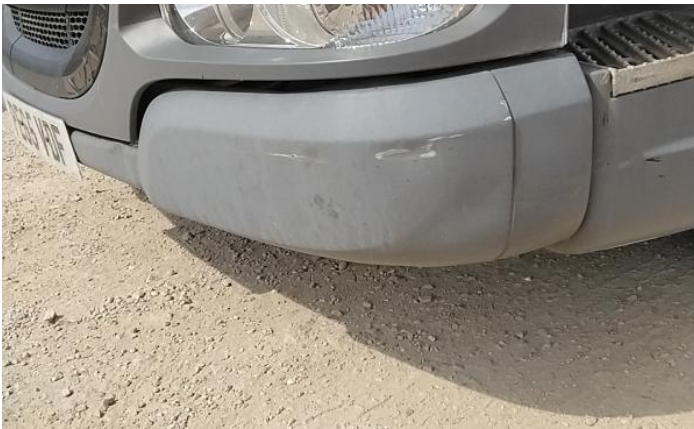
5: Bumper Front  
Dented  
With Paint Damage

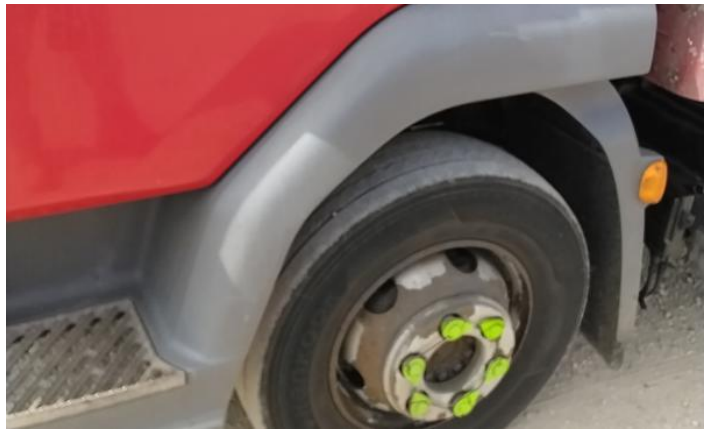
6: Wing Front Arch Extension ns  
Scuffed (Unpainted)  
UpTo 100mm

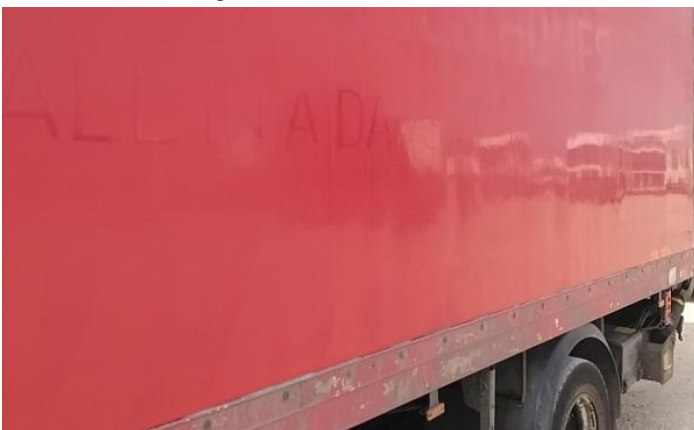
7: Qtr Panel nsr  
Scratched  
Over 25mm Not Thru Paint

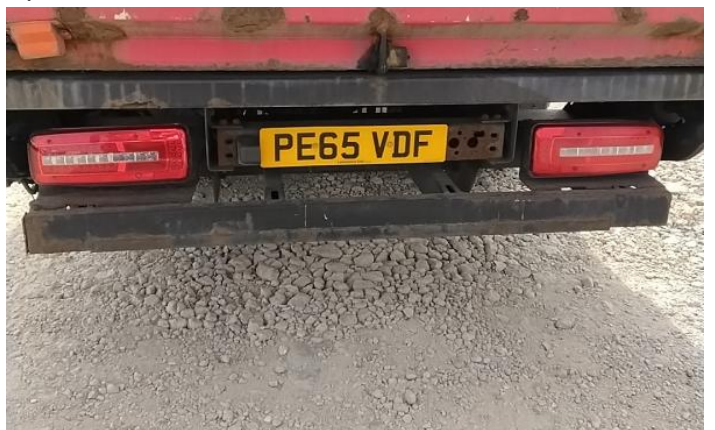
8: Bumper Rear  
Rusted  
Over 5mm

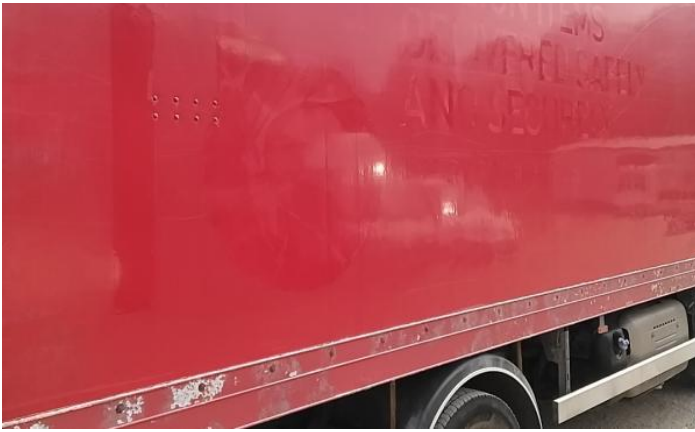
9: Qtr Panel osr  
Scratched  
Over 25mm Not Thru Paint

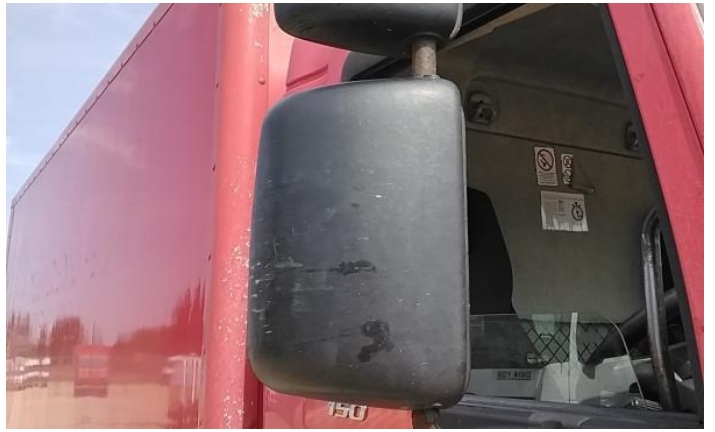
10: Door Mirror Assy osf  
Scuffed (Unpainted)  
UpTo 100mm

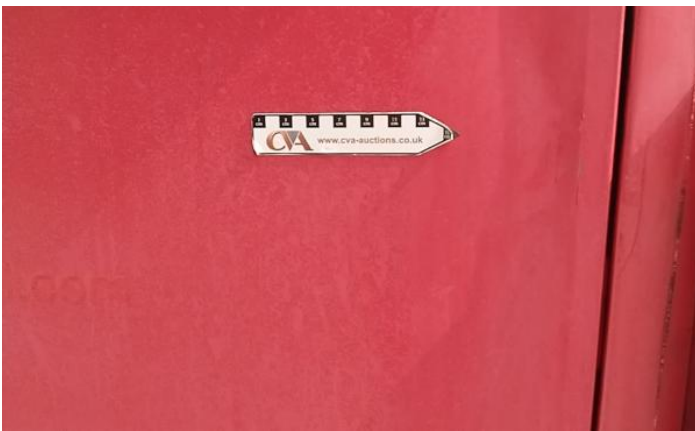
11: Door osf  
Dented  
With Paint Damage

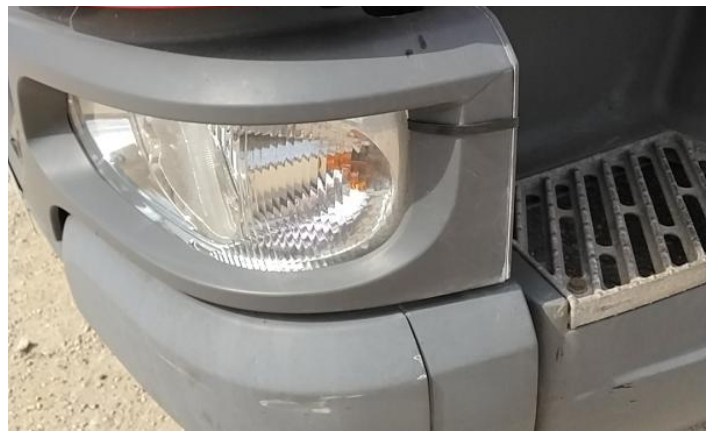
12: Fog Lamp Surround ns  
Broken  
Replace

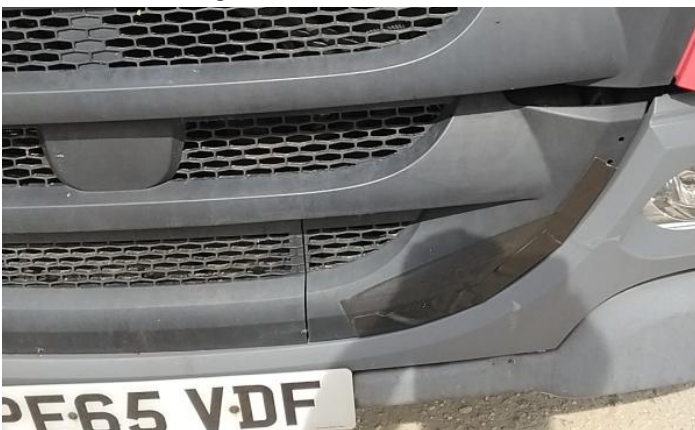
13: Grille Front  
Broken  
Replace

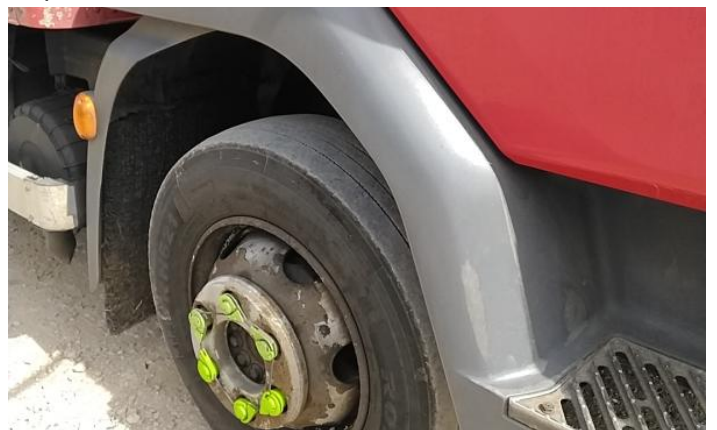
14: Wing Front Arch Extension os  
Scuffed (Unpainted)  
UpTo 100mm

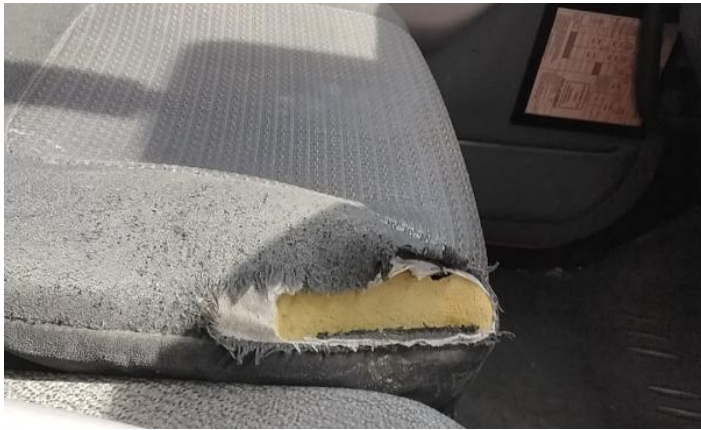
15: Seat Base Cover nsf  
 Holed  
 Over 3mm
