# VEHICLE INSPECTION REPORT

**EX22ZXB**

## Ford Transit 350 2.0 EcoBlue 130ps

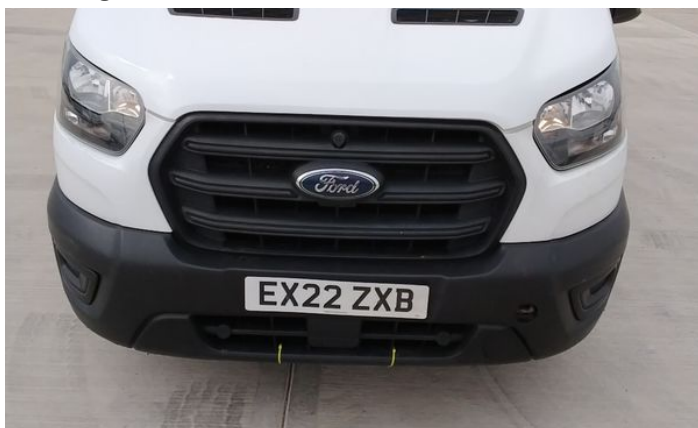
1: Bonnet  
Chipped  
Multiple Chips

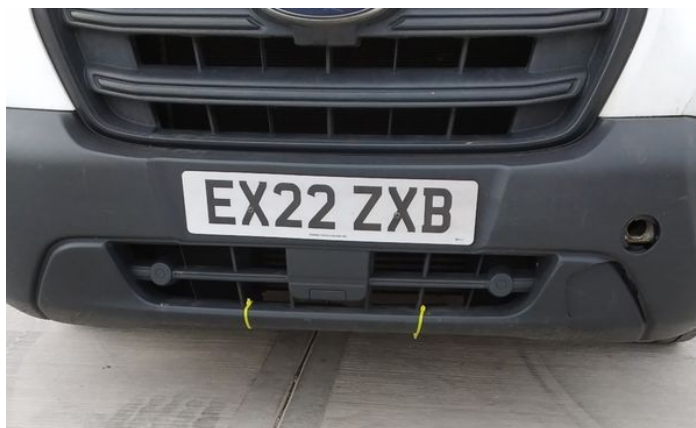
2: Bumper Front Grill  
Broken  
Replace

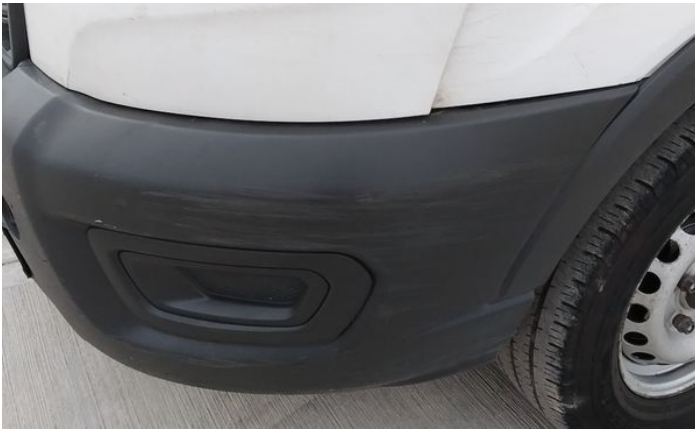
3: Bumper Front  
Scratched  
Over 100mm Thru Paint

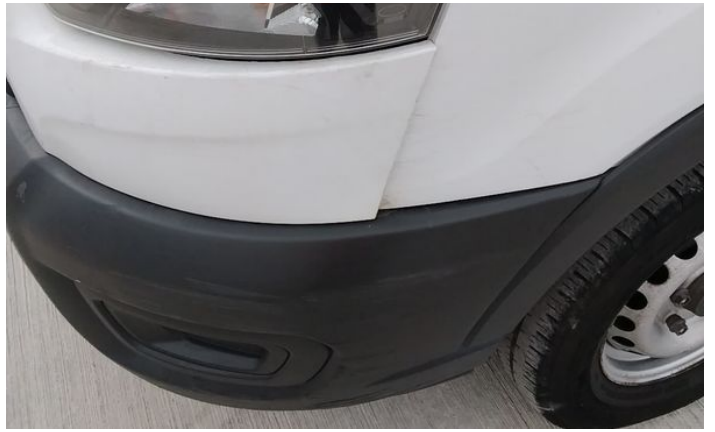
4: Wing nsf  
Scratched  
Over 25mm Thru Paint

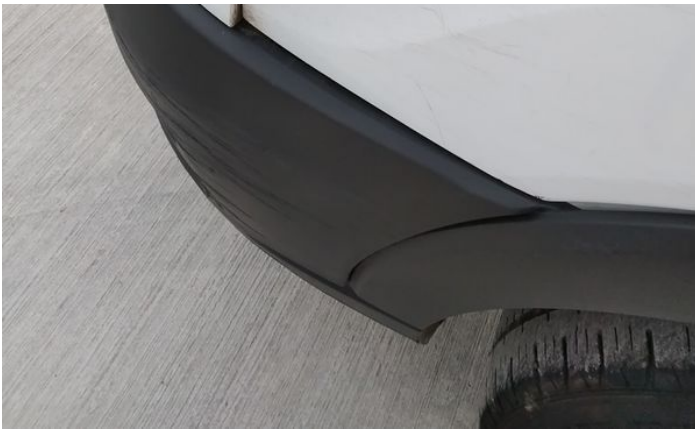
5: Wing nsf  
Dented  
Over 30mm

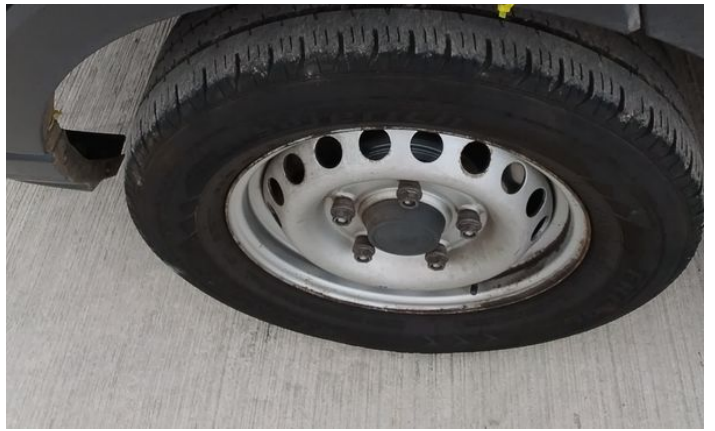
6: Wing Front Arch Extension ns  
Broken  
Replace

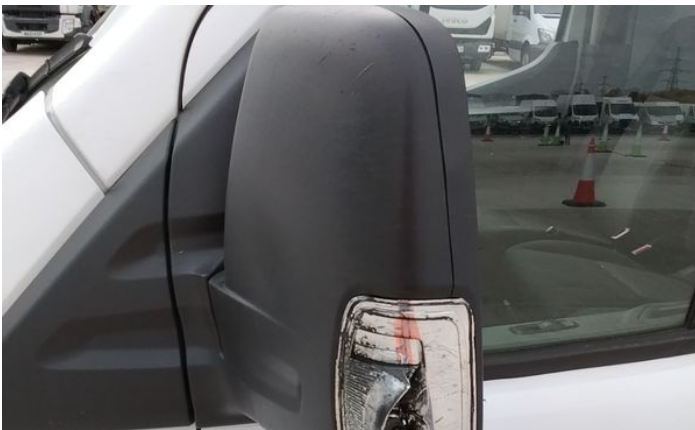
7: Door Mirror Assy nsf  
Broken  
Replace

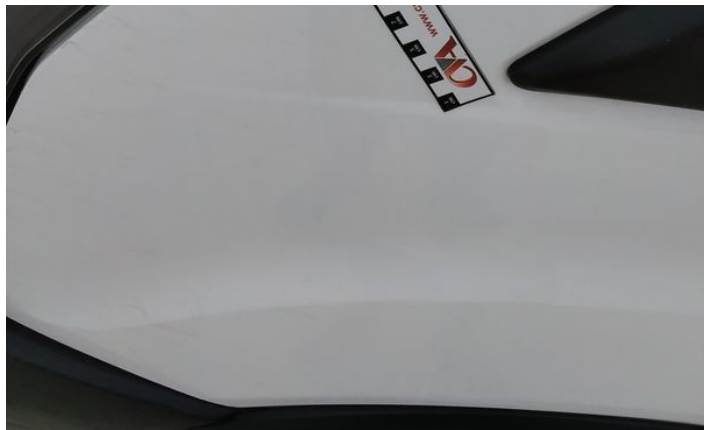
8: Wing nsf  
Dented  
With Paint Damage

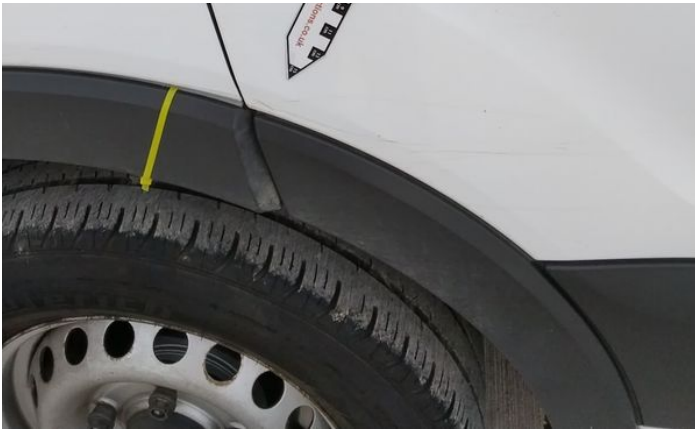
9: Door nsf  
Scratched  
Over 25mm Thru Paint

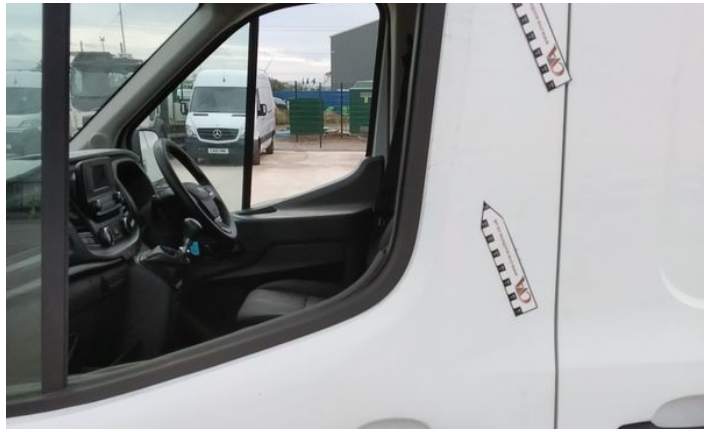
10: Door nsf  
Scratched  
Over 25mm Thru Paint

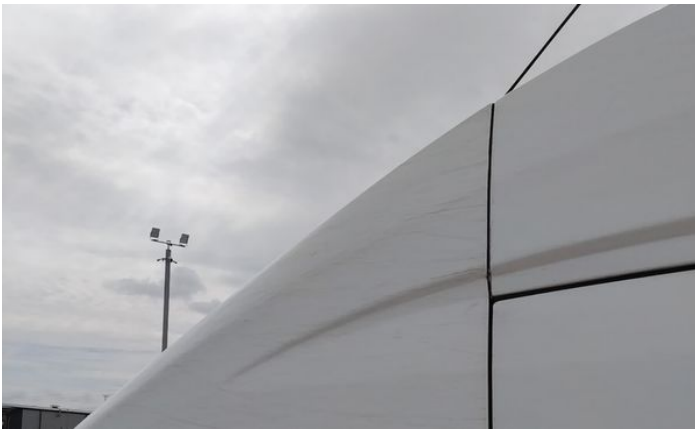
11: Roof  
Scratched  
Over 25mm Thru Paint

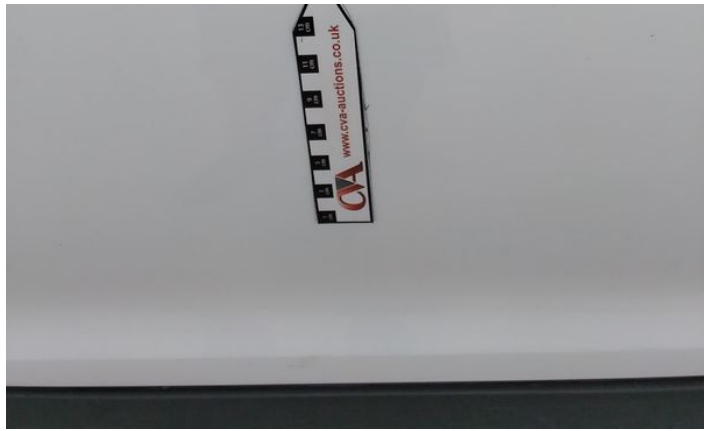
12: Qtr Panel nsr  
Cracked  
Replace

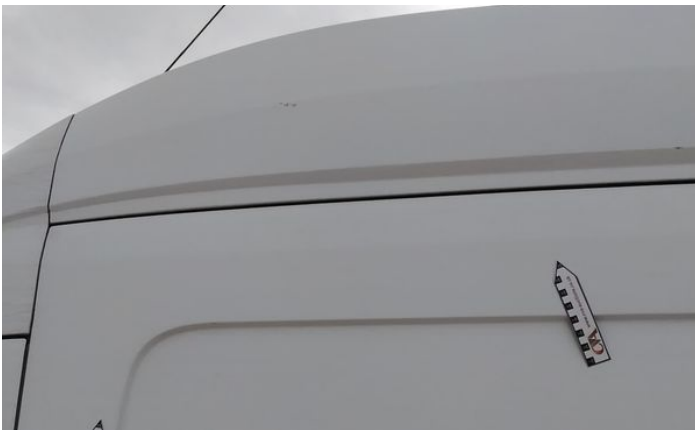
13: Qtr Panel nsr  
Scratched  
Over 25mm Thru Paint

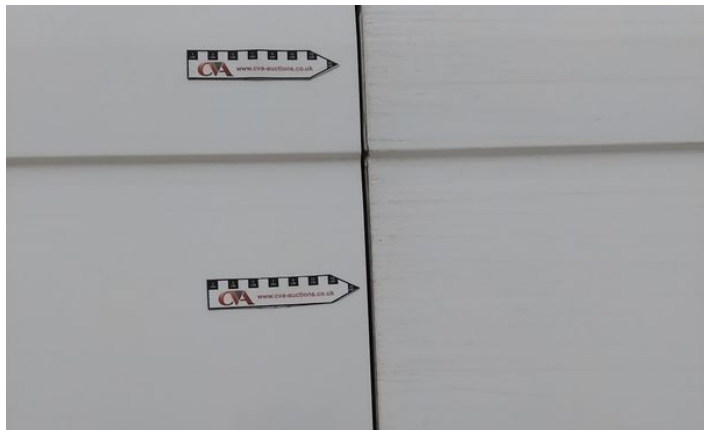
14: Qtr Panel nsr  
Scratched  
Over 25mm Thru Paint

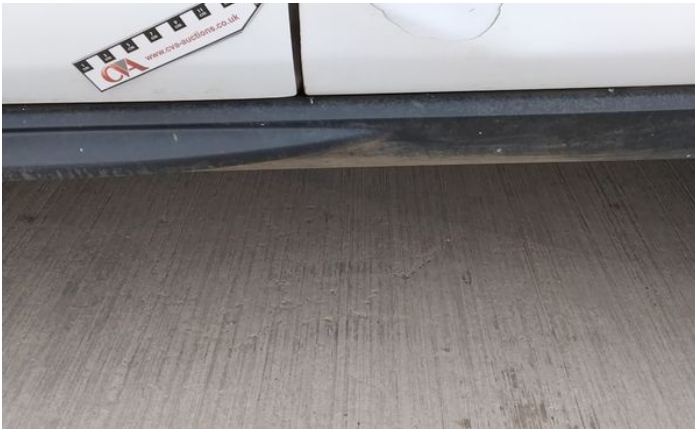
15: Qtr Panel nsr  
Cracked  
Replace

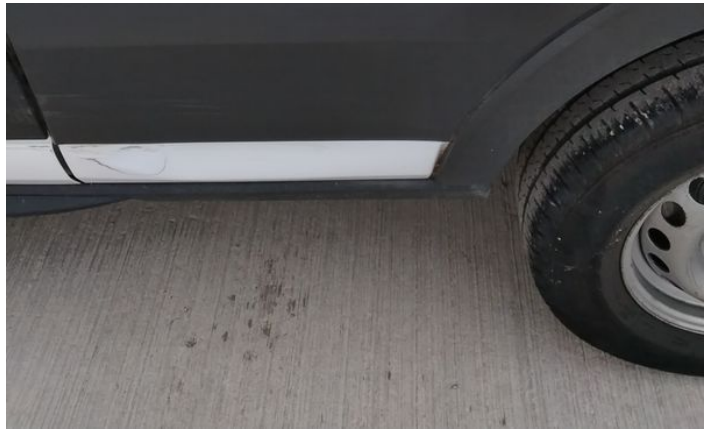
16: Qtr Panel nsr  
Scratched  
Over 25mm Not Thru Paint

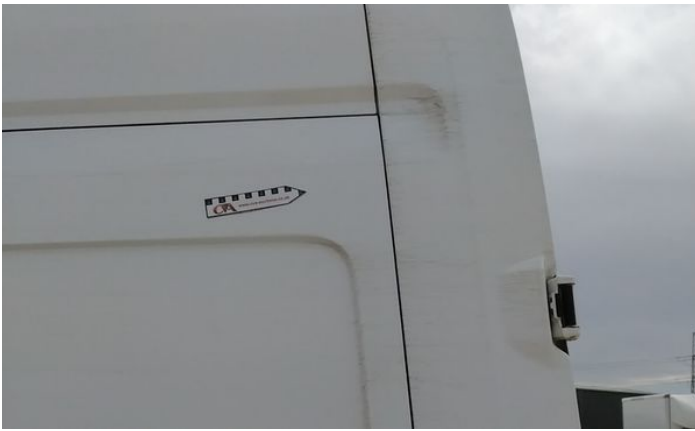
17: Qtr Panel nsr  
Scratched  
Over 25mm Thru Paint

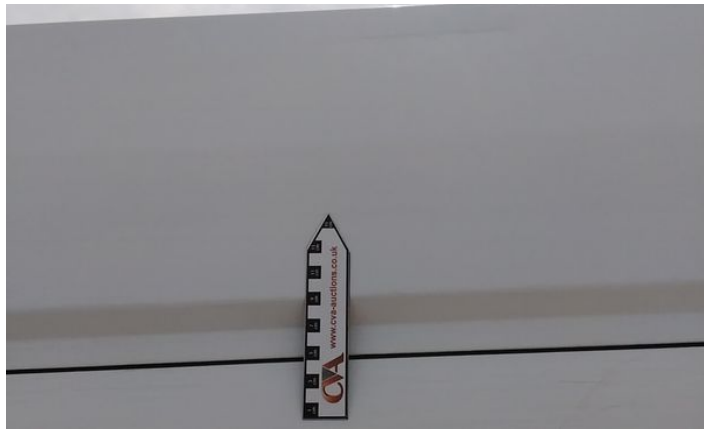
18: Qtr Panel nsr  
Dented  
Over 30mm

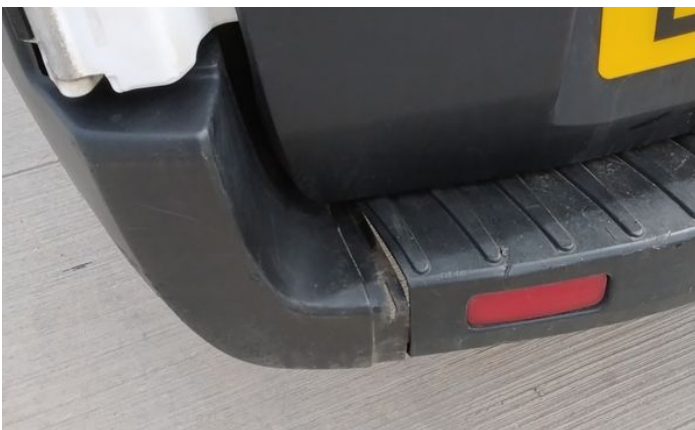
19: Bumper Rear  
Insecure  
Action Required

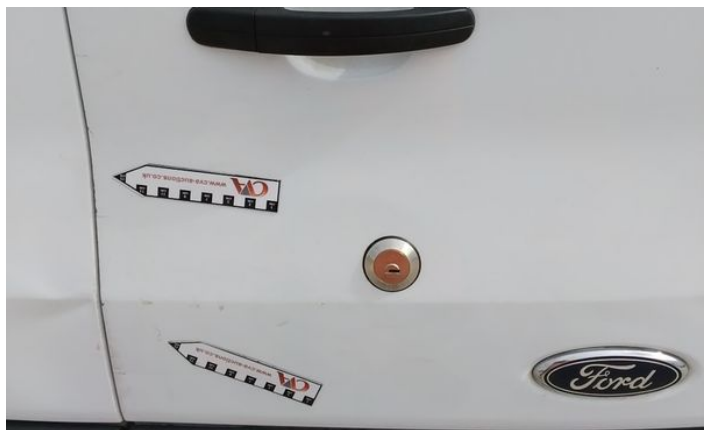
20: Door osr  
Scratched  
Over 25mm Thru Paint

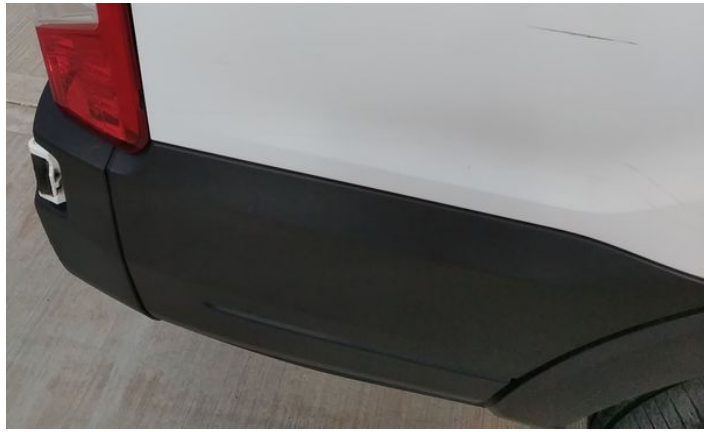
22: Qtr Panel osr  
Scratched  
Over 25mm Thru Paint

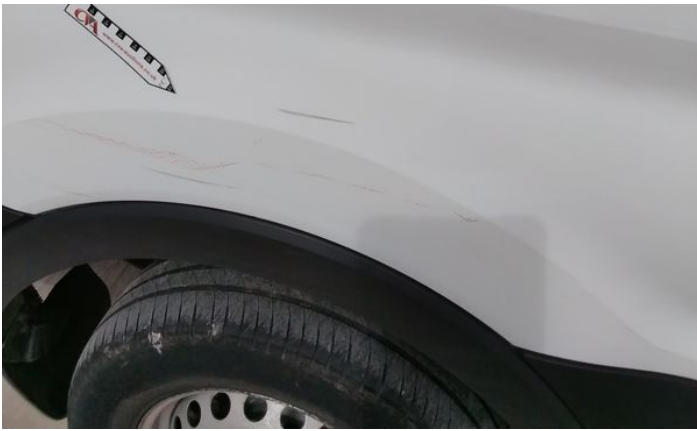
23: Qtr Panel osr  
Scratched  
Over 25mm Thru Paint

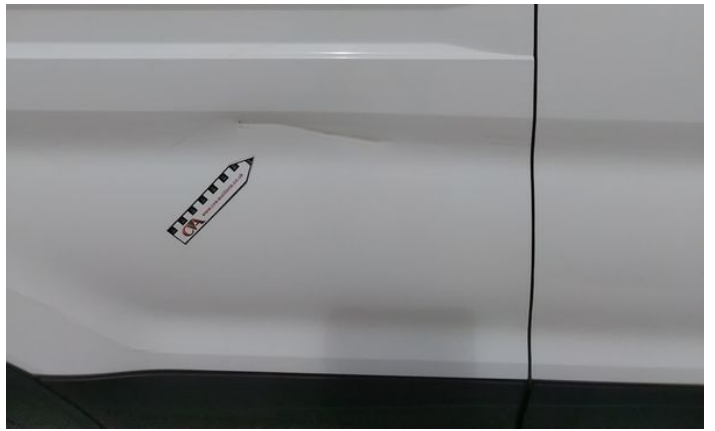
24: Qtr Panel osr  
Scratched  
Over 25mm Thru Paint

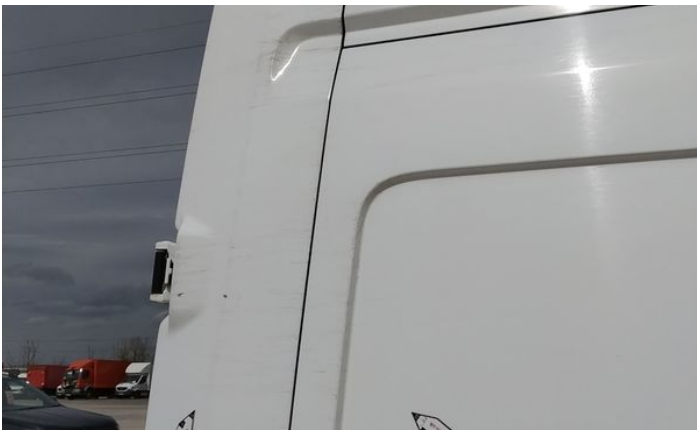
25: Qtr Panel osr  
Scratched  
Over 25mm Thru Paint

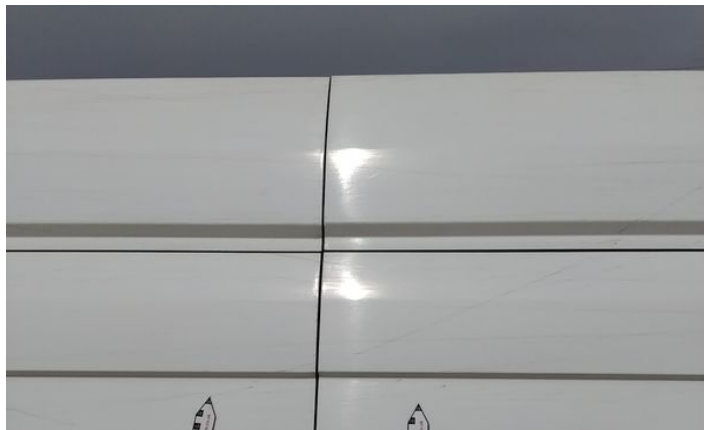
26: Qtr Panel osr  
Scratched  
Over 25mm Thru Paint

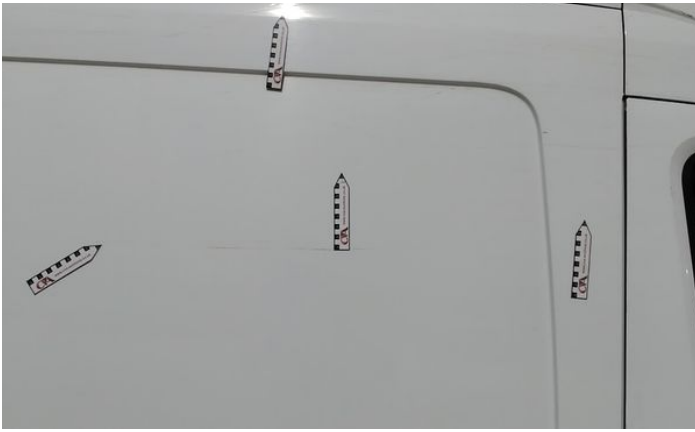
27: Qtr Panel osr  
Scratched  
Over 25mm Thru Paint

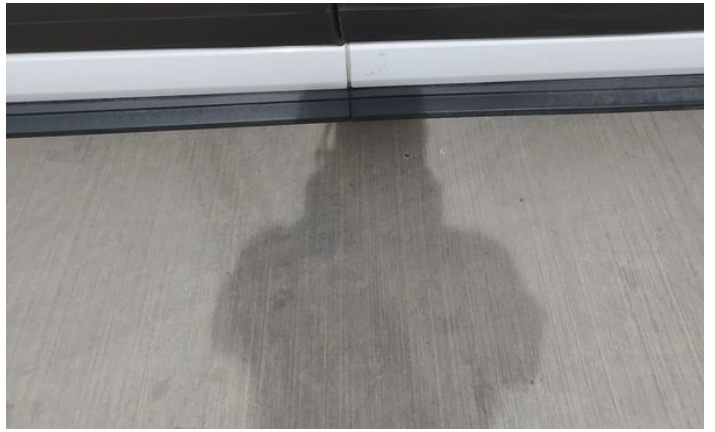
28: Qtr Panel Moulding os  
Scratched (Painted)  
Over 25mm Thru Paint

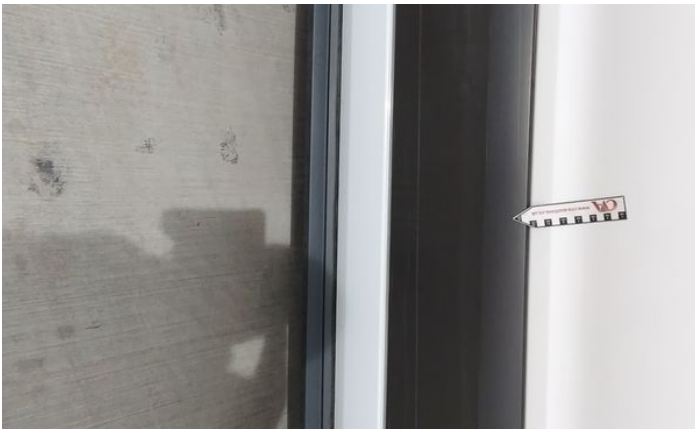
29: Qtr Panel Moulding os  
Scratched (Painted)  
Over 25mm Thru Paint

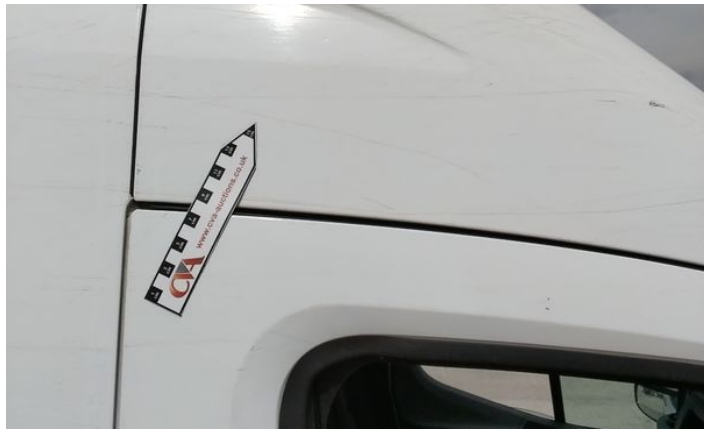
30: Roof  
Scratched  
Over 25mm Thru Paint

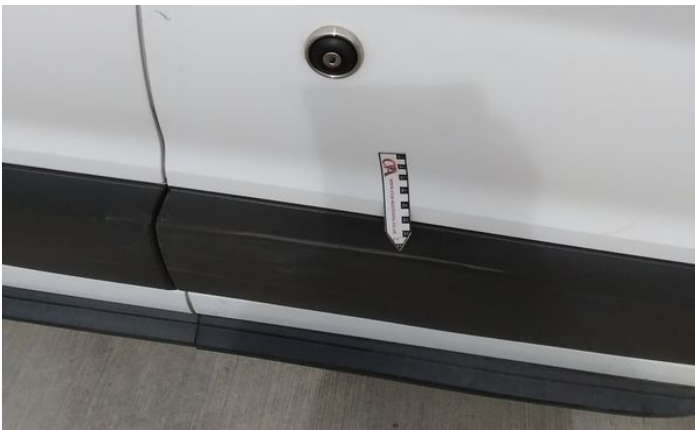
31: Door osf  
Scratched  
Over 25mm Thru Paint

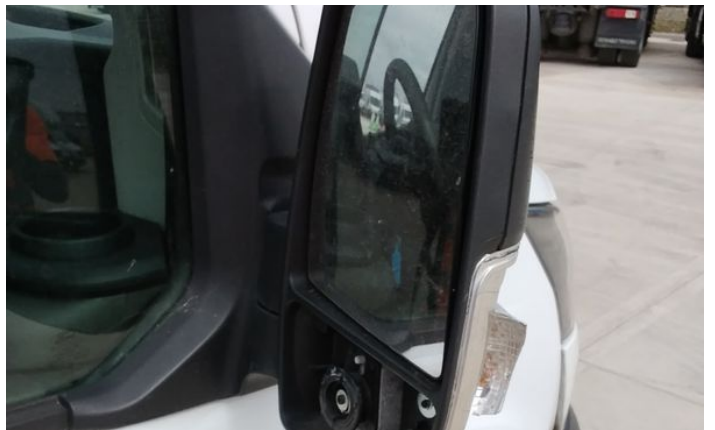
32: Door Mirror Assy osf  
Broken  
Replace

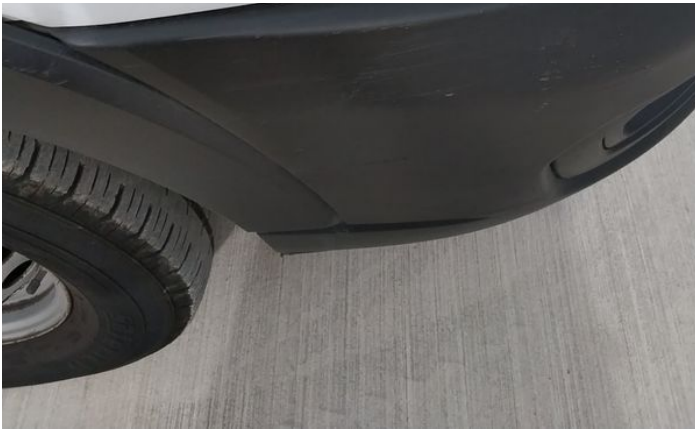
33: Wing osf  
Dented  
Over 30mm

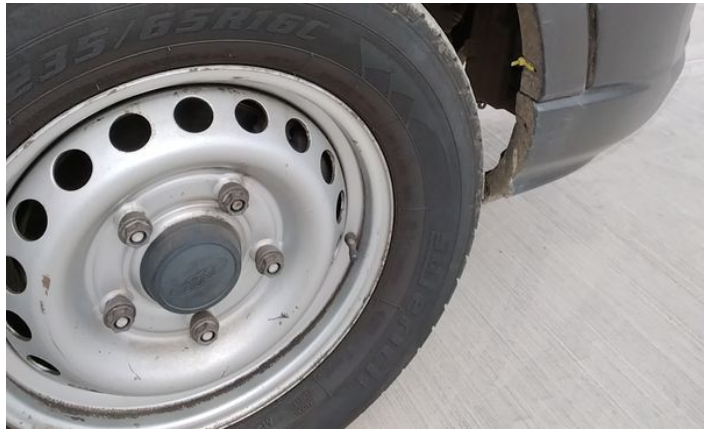
34: Wing Front Arch Extension os  
Broken  
Replace

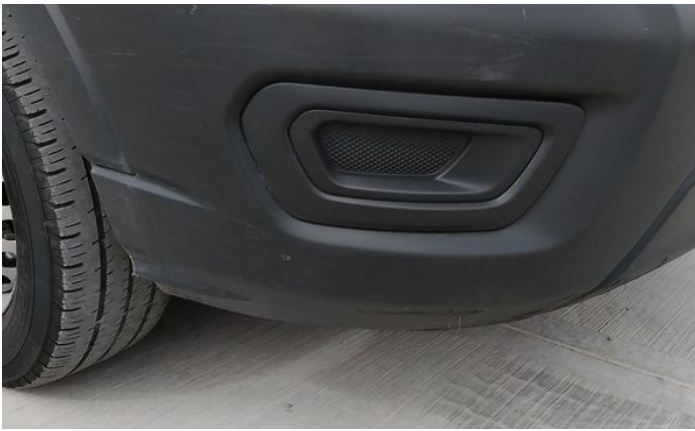
35: Bumper Front  
Scratched  
Over 100mm Thru Paint

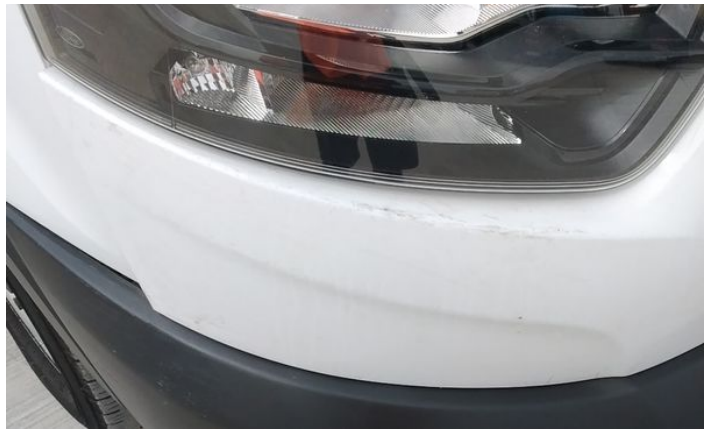
36: Wing osf  
Scratched  
Over 25mm Not Thru Paint

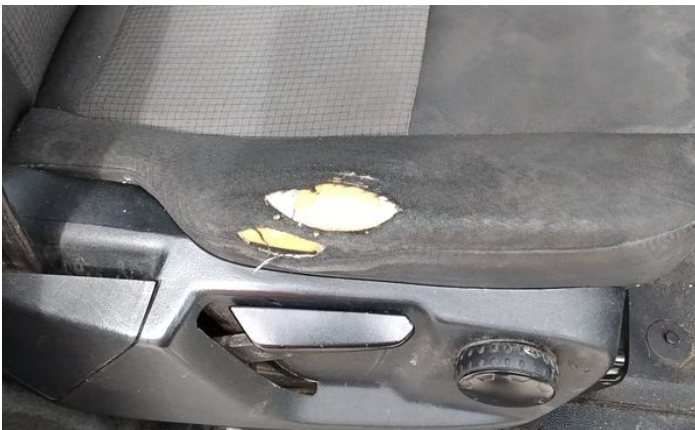
37: Seat Base Cover osf  
Holed  
Over 3mm

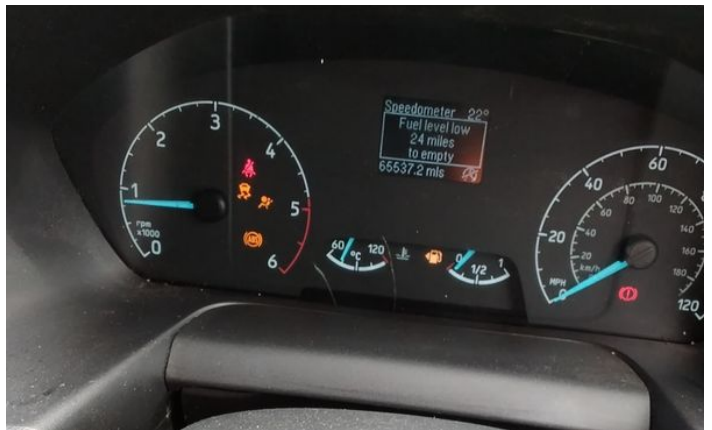
38: Dash Warning Lights  
Displayed  
No Action

| Carpet Condition | | Average | Upholstery Condition | | Average |
|---|---|---|---|---|---|
| Airbag light illuminated | Fault | | | | |
| ABS light illuminated | Fault | | | | |
