## VEHICLE INSPECTION REPORT

**KM11NKU**

### Mercedes-Benz Sprinter 313 CDI

**Non Runner**  
Inspection

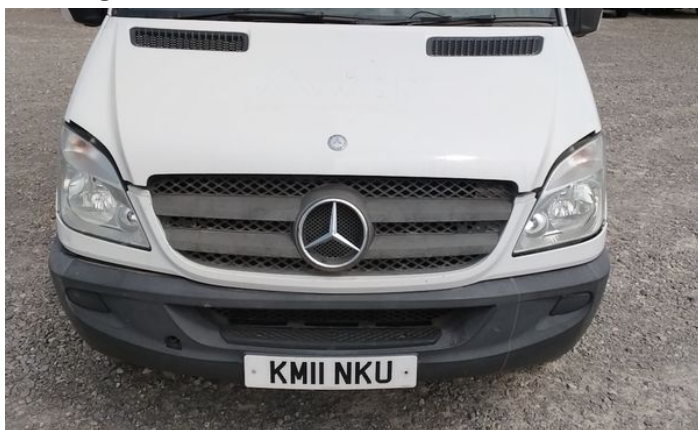
1: Bonnet  
Chipped  
Multiple Chips

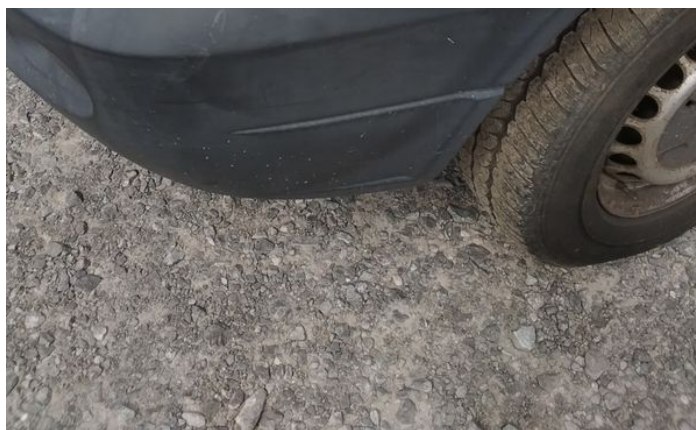
2: Wing nsf  
Cracked  
Replace

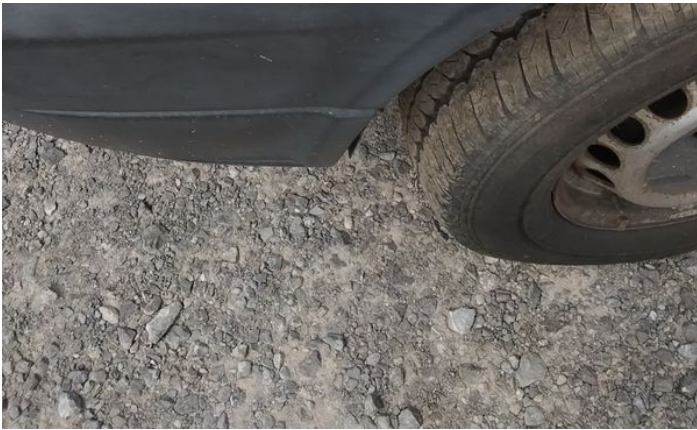
3: Bumper Front  
Insecure  
Action Required

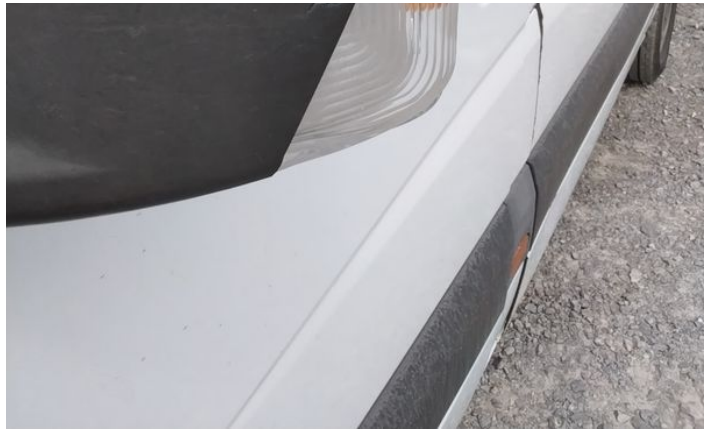
4: Door Mirror Assy nsf  
Broken  
Replace

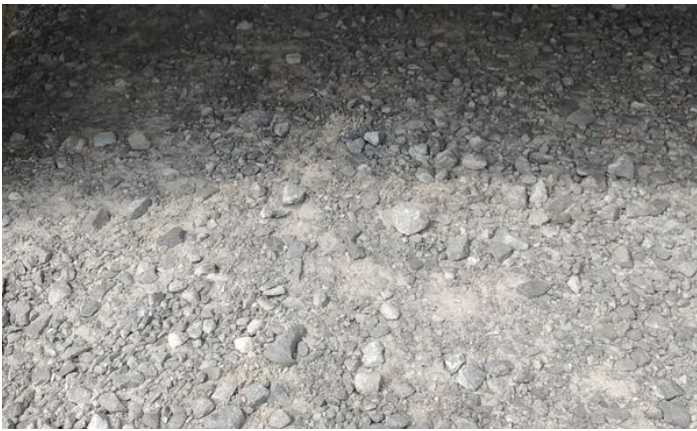
5: Sill ns  
Rusted  
Over 5mm

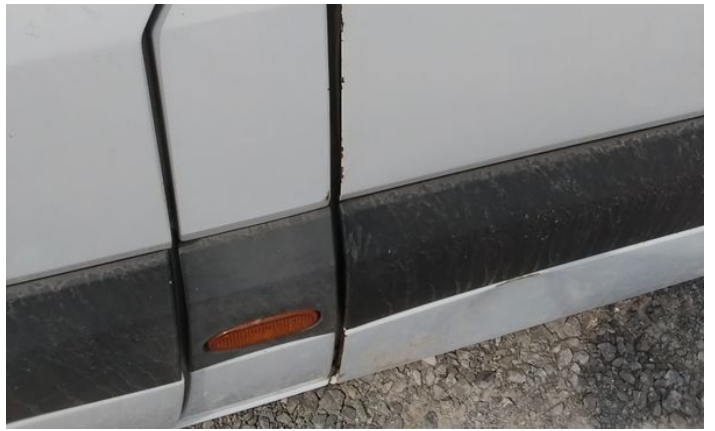
6: Qtr Panel nsr  
Chipped  
Multiple Chips

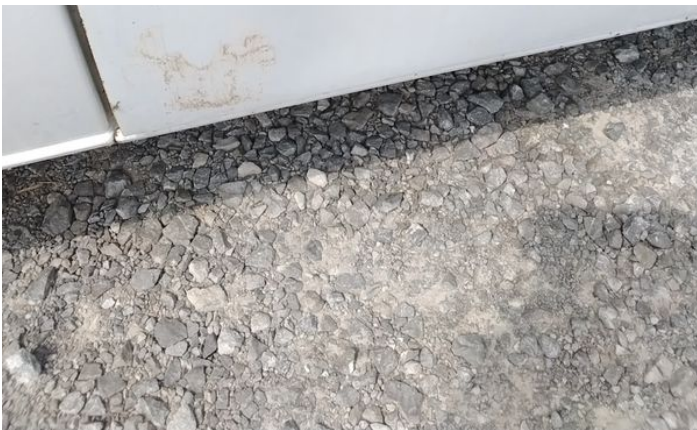
7: Qtr Panel nsr  
Dented  
With Paint Damage

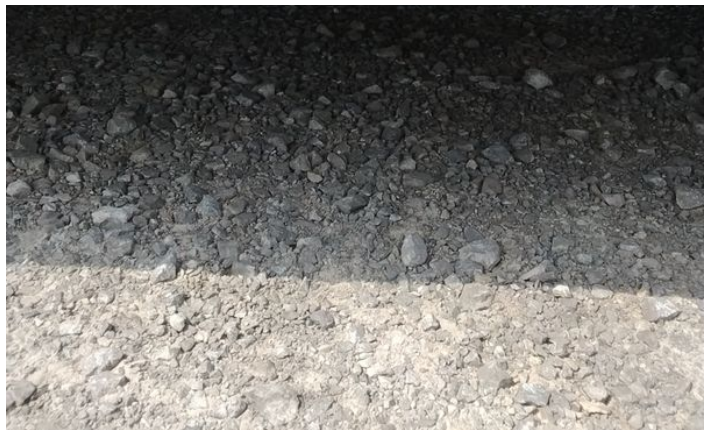
8: Sill ns  
Dented  
Over 30mm

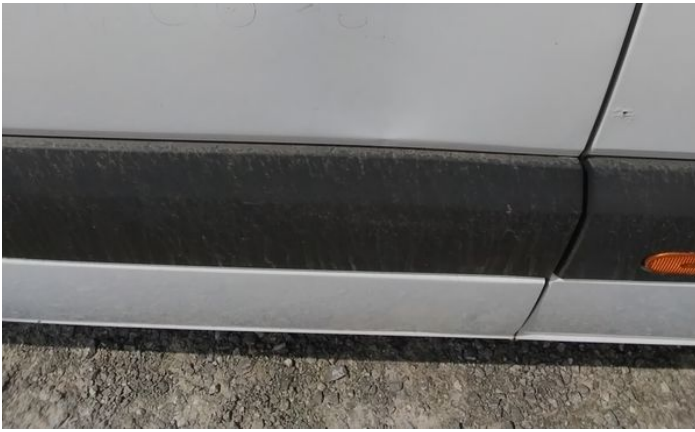
9: Qtr Panel nsr  
Cracked  
Replace

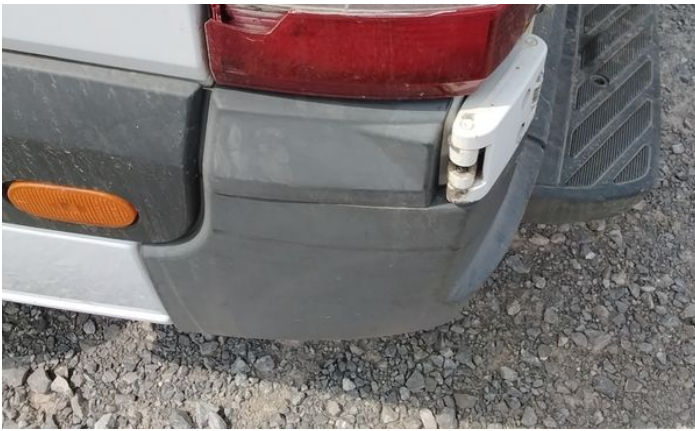
11: Lamp nsr  
Broken  
Replace

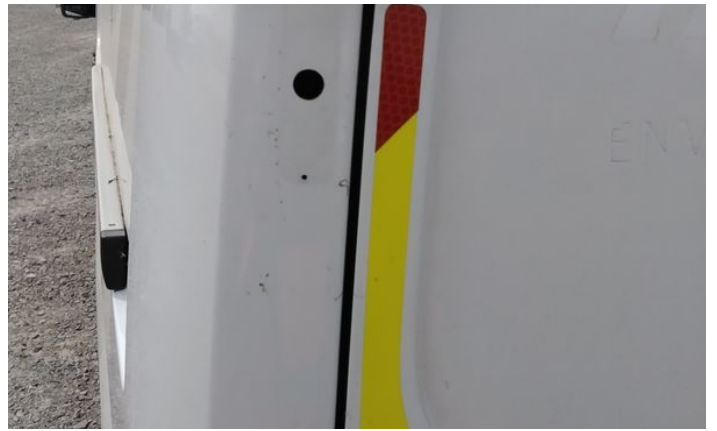
12: Qtr Panel Moulding ns  
Missing  
Replace

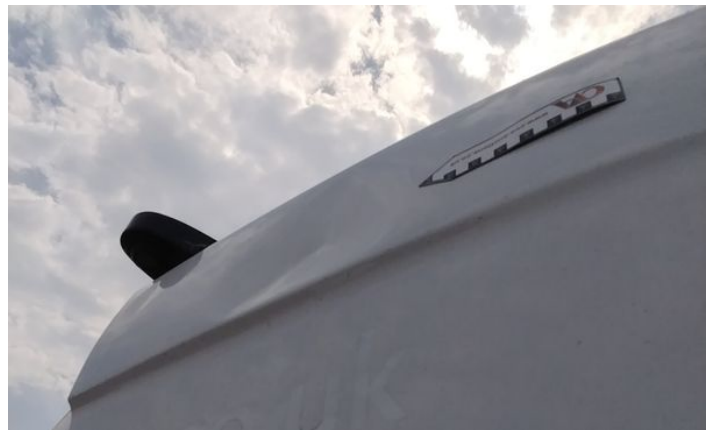
14: Door osr  
Dented  
Over 30mm

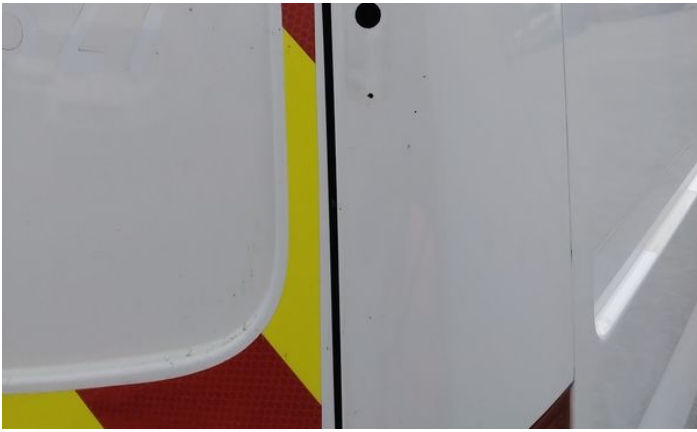
15: Qtr Panel Moulding os  
Missing  
Replace

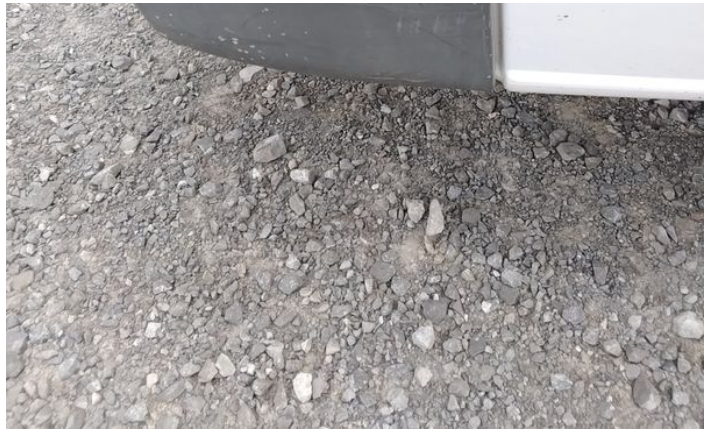
16: Bumper Rear  
Scratched  
Over 100mm Thru Paint

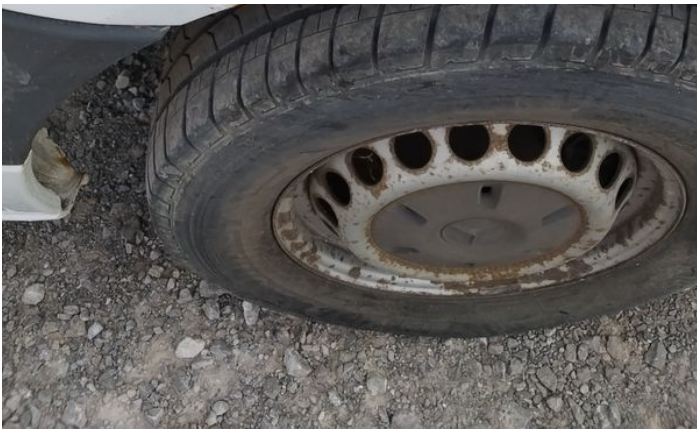
17: Qtr Panel osr  
Rusted  
Over 5mm

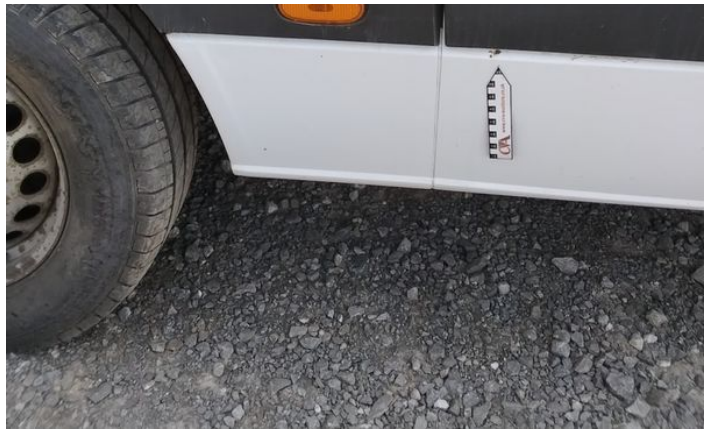
18: Qtr Panel osr  
Rusted  
UpTo 5mm

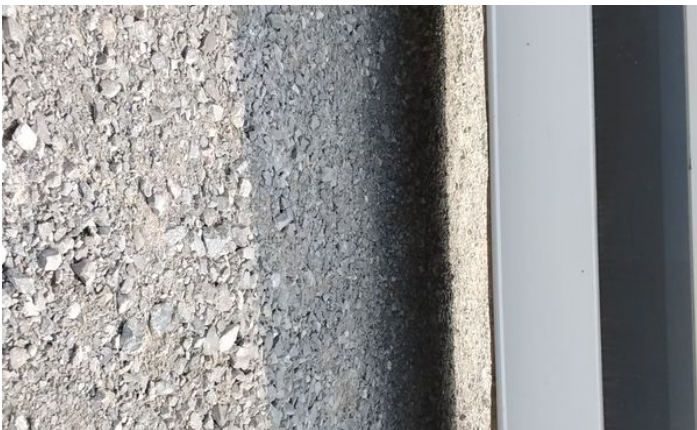
19: Sill os  
Dented  
Over 30mm

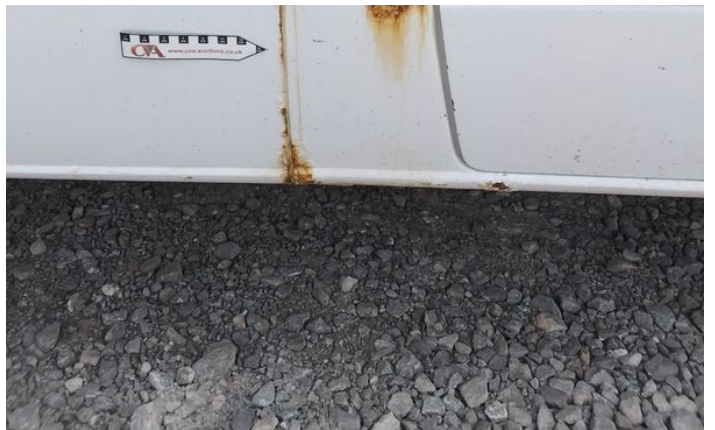
20: Qtr Panel osr  
Rusted  
Over 5mm

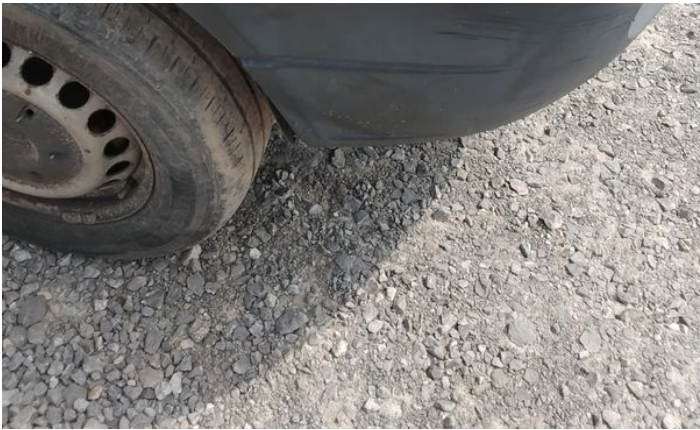
21: Bumper Front  
Insecure  
Action Required

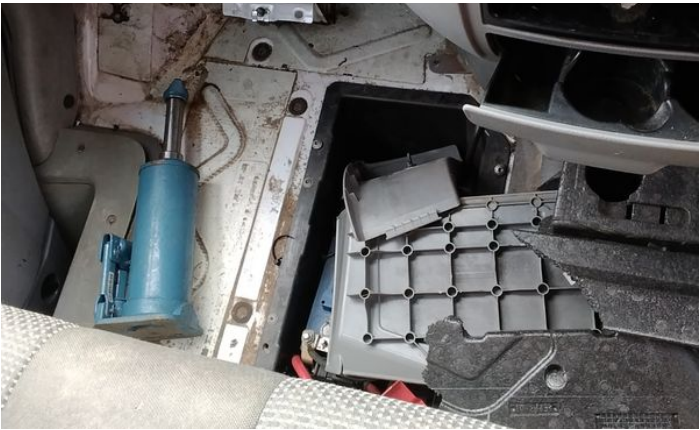
22: Carpets Front  
Missing  
Replace

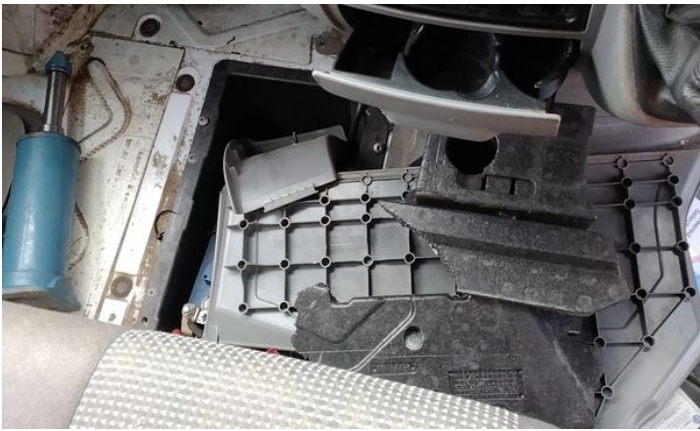
23: Fascia Trim  
Missing  
Replace
